Civil Infrastructure

AMS - Electricity Distribution Network

Document number	AMS 20-55
Issue number	3
Status	Approved
Approver	Paul Ascione
Date of approval	21/6/2019

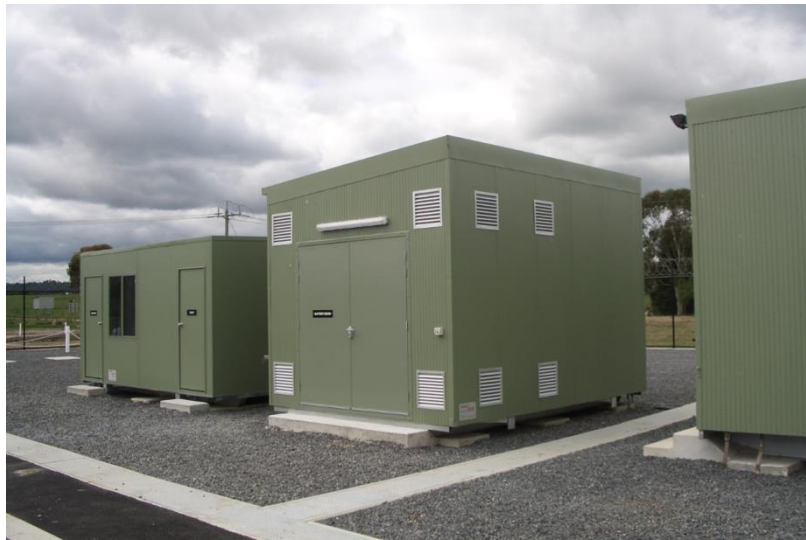
Seventy one percent of buildings inside AusNet Services' sites are modular or prefabricated type. Typically these buildings are sheet-metal cladding over a galvanised steel frame with plaster board linings and laminated timber floors on a concrete pad or pile footing. Constructed offsite; multifunctional modular buildings have minimal installation costs and are currently most economic for new infrastructure and station rebuilds. These constructions have an engineering life in excess of 40 years. Figure 3 below shows modular type building located at Lysterfield zone substation (LYD).

Figure 3 – Prefabricated buildings at Lysterfield zone substation (LYD)

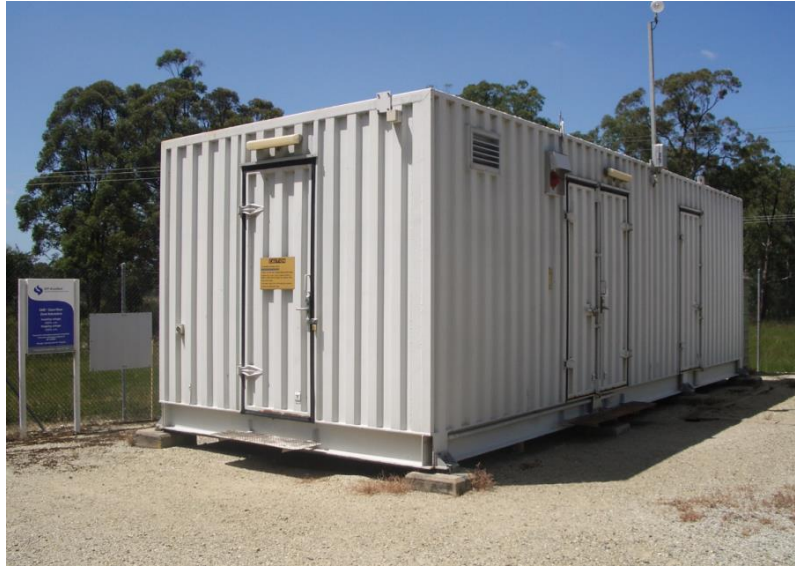
In two stations, Kilmore South (KMS) and Cann River (CNR), shipping containers also have been used as modular buildings. These buildings are supported by the concrete pad footings or slab foundation depending on the geotechnical conditions of the site. An example of shipping container type control building at CNR zone substation is shown in Figure 4.

Figure 4 – Shipping container type control building at Cann River zone substation (CNR)

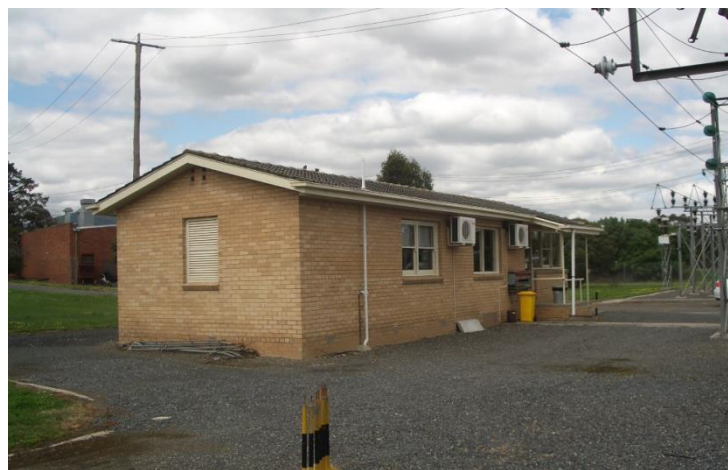
Approximately seventeen percent of buildings have been constructed with brick veneer and concrete slab flooring. As a cladding material, brick has excellent fire resistance and security performance. Tilt-slab concrete construction has also been used for control rooms and 22 kV indoor switchgear buildings. Entrance landings and steps to these buildings are also built on concrete slabs. Figure 5 below shows concrete slab and brick wall control building located at Croydon zone substation (CYN).

Figure 5 – Brick control building at Croydon zone substation (CYN)

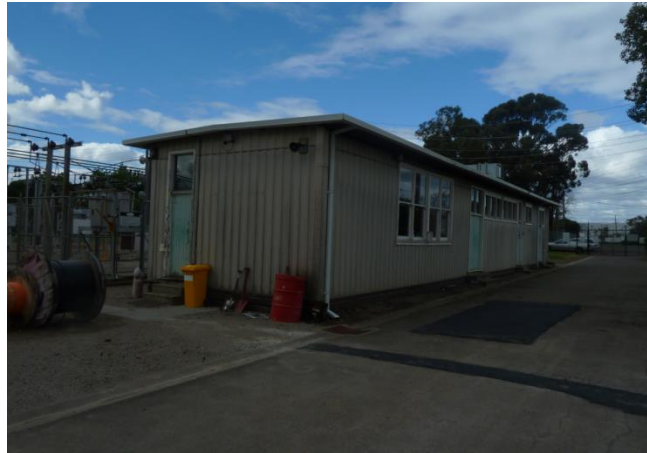
Asbestos, which have been actively targeted for removal, is still present in 5% of AusNet Services' zone substation sites with varying levels of volume and risk. These buildings induce potential health and environmental risks to the personal who are onsite. Seven buildings at four zone substations contain asbestos in different components including exterior wall cladding, eave linings, doors, windows, floor tiles or roof sheeting or ceiling linings. These buildings usually have a hardwood timber frame and are mounted on either concrete flooring slabs or concrete or timber stumps. In other cases there are still small amounts of asbestos found within the cladding, at the rear of relay mounting panels and in doors and window frames. Figure 6 below shows the the control building at Thomastown zone substation (TT) which has DC and relay panels, isolating transformer

cubicle and main distribution board with asbestos. These are non-friable and in Good to Fair condition so the risk to personnel is low (i.e. Residual Risk rating of IV).

Figure 6 –Thomastown zone substation (TT) control building has ACM panels, transformer cubicles, etc.

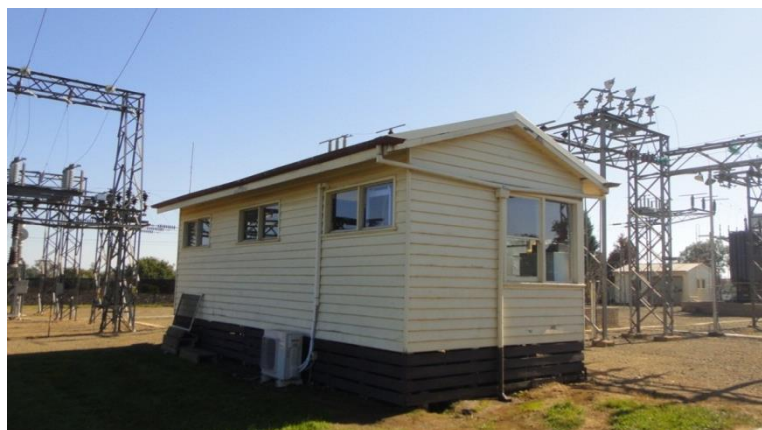
One percent of AusNet Services' buildings are Hardie plank or timber weatherboard clad structures. These buildings are typically built on timber or concrete stumps with a timber floor and frame. Where they have been built on stumps, wooden slats have been installed as a skirt between the floor and ground level to restrict entry to secondary cabling. Cable trenches in these buildings finish under the edge of the building and exposed cables then run along ground directly to a point underneath the secondary panel in which they terminate. Figure 7 shows a typical weather board clad control building located at Warragul zone substation (WGL).

Figure 7 – Wood board clad control building at Warragul zone substation (WGL)

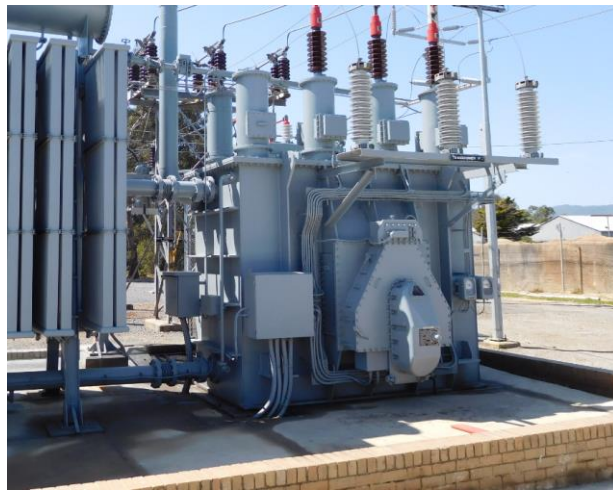
New transformers are installed with concrete-floored sealed bunds and appropriate oil handling drainage. These installations use materials and seals that are impervious to oil. Drainage includes flame traps, valves, oil interceptor pits and Puraceptor separation system allow rainwater to drain but trap oil. This design has proven to be the most effective way to minimise the risk of transformer oil having an environmentally significant impact. New constructions for oil containment on the distribution network are compliant with AS 2067² and AS1940³ as required:

- A full volume holding tank/ Triple interceptor tank for primary sedimentation and oil separation
- Concrete bunding area with drainage pit
- Oil transfer pipe line network with flame trap
- Oil Water Separator unit / system to limit the discharge to less than 5ppm

Figure 8 – Concreted bunded area at Bayswater zone substation (BWR)

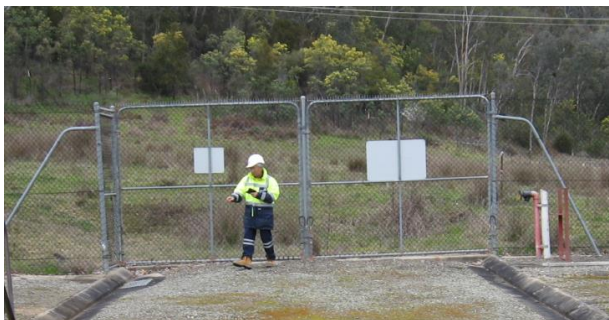
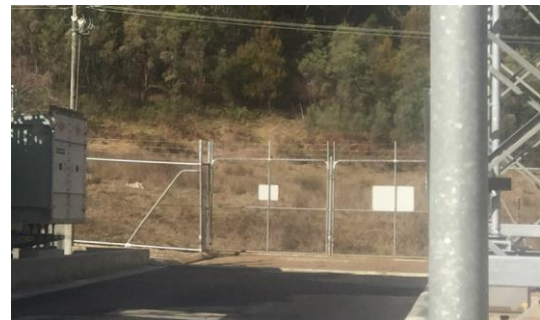
Figure 9 a and b illustrate an early type of fence which had additional security features added, i.e. topping of barb wires, in accordance with assessed security risk during a planned asset replacement project. AusNet Services likewise take appropriate actions to restore the security fence condition whenever a damaged fence is identified.

Figure 9 a and 9b - Security fence & gate at Mt. Beauty zone substation (MBY), before & after augmentation

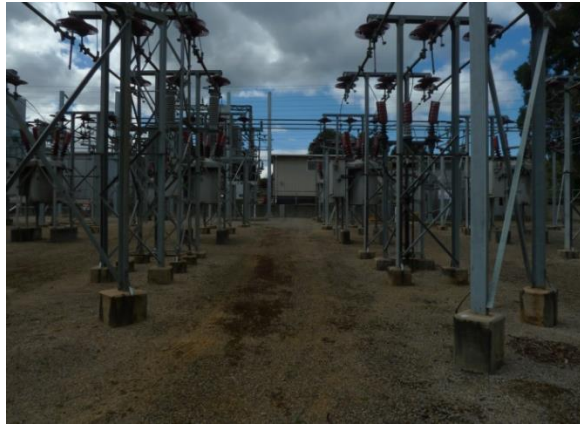
Figure 10 shows the unsurfaced switchyard at Watsonia zone substation (WT).

Figure 10 – Unsurfaced Switchyard surface at Watsonia zone substation (WT)

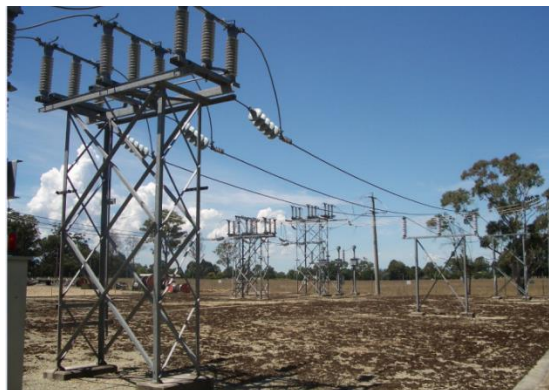
Figure 11 shows the switchyard with weed and moss growth at Numeralla zone substation (NLA).

Figure 11 – Condition of switchyard surface at Numeralla zone substation (NLA)

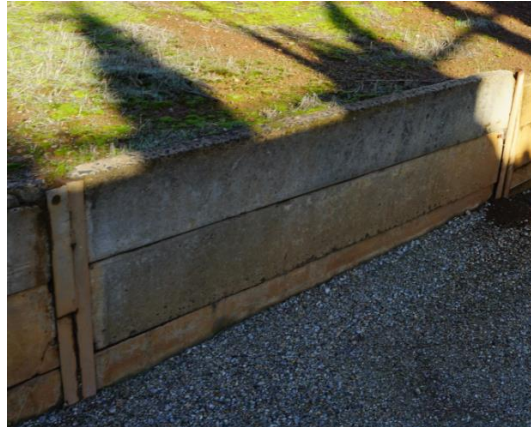
Some stations have been benched at several levels across the site depending on the local topographical and geometrical conditions. Typically some form of retaining wall is required to stabilise the fill or slope areas and protect equipment from possible slippages and slope failures. Recently, the retaining wall along the access road at Warragul zone substation (WGL) has been replaced as part of its rebuild as shown in Figure 12.

Figure 12 – Retaining Wall at Warragul zone substation (WGL)

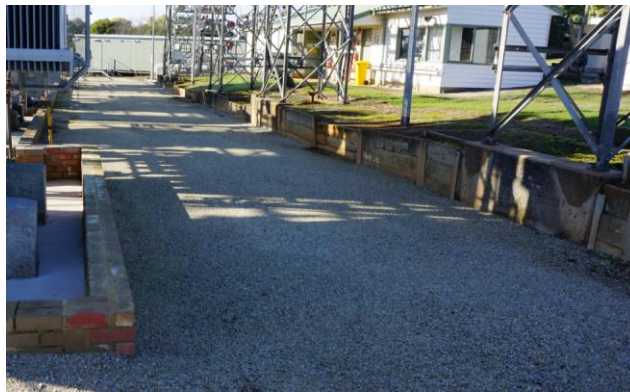
Figure 13 shows the access road located at Warragul zone substation (WGL).

Figure 13 – Access road surface located at Warragul zone substation (WGL)

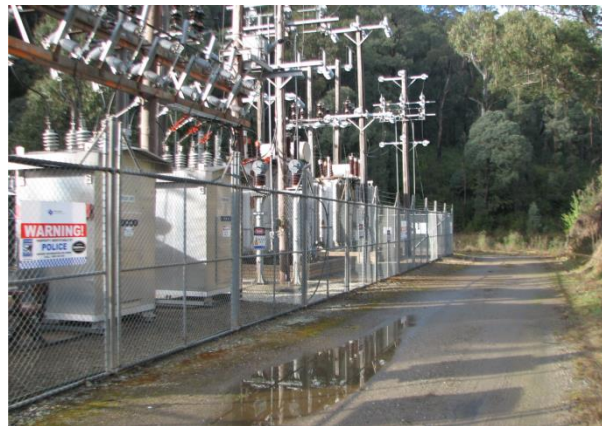
Sealed roadways within stations are typically not heavily utilised and exhibit low rates of wear compared to public roads. The low rate of traffic can allow weeds to grow in cracks and accelerate the break-up of the road surface. These roads can easily be repaired by patches or by being resealed and should be targeted during station rebuilds where road condition necessities arise. Figure 14 below shows the condition of the main access drive to Clover Flat zone substation (CF).

Figure 14 – Main Access Drive at Clover Flat zone substation (CF)

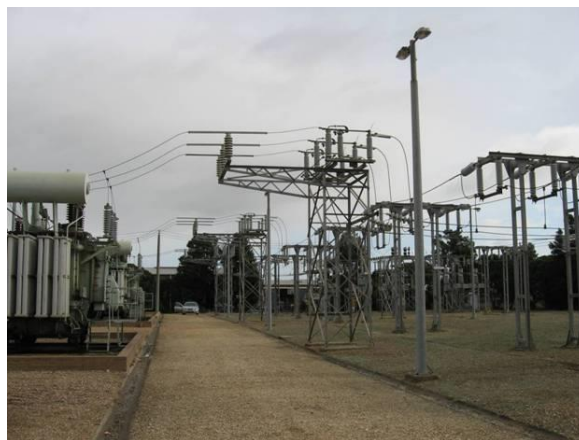
In a few stations, lights have been fitted on the existing primary plant supporting structures, therefore eliminating the need for additional poles or posts to be erected. In newer stations; lights are installed on the dedicated galvanised steel posts which are supported by concrete pad footings. Figure 15 shows switchyard lighting used at Sale zone substation (SLE).

Figure 15 – Switchyard Lighting at Sale zone substation (SLE)

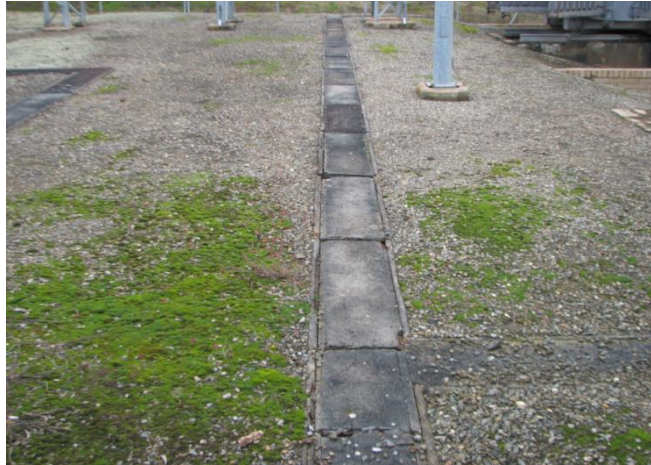
Some stations contain the direct buried cables coupled with a pit and conduit system; therefore no cable trenches are employed. Figure 16 shows the cable trench located at Mt Beauty zone substation (MBY) and its physical condition.

Figure 16 – Cable trench and cover lids at Mount Beauty zone substation (MBY)

The cable trenches have a number of issues including condition, strength and capacity. Therefore, their condition varies widely across the zone substations.

In some cases the preformed duct walls are starting to break causing the surrounding soil and rocks to enter the cable duct. This also causes the loss of the top lip of the tray that holds the concrete lid allowing it to fall onto the cable. The lids are breaking down in the same way and causing them to fall on the cables or giving the users a false sense of security and then fail under load. Therefore, some of the yards have now become tripping hazards due to the holes in the cable trenches or the failure of the cable lids under foot.

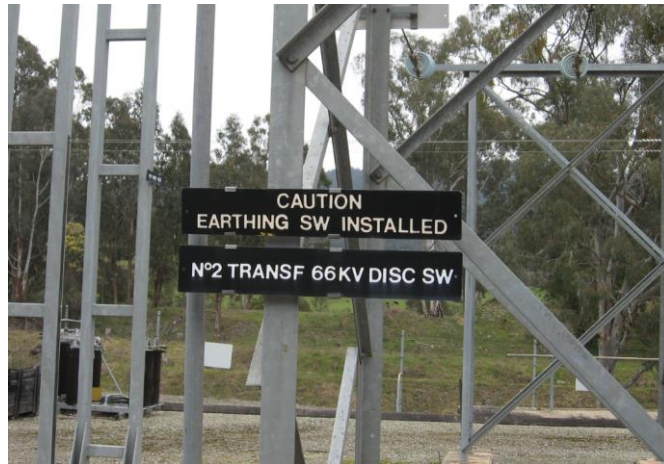
Australian Standards⁸ require that key parts of the station installation, for example busbar systems, switchgear, bays, conductors, protection indication equipment are clearly, legibly, durably and uniquely labelled. Therefore, many equipment nameplates and signs have been installed in zone substations to physically identify these assets. These operational name plates help the safe and reliable operation and maintenance of other electrical assets. Figure 17 shows the operational nameplate mounted on support structures at Mount Beauty zone substation (MBY).

Figure 17 – Operational nameplates at Mount Beauty zone substation (MBY)

Operational nameplates are typically white text on a black background and have reasonable resistance to fading. Their location within the switchyard minimises exposure to vandalism and as a result life expectancy is 10 years.

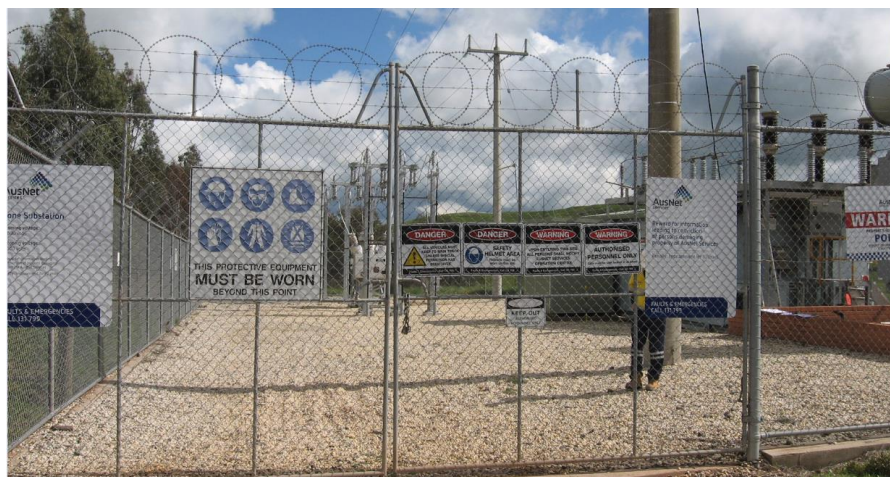
Station perimeter signage advises the public on site ownership, security warnings, and electrical hazards of the station and contact telephone numbers. Figure 18 shows perimeter signage used at Merrijig zone substation (MJG).

Figure 18 – Perimeter and Gate Signage at Merrijig zone substation (MJG)

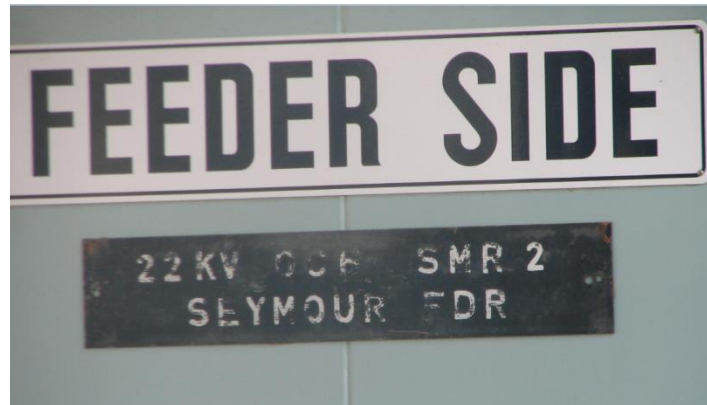
Many operational nameplates within AusNet Services' stations are becoming hard to read therefore, warrant replacement to avoid increasing human error incidents that could cause safety incidents. In a five-year period it is prudent to replace 50 per cent of operational nameplates. Figure 19 shows Faded Nameplates at 22 kV switchyard at Seymour zone substation (SMR).

Figure 19 – Faded nameplates at 22 kV Switchyard Seymour zone substation (SMR)
