Sub-transmission Towers, Insulators and Ground Wires

AMS – Electricity Distribution Network

Document number	AMS 20-64
Issue number	2
Status	Approved
Approver	Paul Ascione
Date of approval	24/10/2019

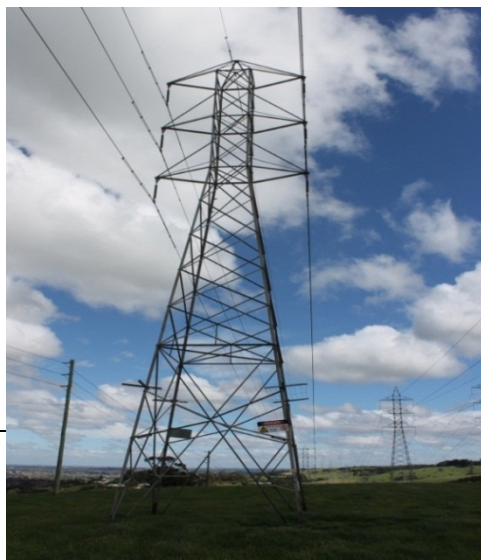
Figure 1 shows Tower 297 on the line. This tower is a double circuit conductor per phase.

Narre Warren to Pakenham structure with single

Figure 1 – Tower 297 PHM-NRN.

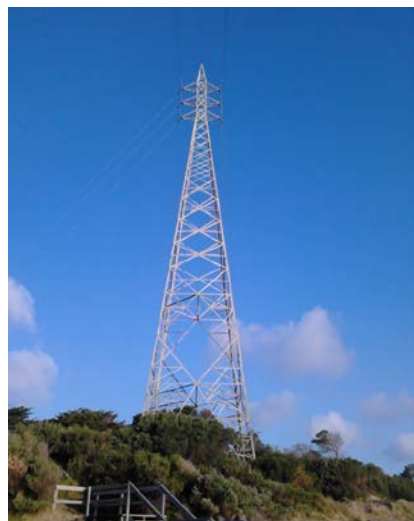
Figure 4 – San Remo Tower

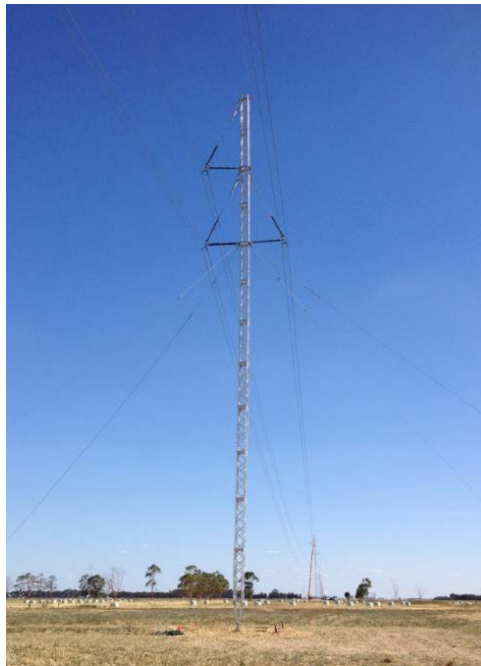
The frequency of exposure to extreme winds is regional and depends on the geographic location of the structures. Additionally, the potential of a tower failure due to extreme winds would identify the towers as having inadequate strength to withstand the downdraft winds. No spares are held for this fleet of sub-transmission towers. The plan for management of a tower failure is to utilise the transmission network emergency restoration system as illustrated in Figure 12. The emergency restoration system will then be replaced by a concrete pole.

Figure 12 – An emergency restoration system stayed tower.

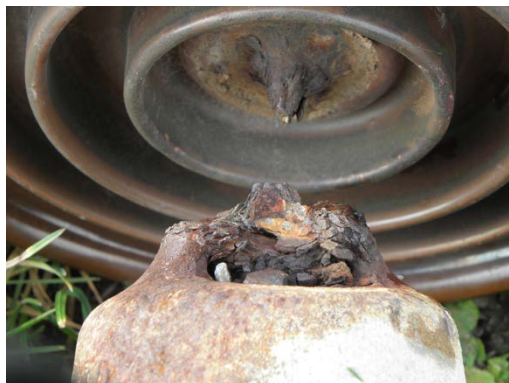
Figure 13 below shows a steel pin which failed due to corrosion that has resulted in a conductor drop. These disc string insulators had been progressively replaced with polymeric strings, which do not get affected by the aggressive environment due to corrosivity.

Figure 13 – Failed insulator string due to pin corrosion
