# Crossarms

## AMS Electricity Distribution Network

<b>Document number</b>	<b>AMS 20-57</b>
<b>Issue number</b>	11
<b>Status</b>	Approved
<b>Approver</b>	Paul Ascione
<b>Date of approval</b>	28/05/2019

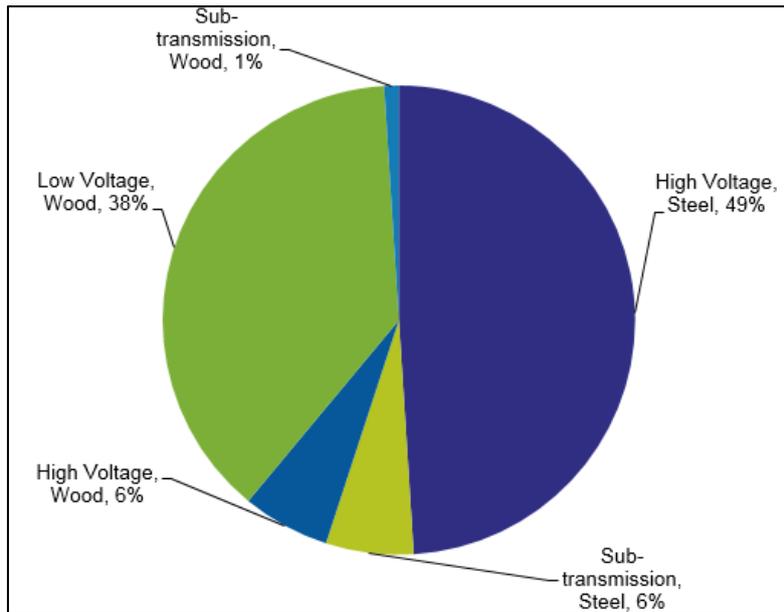
**Figure 1: Crossarms by type**

Overall, approximately 38% of the crossarm fleet are wood crossarms supporting LV circuits, 6% are wood crossarms supporting HV circuits, 1% are wood crossarms supporting 66kV circuits, 49% are steel crossarms supporting HV circuits, and the remaining 6% are steel crossarms that support 66kV circuits. This is illustrated in Figure 1.

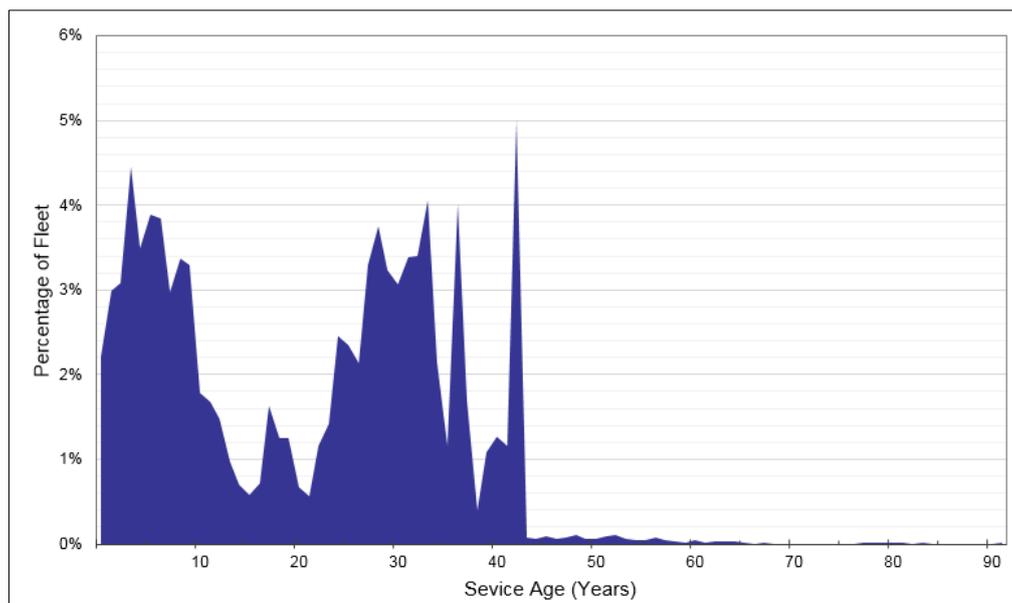
The galvanised steel crossarm service age profile is illustrated in Figure 2. The spike at 44 years is due to assets lacking a confirmed installation date.

**Figure 2: Steel Crossarm Service Age**

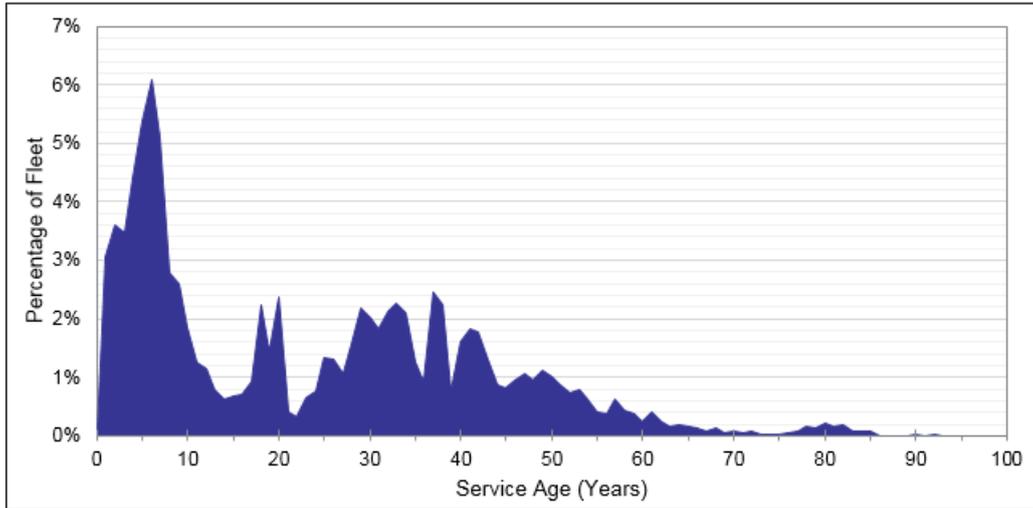
Figure 3 shows that more than half of the wood crossarm population has a service age less than 25 years due to the impact of accelerating replacement rates over the last decade. The proportion of variable quality wood, installed before 1990, is now estimated to be less than 15% of the crossarm population.

**Figure 3: Wood Crossarm Service Age**

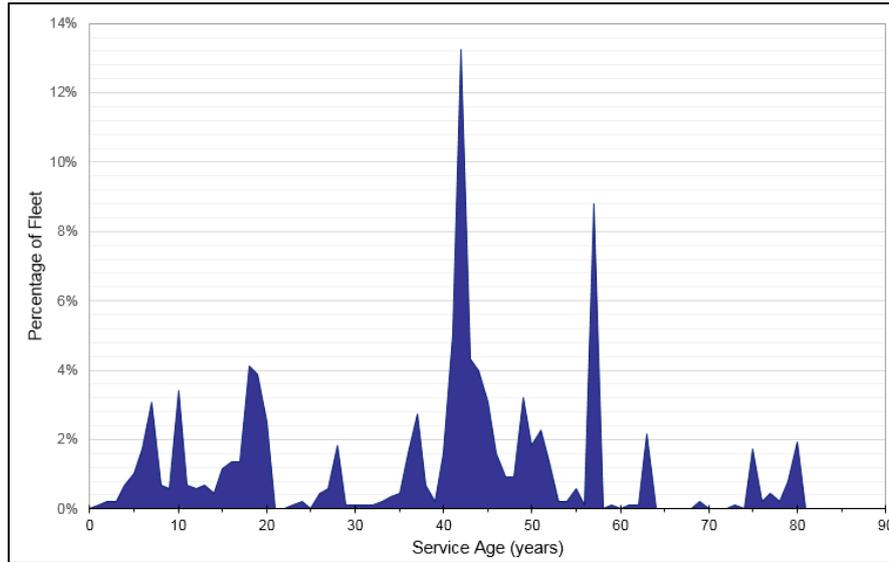
At the current rate of replacement, it is expected that variable quality wood crossarms will be eliminated from 66kV circuits by 2020. The service age of this small population is illustrated in Figure 4.

**Figure 4: 66kV Wood Crossarm Service Age**

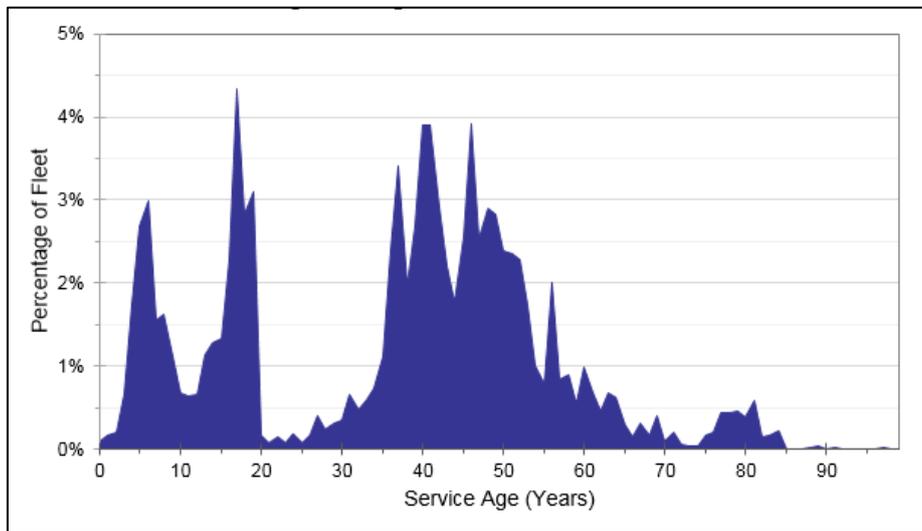
The service age of this fleet is illustrated below in Figure 5.

**Figure 5: HV Wood Crossarm Service Age**

The prevailing focus on replacing HV wood crossarms with galvanised steel units over the last decade has reduced the population of wood crossarms supporting 22kV, 11kV and 6.6kV feeders to less than 6% of the crossarm population.

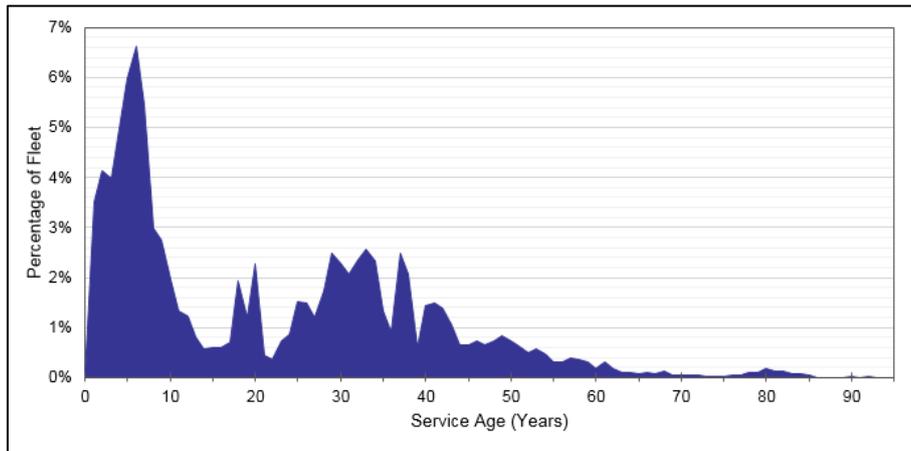
Low voltage wood arms supporting LV circuits contribute approximately 38% of the crossarm population. The service age of this fleet is illustrated in Figure 6.

**Figure 6: LV Wood Crossarm Service Age**

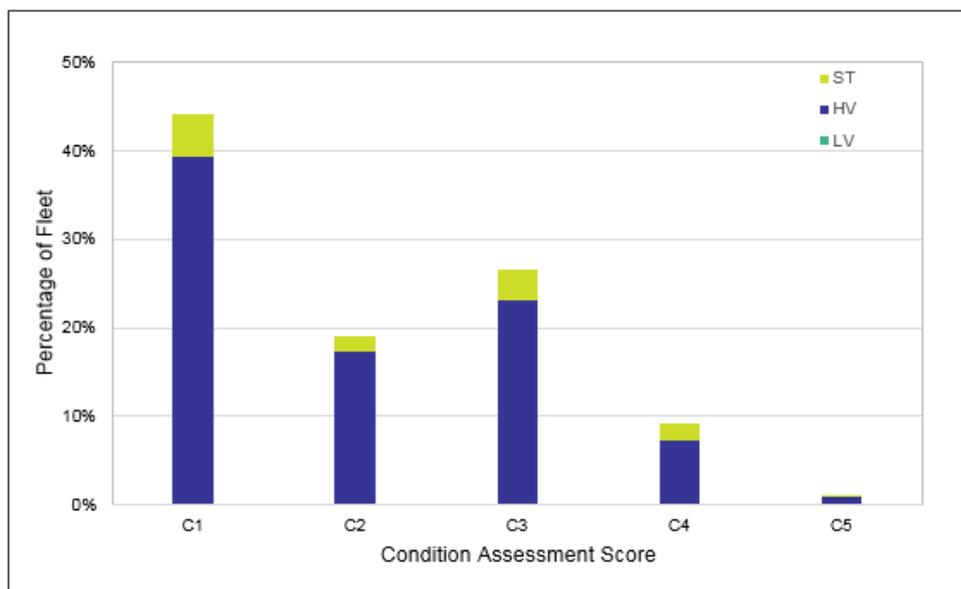
Approximately 10% of the steel crossarm population are considered to be in a “below average” condition (8% HV crossarms and 2% sub-transmission crossarms) these crossarms are currently assessed as C4 and C5 condition as shown in Figure 7.

**Figure 7: Condition Assessment for Steel Crossarms**

Overall, it is expected that steel crossarms will deliver long service lives as 63% of steel crossarms are assessed as “Good” or “Very Good” condition (C1 and C2), 26% are in “Average” condition (C3), 9% have been assessed as in “Poor” condition (C4) and 1% in “Very Poor” condition (C5).

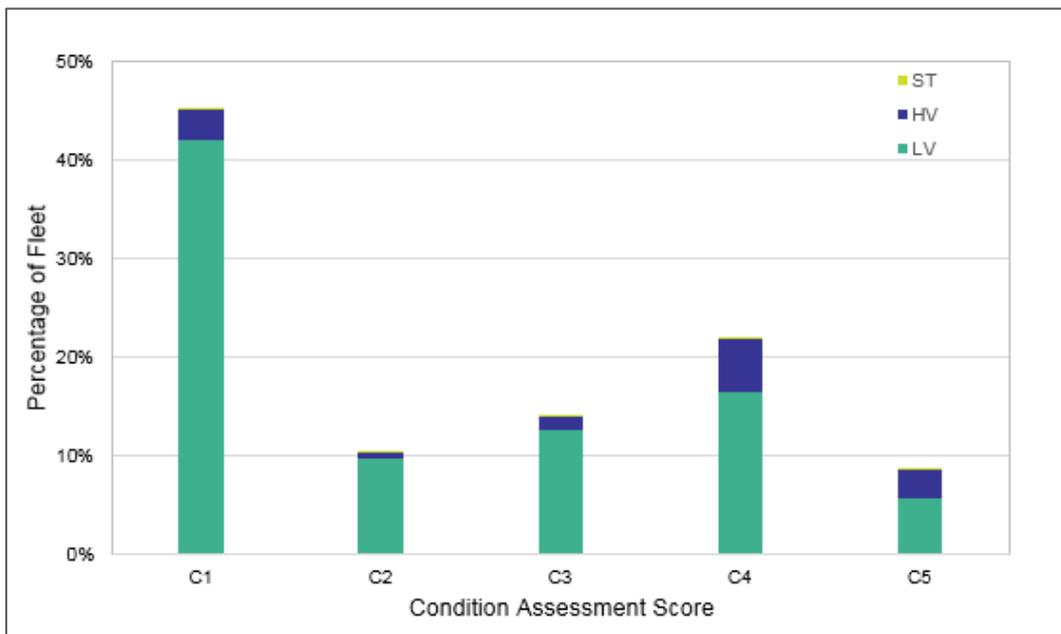
Figure 8 shows that approximately 56% of wood crossarms are assessed as “Good” or “Very Good” condition (C1 and C2), 14% are in “Average” condition (C3) and 30% have been assessed as in “Poor” (C4) or “Very Poor” condition (C5).

**Figure 8: Wood Crossarm Condition**

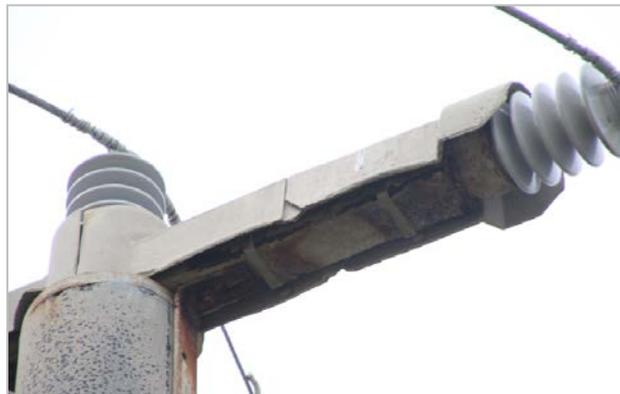
Figure 9 shows a steel crossarm, which has suffered corrosion. The corrosion which can only be seen from the underside of the crossarm, has been exacerbated by the presence of the animal cover as the moisture is retained after being wetted by rain.

**Figure 9: Steel Crossarm rusting under an animal cover**

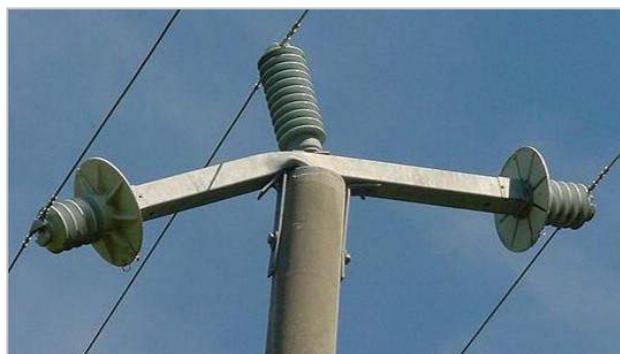
Mechanical damage due to external factors such as trees or vehicles is occasionally responsible for a bending failure, as illustrated in Figure 10.

**Figure 10: Steel Crossarm Bending Failure**

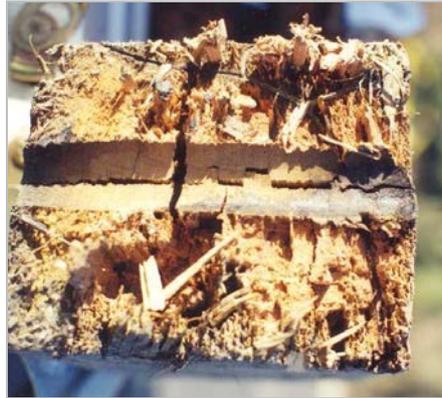
**Figure 11: Wood Crossarm Fracture**

The predominant failure mode for wood crossarms is a fracture at a stress concentration point such as the kingbolt or insulator mounting; when mechanical loadings of conductors exceed the strength of deteriorating wood, as illustrated in Figure 11 and Figure 12.

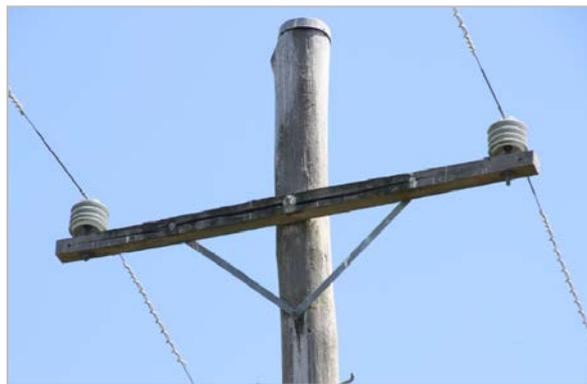
**Figure 12: Wood crossarm fracture at kingbolt**

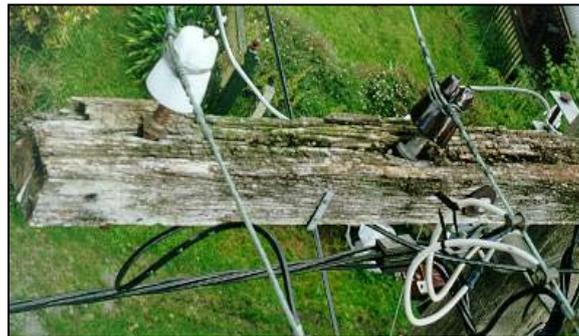
Wood rot is usually detectable and failure is largely predictable as shown in Figure 13.

**Figure 13: Wood Rot**

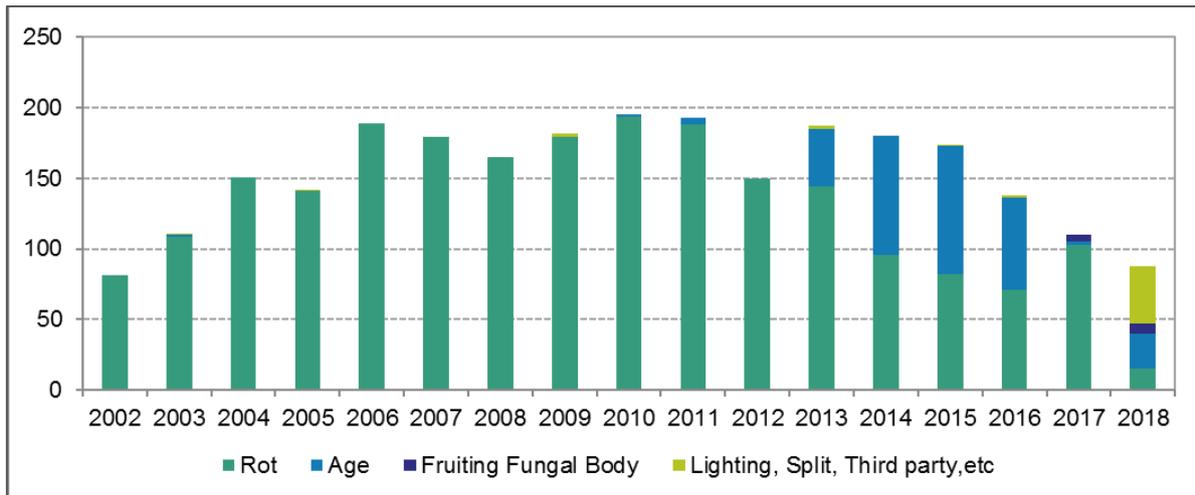
The rate of failures peaked in 2010 with an average reduction of 14% per annum, as shown in Figure 14.

**Figure 14: Crossarms Failures 2002–2018**

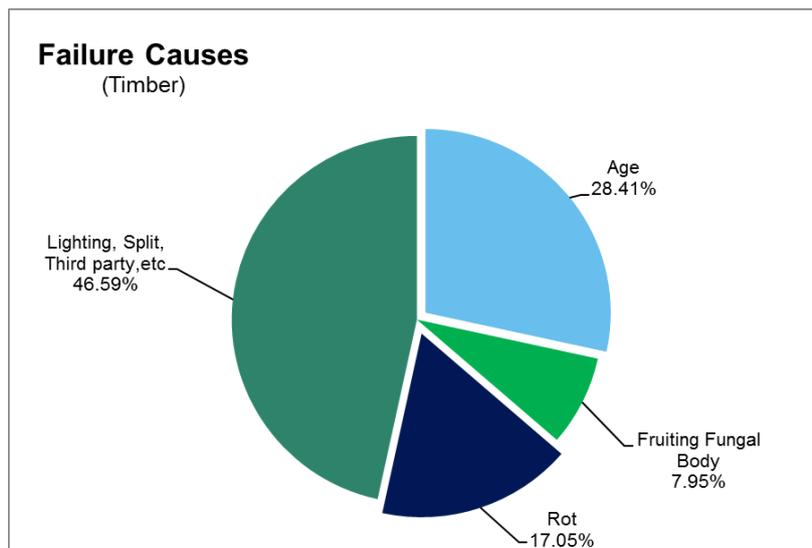
In 2018, 88 crossarm failures occurred with 17% of crossarm failures caused by rot, 28% caused by age deterioration, 8% caused by Fruiting fungal infection and 47% from other causes, i.e. lighting, split & third party, as shown in Figure 15.

**Figure 15: Wood Crossarm Failure Causes, 2018**

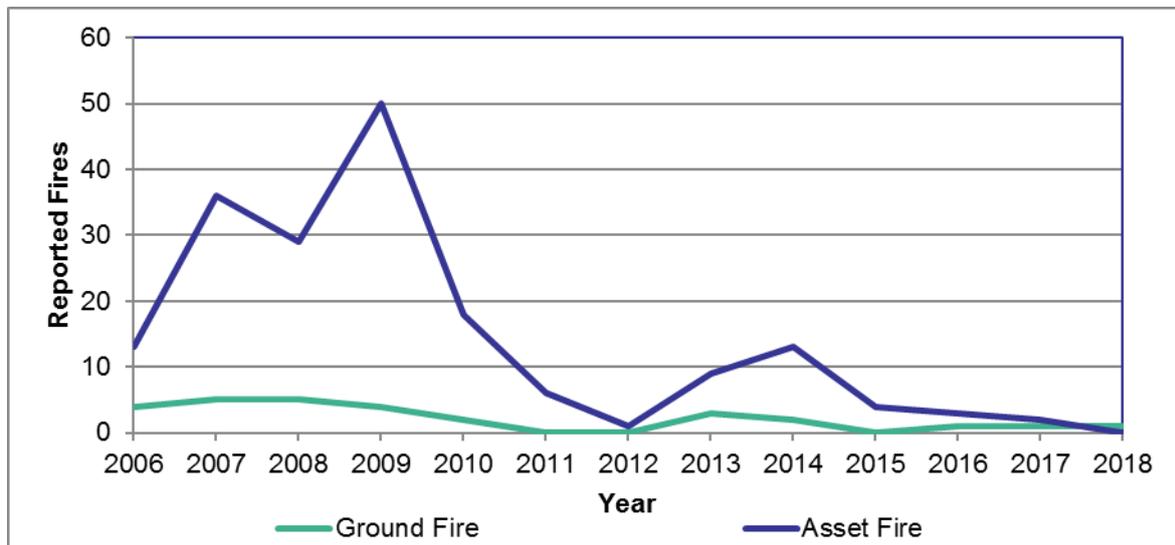
A crossarm failure can cause a fire ignition to occur. In 2011, “F-Factor” was introduced as a scheme to incentivise Distribution Businesses to reduce the number of asset failures causing fire ignitions. AusNet Services has implemented programs targeting fire ignitions; this has resulted in a decline in Asset Fires as shown in Figure 16.

**Figure 16: Fire Starts Attributed to Crossarm Failures**

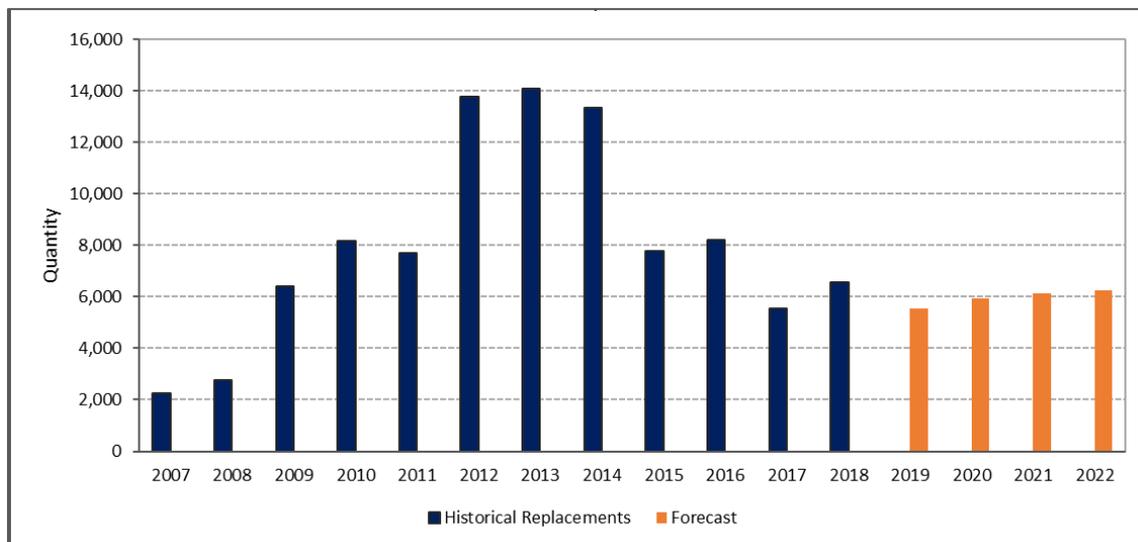
The replacement rate of deteriorated wood crossarms peaked at approximately 14,000 units per annum in the period 2012 to 2013. Since then, the replacement rate has steadily declined after required replacements identified from the first 5-year cycle of the aerial inspection program has been completed.

**Figure 17: Crossarm Replacements, Actual and Forecast**

In 2009, AusNet Services introduced an aerial inspection program to increase the effectiveness of asset inspection. The aerial inspections are carried out on a 5-year cycle to cover all crossarms in HBRA areas, which is approximately 55% of the network. There was an expectation that aerial inspections would identify deteriorated wood crossarms that traditional ground inspections could not identify. Therefore, the volumes of crossarm replacements were forecast to increase, and the actual number of replacements did increase starting from 2010, which can be seen in Figure 117.
