# Indoor Switchboards

## AMS – Electricity Distribution Network

<b>Document number</b>	AMS 20-56
<b>Issue number</b>	1
<b>Status</b>	Approved
<b>Approver</b>	Paul Ascione
<b>Date of approval</b>	27/08/2019

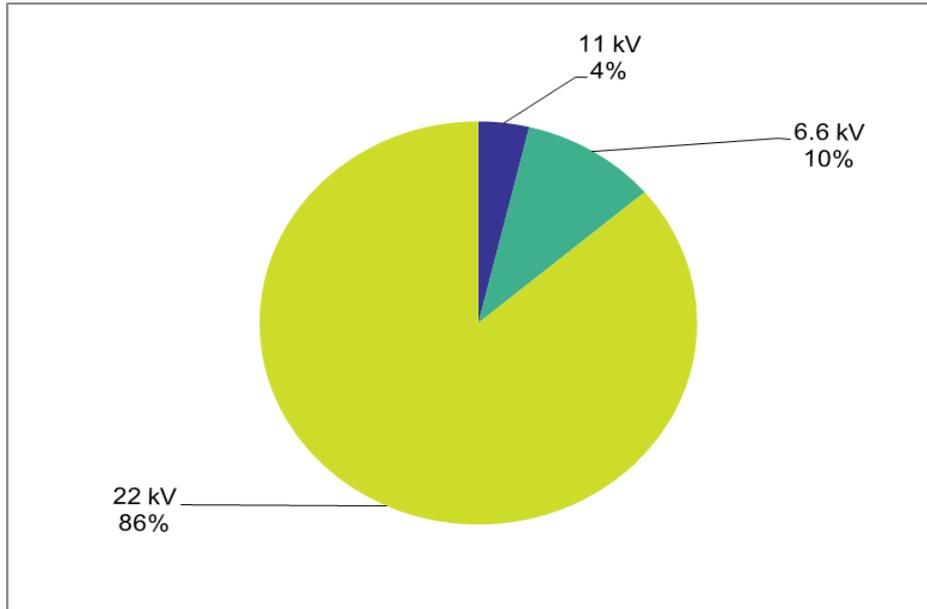
Figure 1 – Indoor switchboards by Service Voltage

A summary of the indoor switchboard population by voltage, vintage type & voltage, vintage type & bus insulation and vintage type & Manufacturer / Model is shown in Figures 1 to 4 respectively.

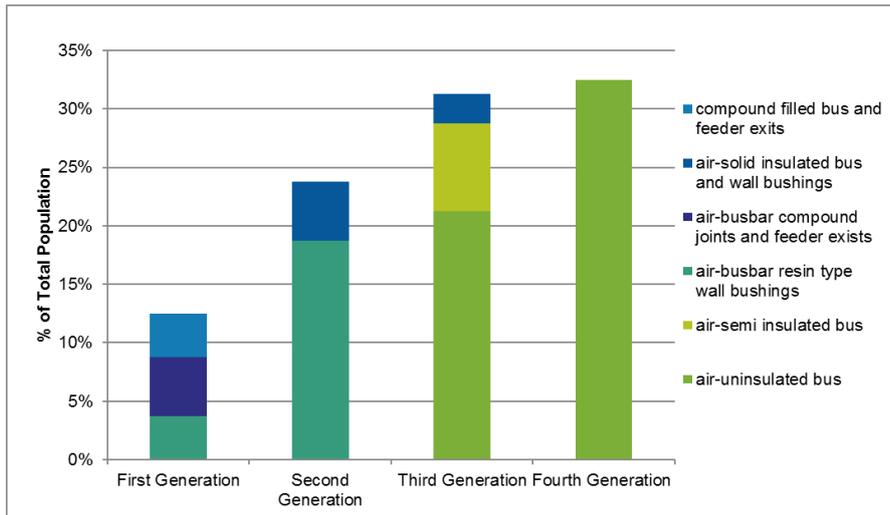
Figure 3 – Indoor switchboards by Vintage type and bus bar insulation

All new indoor switchboards are of air uninsulated bus bar type while older types consist of mixture of either air or solid insulation of resin or compound filled types. It is noted that resin and compound filled insulation type switchboards have had major insulation failures in first generation type switchboards namely LYS and MPS substations.

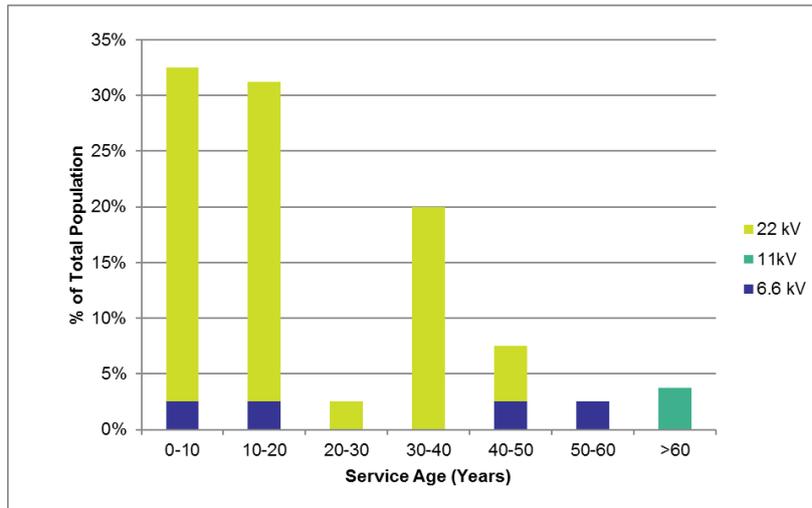
Figure 5 – Indoor switchboards Age Profile by Service Voltage

The average service age of indoor switchboard population is 21 years and the oldest being 68 years. Figure 5 & 6 shows the service age profile against service voltage and bus bar insulation type.

The oldest indoor switchboard is located at MPS with compound filled bus bars and feeder exits and it is planned to be retired by 2019/20. The next oldest switchboards are located at open cut substations at MWN and YN substations. They are expected to be retired within the next 5-10 years.

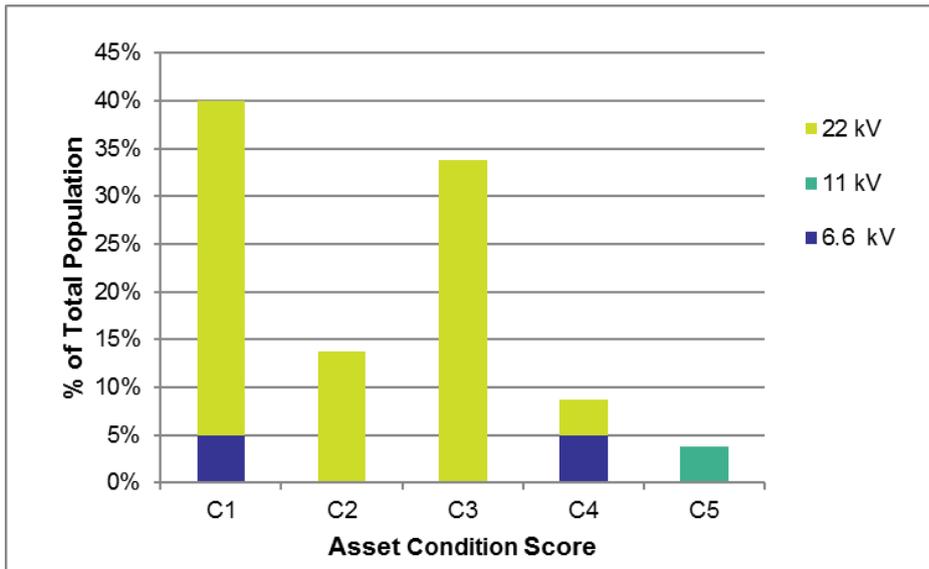
Figure 7 – Condition Profile of ZSS indoor switchboards by Service Voltage

Condition profile of indoor switchboards by service voltage and vintage type are shown in Figure 7 and 8 respectively.

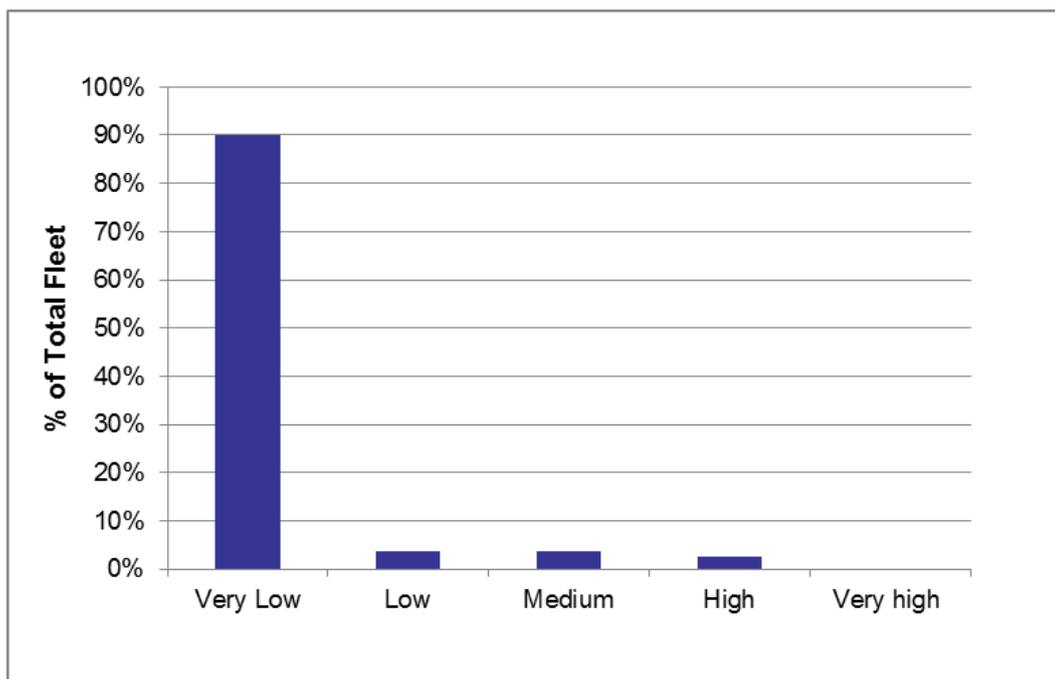
Figure 9 – Relative Base Criticality Profile

The Figure 9 shows the Relative asset criticality profile of indoor switchboards.
