# Power Transformers and Station Regulators

## AMS - Electricity Distribution Network

Document number	AMS 20-71
Issue number	9
Status	Approved
Approver	Paul Ascione
Date of approval	20/06/2019

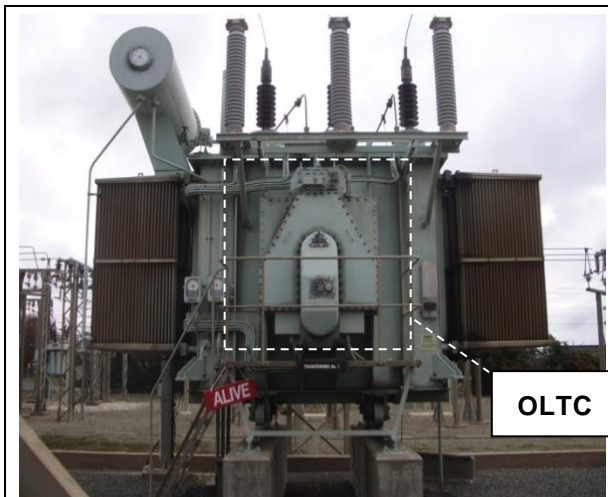
The power transformer fleet has nameplate ONAN (oil natural air natural)<sup>1</sup> ratings ranging from 2 MVA to maximum continuous power ratings of 45 MVA. In order to maintain rated output voltage, 90% of power transformers are fitted with on-load tap changers (OLTCs), as illustrated in Figure 1.

Figure 1 – Typical Zone Substation Power Transformer with OLTC
