Service Cables

AMS– Electricity Distribution Network

| Document number | AMS 20-76 |

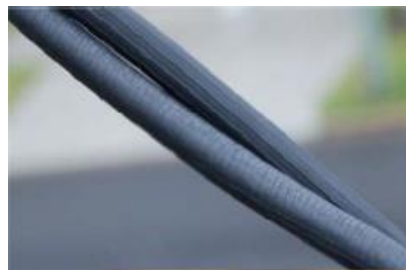
Figure 2 – Twisted Black XLPE ABC

Twisted Black aerial service cables are an aluminium conductor with a XLPE outer sheath. These are the preferred replacement option and installation material for aerial service cables.

This fleet is steadily growing due to new connections and replacement of other aerial service types. Since 2014, the population has grown from 23% to 32% of the entire aerial service cable population, the largest type of service cables in the network. Figure 2 shows a typical Twisted Black XLPE ABC cable.

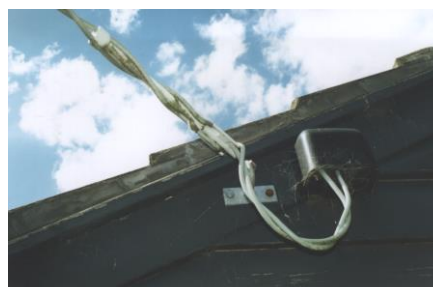
Figure 3 – Grey PVC Service & 'Dog-bone' Termination Fitting

Twisted Grey aerial service cables are an aluminium conductor, with a PVC outer sheath, comprising 19% of the entire service cable population. This fleet is diminishing due to the replacement of this cable type with Twisted Black post cable failure. Figure 3 shows a typical Twisted Grey cable.

Service termination failures are caused by mechanical failure of the termination fitting at the service point of attachment. The typical termination fittings include 'dog-bone' fittings, 'roller clamps', 'PG clamp' and 'helical wraps'. These failures generally require a maintenance activity on the termination itself, provided the cable has not been damaged by the termination failure the service cable generally does not require replacement.

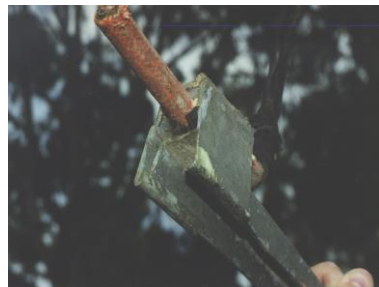
The remaining “other” aerial service cables on AusNet Services’ electricity distribution network primarily consist of open wire, red lead and black webbed PVC service cables as shown in Figure 5. These contribute a small (1%) proportion of the overall service cable population and are progressively being replaced with Twisted Black cables.

Red Lead Service Cable

Figure 5 – Obsolete Aerial Service Cables

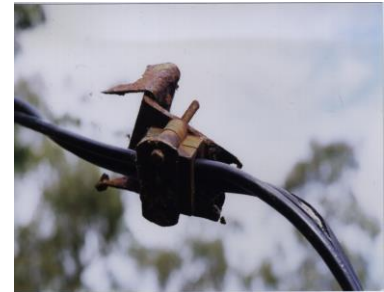
Black Webbed PVC
