Poles

AMS - Electricity Distribution Network

Document number	AMS 20-70
Issue number	7
Status	Approved
Approver	Paul Ascione
Date of approval	04/06/2019

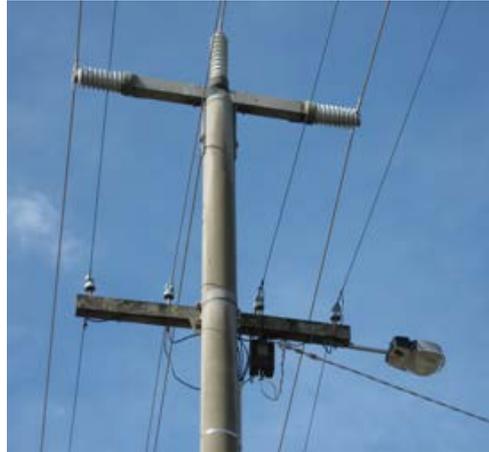
Figure 2 shows a typical 22kV and LV circuit concrete pole.

Figure 2 - Concrete Pole

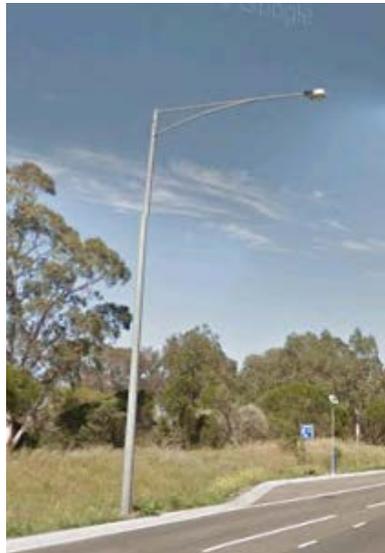
Figure 3 shows a typical galvanised steel pole.

Figure 3 - Galvanised Steel Pole

Galvanised steel poles have been predominately used as street light poles within the electricity distribution network. Similar to concrete poles, galvanised steel poles are electrically conductive and require additional engineering of insulation and earthing systems to ensure safety and reliability. There are approximately 87,000 galvanised steel poles supporting public-lighting lanterns in eastern part of Victoria.
