AMS 10-54 Circuit Breakers

2023-27 Transmission Revenue Reset

Document number	AMS 10-54
Issue number	9.7
Status	FINAL
Approver	Paul Ascione
Date of approval	17/09/2020

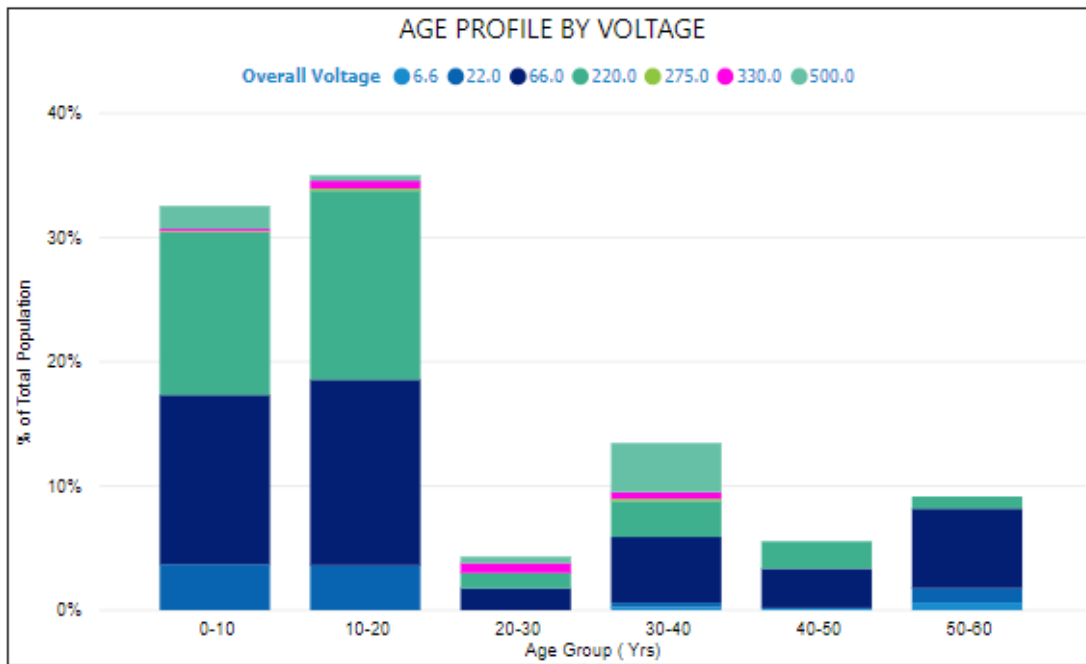
Figure 7 – Service Age Profile by CB by Operating Voltage

Figure 6 and Figure 7 provides the population distribution of transmission circuit breakers against the object type and operating voltage.

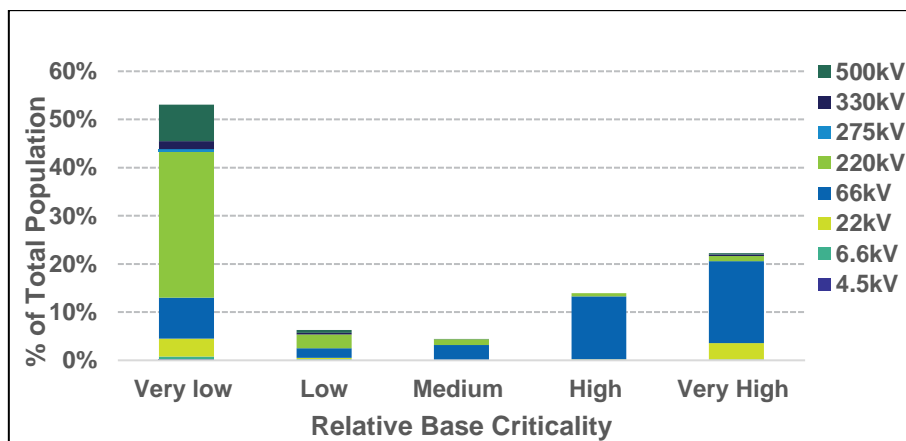
Figure 11 – Relative base criticality by Service Voltage

The Figure 11 shows the Relative asset criticality based on CB Technology, Service Voltage, and Asset Condition of CBs.

- Approximately 40% of the CB population contribute to medium to very high criticality on the relative base mainly due to 66kV circuit breakers (33%). (Refer figure 11)

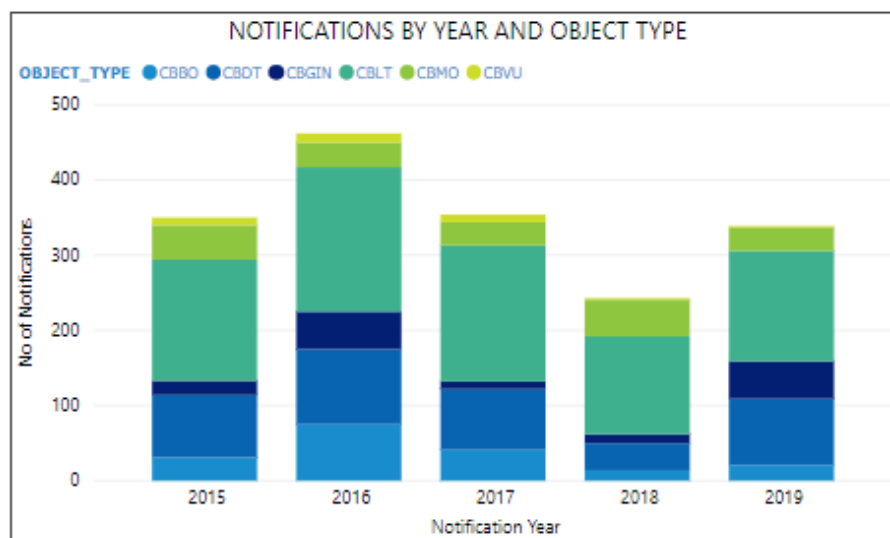
Figure 12 – Number of ZA Notifications per CB object type 2015 – 2019

It is noted that there is only a marginal improvement of the total number of condition-based notifications (ZA) raised per CB object type from 2015 to 2019 (Refer figure 12) except for circuit breakers installed in older GIS installations where a marked increase was noticed in SMTS and SYTS due to defects in hydraulic systems etc. Refer AMS 10-62 -GIS installations for details.

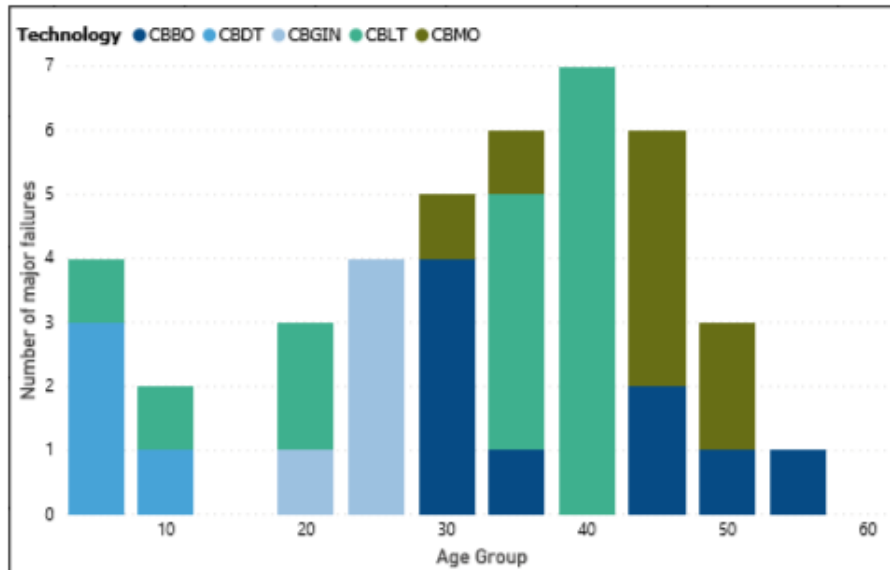
Figure 19 –CB major failures by technology and service age (low operating CBs)

Figure 19 below shows the average CB failure by technology and age group, excluding high operation CBs.

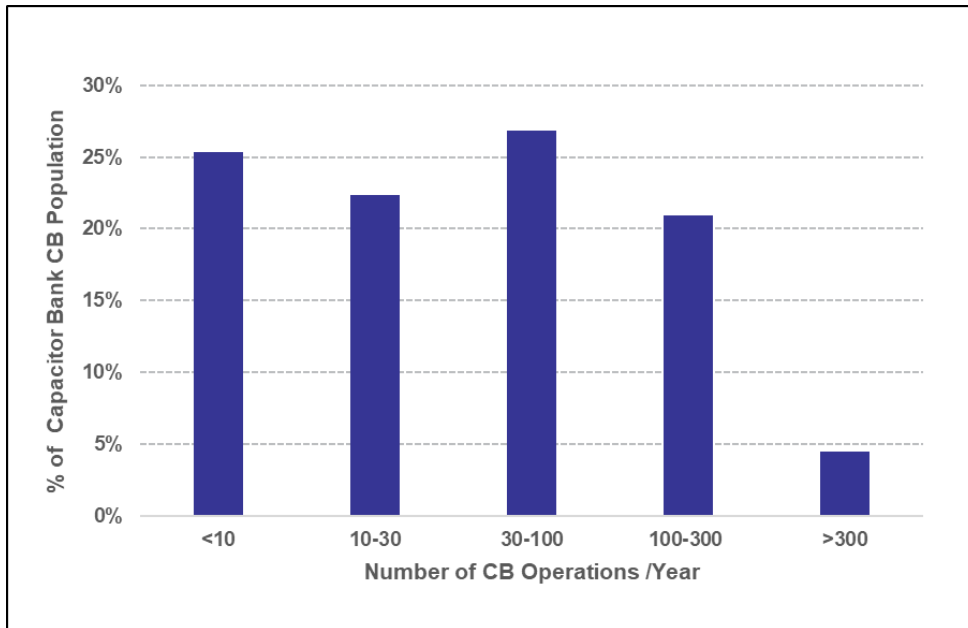
Figure 21 – Annual Capacitor Bank CB Operations

Figure 21 below shows the average operation frequency of capacitor bank circuit breakers. It is observed that approximately 25% of the Cap bank CB population undergoes more than 100 operations per year due to the heavy usage.
