AMS 10-55 Civil Infrastructure

2023-27 Transmission Revenue Reset

Document number	AMS 10-55
Issue number	10
Status	Approved
Approver	P. Ascione
Date of approval	14/07/2020

Civil Infrastructure

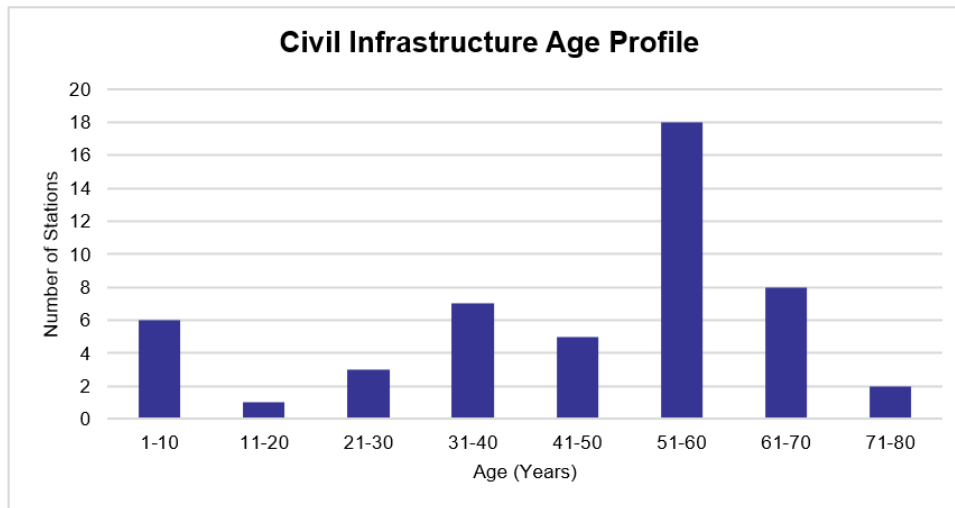
Figure 1 – Civil infrastructure age profile

The age profile of civil infrastructure across all the terminal stations is illustrated in Figure 1.

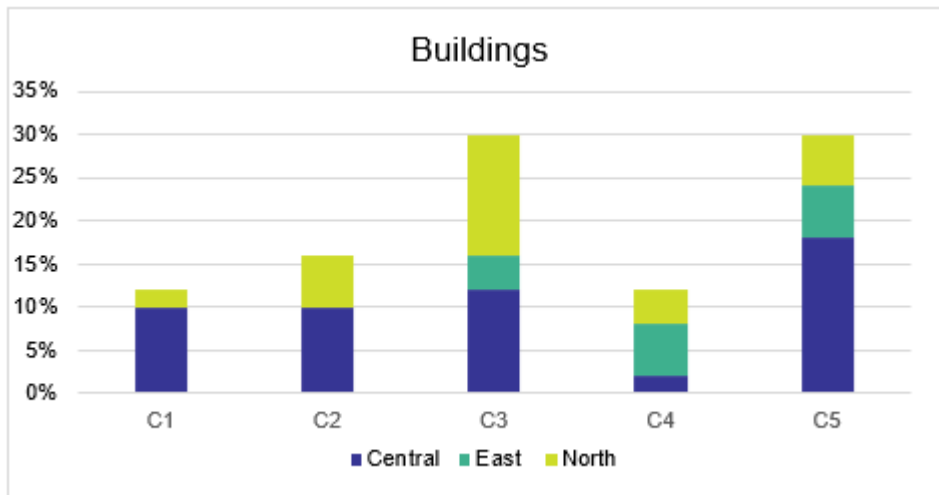
Figure 2 – Condition profile of Buildings inside terminal stations

Buildings at terminal stations vary widely in the construction material used, age and condition. Almost 60% of the buildings in terminal stations are in Very Good to Average condition, C1 to C3, while approximately 40% of buildings are in Poor to Very Poor condition (i.e. C4 and C5). These sites will need to be refurbished in the next five to ten years.

Table 4 below is a list of recent building construction/upgrade works done at various terminal stations, while the condition of the buildings is shown in Figure 2.

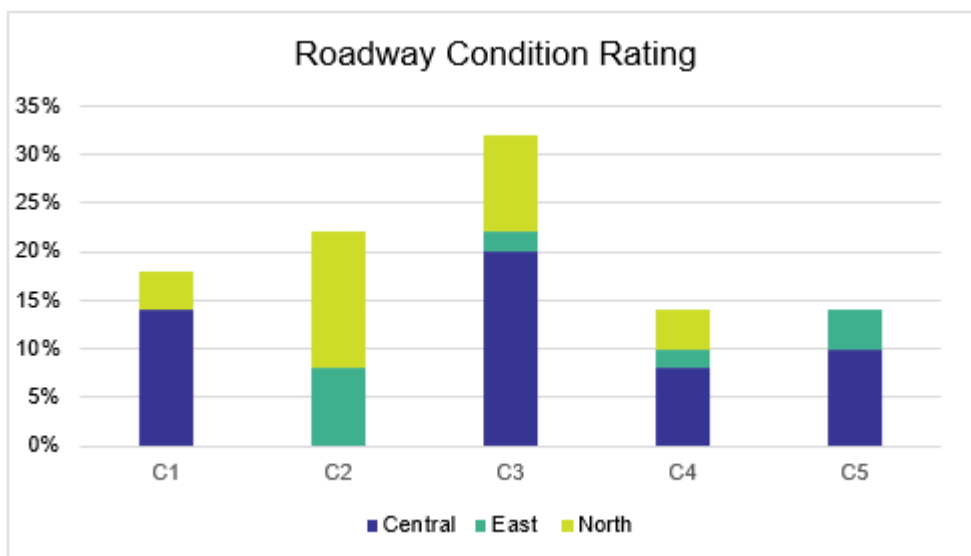
Figure 3 – Condition profile of roadways and drainage systems

The condition profile of roadways and drainage systems is shown in Figure 3.

The condition of most of the switchyard access roads (72%) is Very Good to Average condition, C1 to C3, due to investment in civil infrastructure over the past few years. However, some switchyard roads are currently only suitable for light operational traffic and will require improvement to facilitate access for construction traffic associated with equipment refurbishment or replacement. The Poor to Very Poor scores, C4 to C5, (28%) is currently driven by the poor condition of some minor roads in terminal stations and not by the major road conditions.

Drains¹³ in all terminal stations are in good condition. However, the increasing Environmental Protection Agency (EPA) requirements around controlling the discharge of rainwater from switchyards, which may have low oil contamination levels, are driving increased investment in purpose designed collection drains, piping of existing open drains and extensive oil interceptor traps and water treatment works.

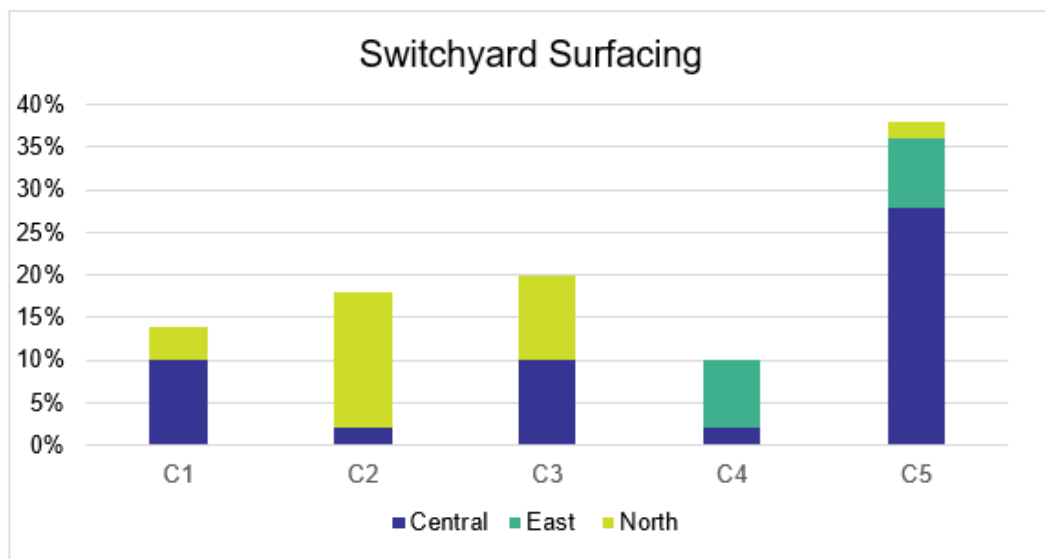
Figure 4 – Condition profile of switchyard surface

The increased traffic in switchyards due to high volume of augmentation works are having a negative impact on the switchyard surface conditions. The condition profile of switchyard surface roadways is shown in Figure 4.

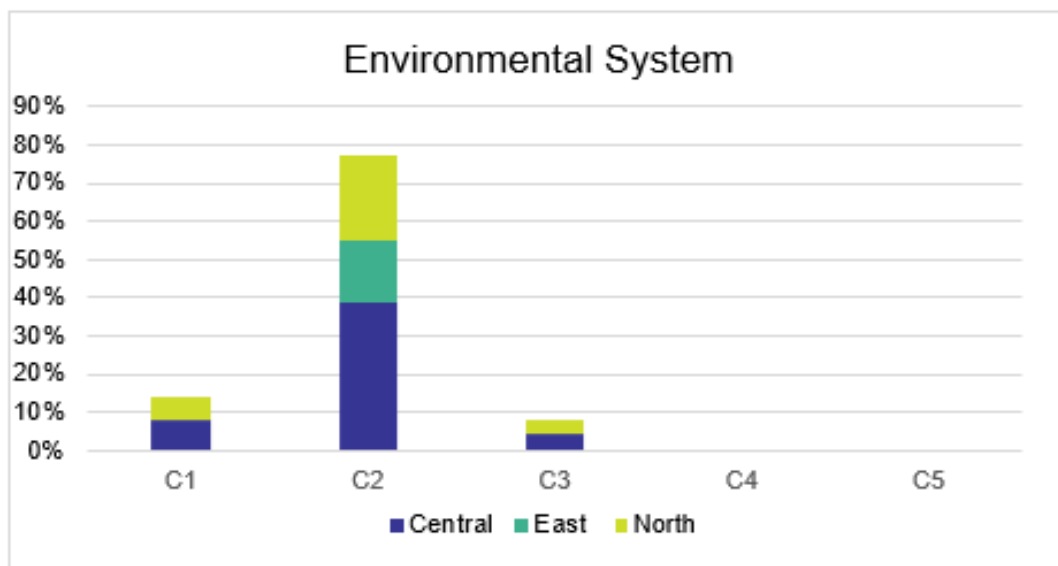
Figure 6 – Condition on environmental systems

Five stages of the program have been completed successfully across all terminal stations, including Eildon Power Station (EPS) and Morwell Power Station (MPS). The completion of the environmental upgrade projects has resulted in majority (92%) of stations having an environmental system in Good condition (C1), with the remaining 8% in Average (C3) condition. The condition profile of environmental systems is shown in Figure 6.

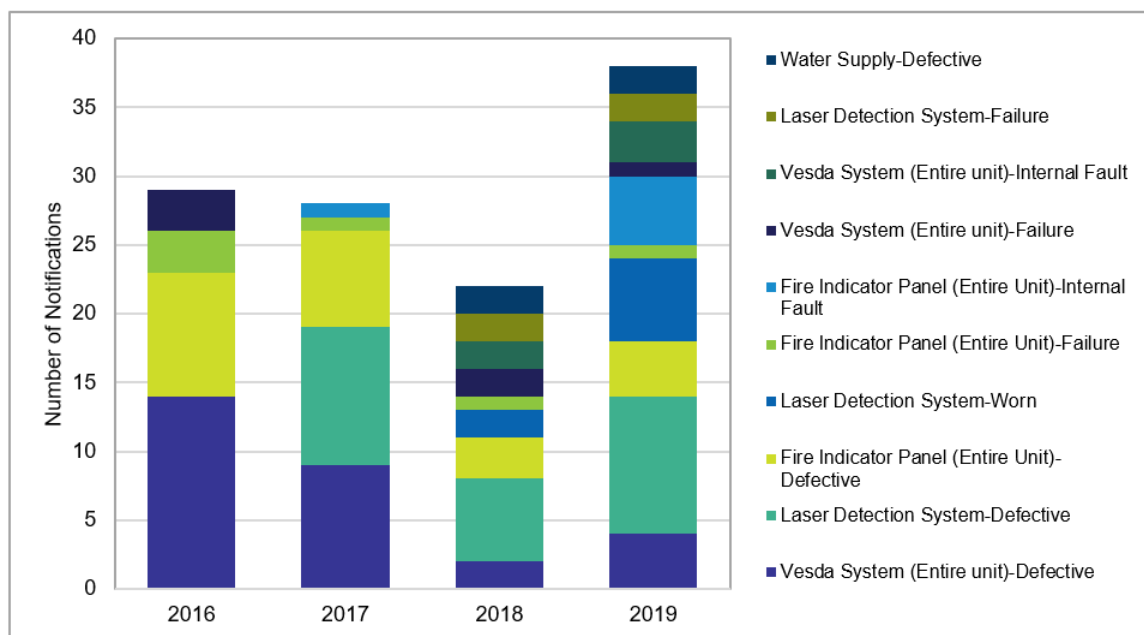
Figure 8 – Fire protection system, functional failure

Fire protection failures is dominated by issues with the VESDA system at 24%, followed by faults at the laser detection issues at 21%, then fire indicator panel issues at 19%, then water supply issues. Figure 13 shows the distribution of the issues.
