AMS 10-59 Disconnectors and Earth Switches

2023-27 Transmission Revenue Reset

Document number	AMS 10-59
Issue number	9.6
Status	FINAL
Approver	P. Ascione
Date of approval	01/09/2020

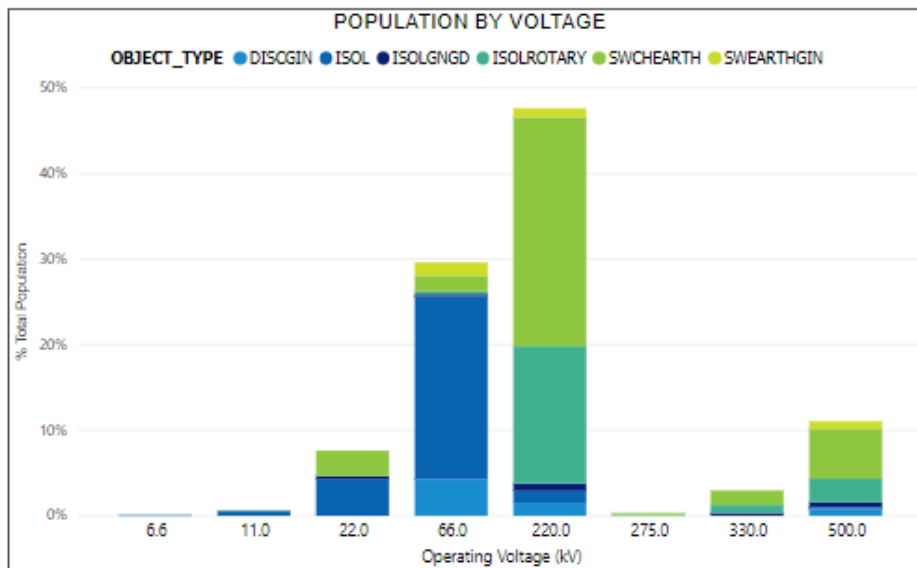
Figure 2 below illustrates various types of disconnectors and earth switches by service voltage in terminal substations in AusNet Services network. The larger population of Switches are found in the 220kV Transmission network (approx. 47%) followed by 66kV transmission network (approx. 29%) together constitute 76% of the total population of disconnectors and earth switches.

Figure 2 – Population of Disconnectors and earth switches by service voltage and type

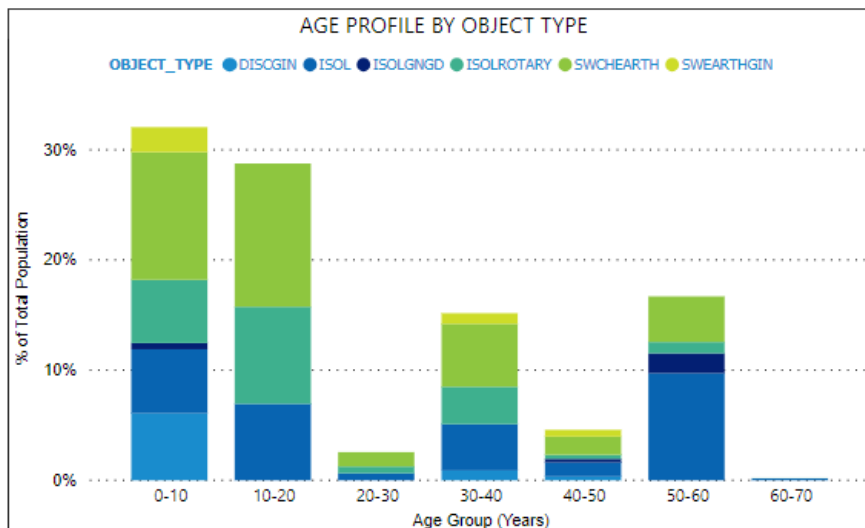
Figure 4 provides the service age profile of switches and Disconnectors and earth switches by type.

Figure 4 – Age Profile of disconnectors and earth switches by Type

- I. Approximately 16.9% of the total population are older than 50 years old. From a type perspective, approximately 9.9% of total population in this age bracket are the single phase underslung type. These are mainly [C-I-C], [C-I-C] and switchgear IS2/4 and G1 make where the support insulators are mainly cap and pin type. Cap and pin type have a historical failure of insulators breaking away from the metal pin and posed operator safety risk during their operation during operation and maintenance activities.
- II. Approximately 2.9% of the total population in the older than 50 years age bracket are ganged horizontal and vertical break type switches. These are mainly [C-I-C] types. The remainder are their associated earth switches.
