# AMS 10-61 Fire Detection and Suppression

2023-27 Transmission Revenue Reset

Document number	AMS 10-61
Issue number	10
Status	Approved
Approver	P. Ascione
Date of approval	16/07/2020

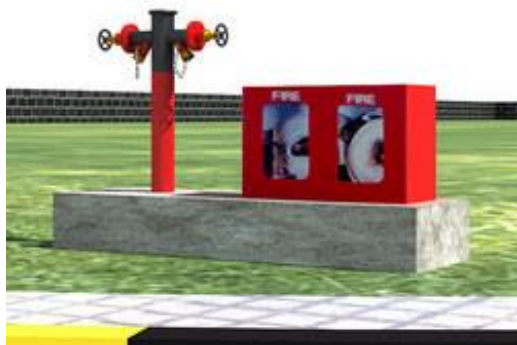
Figure 1: Fire hydrant system

FHSs are installed at strategic positions to provide water supply for fire-fighting agencies attending in response to a fire. The water supply for these hydrants comes via underground pipe work from external mains supply or on-site storage facilities such as dams and tanks. An example of an FHS is shown in Figure 1. Several stations have booster pumps installed to support weaker supply pressures.

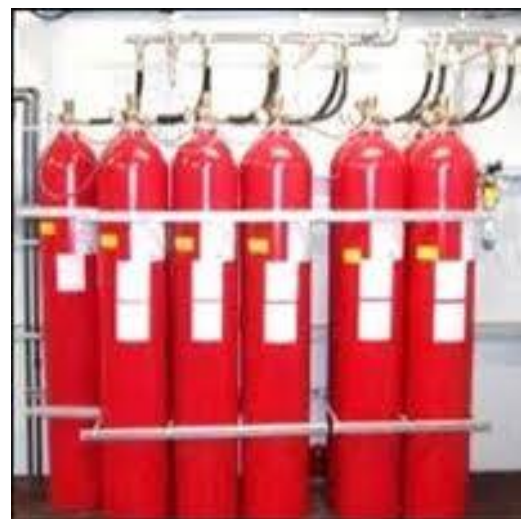
Figure 2: Gaseous fire suppression system

INERGEN, which are gaseous FSSs, have been installed at three critical stations (SMTS, ROTS and HWTS). These systems use a combination of inert gases (Nitrogen, Argon and Carbon dioxide) to extinguish the fire without damage to sensitive equipment. Release of these gases on fire reduces the oxygen level in room to 12.5% which quickly extinguishes the fire giving sufficient time for people to breathe and leave the room. An example of a gaseous FSS is shown below in Figure 2.

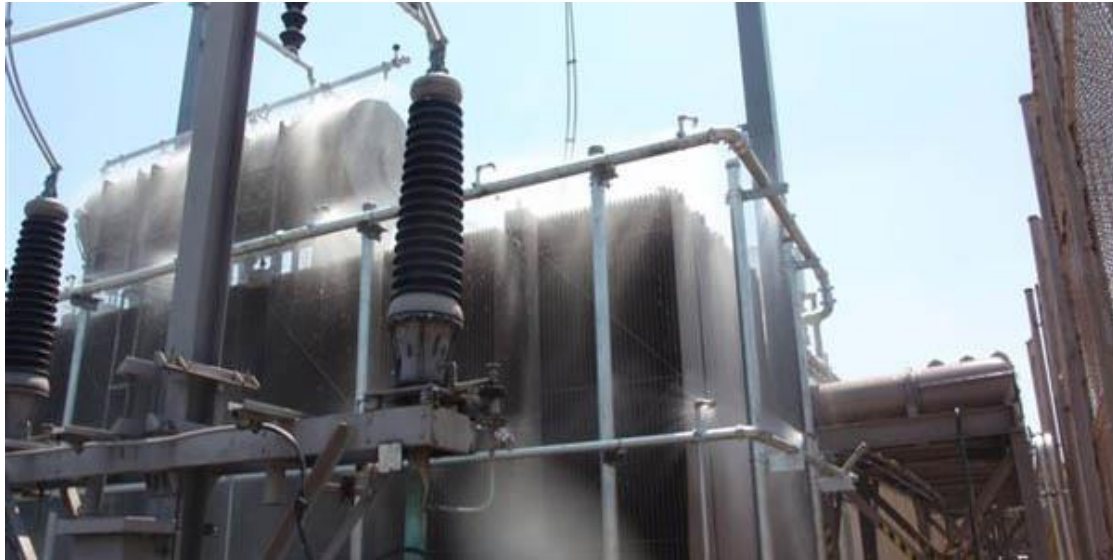
Figure 3 – Water deluge system operating on a power transformer

In switchyards, fire walls and FHSs are installed to provide fire protection to power transformers and buildings (from outside). WDSs provide fire suppression for power transformers, when there is no other fire containment measure. Figure 3 illustrates an example of a WDS operating on a station transformer.

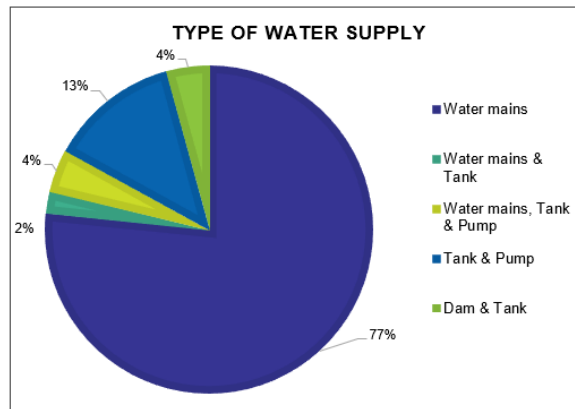
Figure 5 – Type of water supply at terminal stations

Figure 5 shows the type of pipe work and type of water supply to FHSs respectively in all the terminal stations.

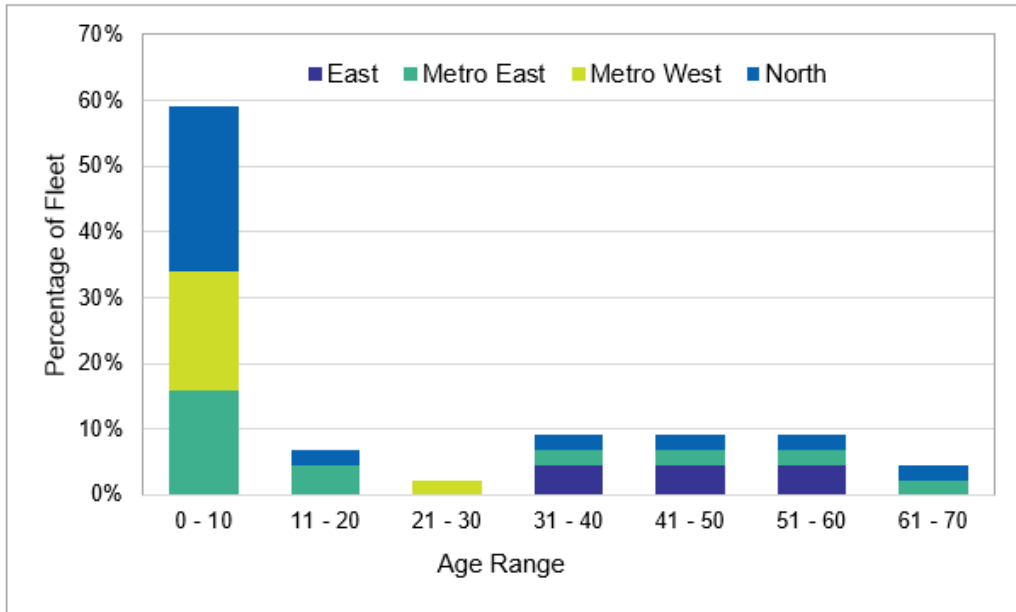
Figure 6 – Age distribution of FHS assets

Figure 6 shows the age distribution of FHSs installed in all the terminal stations.

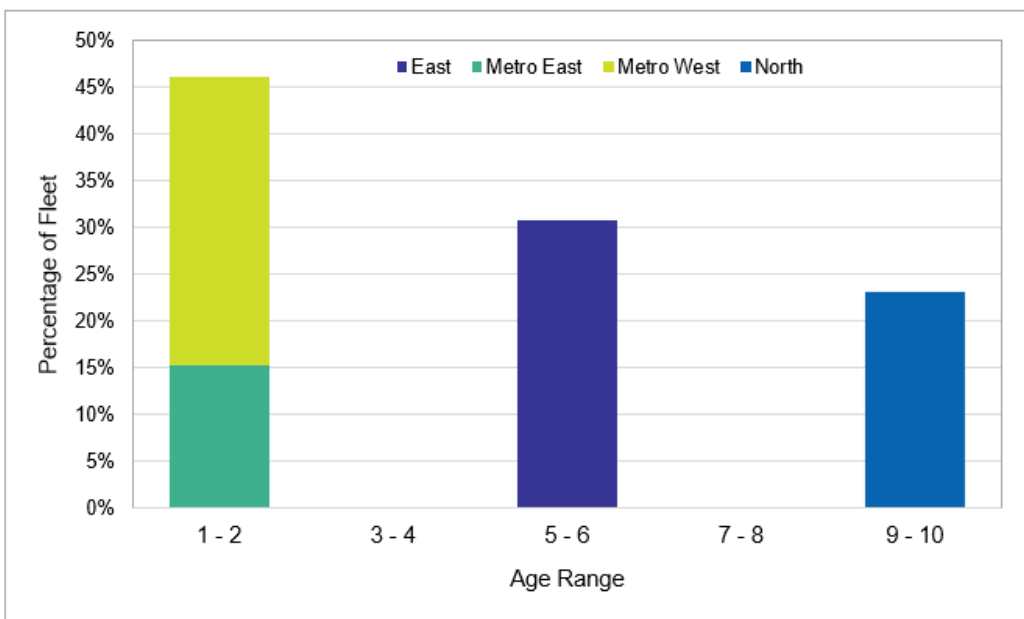
Figure 7 – Age/ Service age distribution of WDS assets

Over the past decade, the WDS at terminal stations have been refurbished/ replaced, so these have effective lives which are much younger than the transformers they are protecting. Figure 7 shows the service age distribution of WDSs installed in terminal stations.

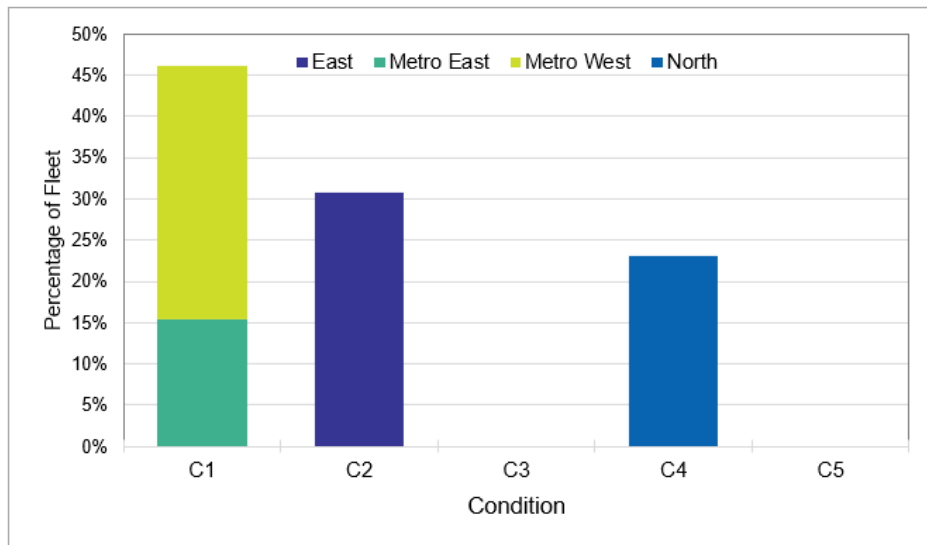
Figure 8 – Condition rating of WDS assets

The WDSs in five terminal stations are between Very Good C1, Good C2 and Poor C4 condition.

Table 3 and Figure 8 below show the overall condition profile of WDS assets.

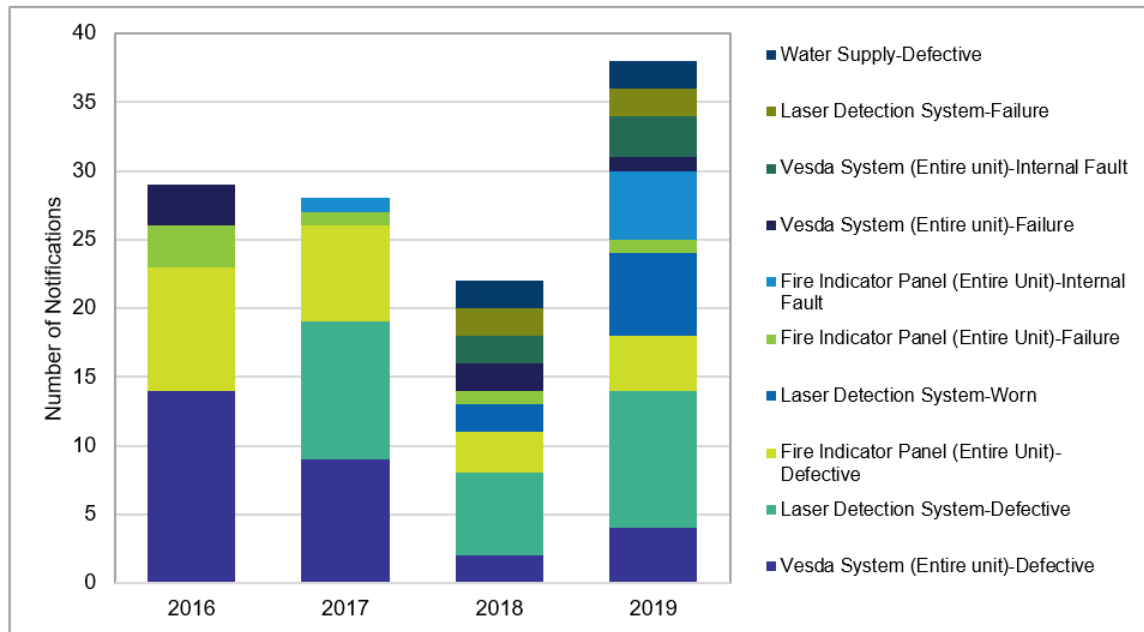
Figure 11 – Fire protection system, functional failure

Fire protection failures is dominated by issues with the VESDA system at 24%, followed by faults at the laser detection issues at 21%, then fire indicator panel issues at 19%, then water supply issues. Figure 11 shows the distribution of the issues.
