# AMS 10-62 Gas Insulated Switchgear

## 2023-27 Transmission Revenue Reset

## Gas insulated switchgear

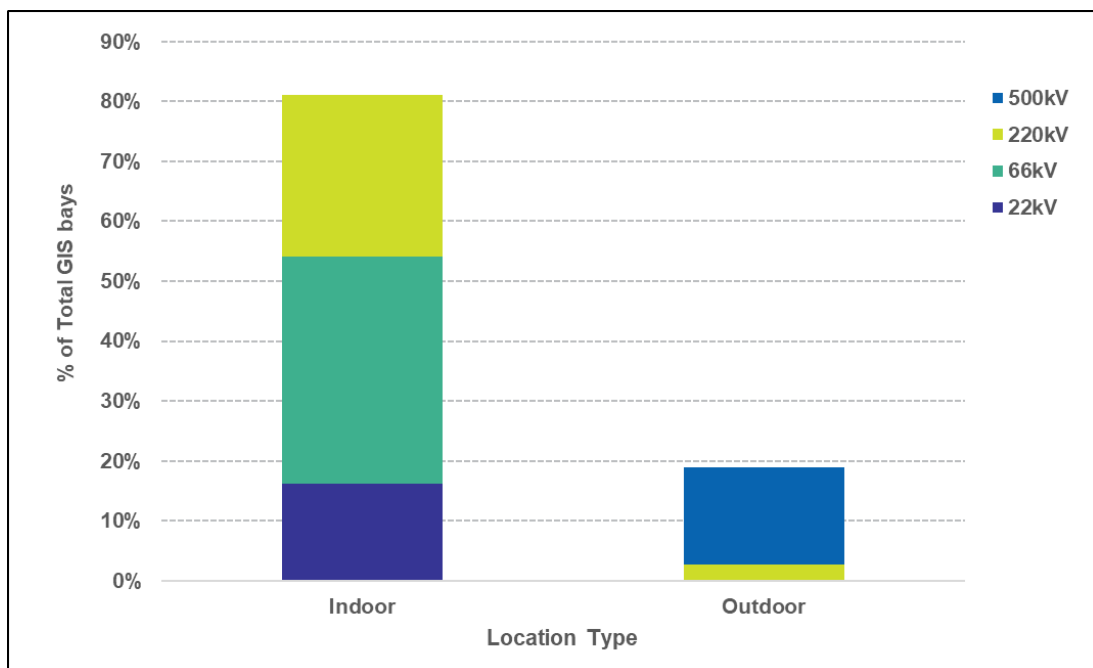
Figure 3 below illustrates the population of Gas Insulated Switchgear bays by location type and operating voltage in terminal substations in AusNet Services network. Approximately 81% of the GIS bays are located indoors and 19% located outdoors. The outdoor locations are 500kV SMTS and SYTS and 500kV / 220kV ROTS Gas insulated lines (GIL).

Figure 3 – Population of Gas Insulated switchgear by Location and voltage

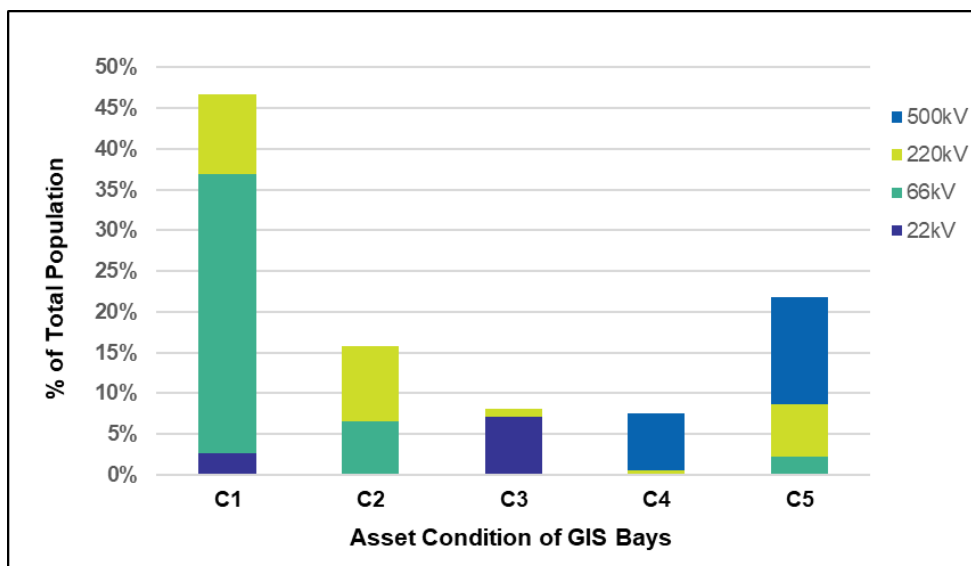
Asset Condition Profile of GIS Bays by Service Voltage is given in Figure 4. The general condition of GIS equipment is good. Approximately 71% of the GIS bays are in either C1, C2 or in C3 condition. The remainder 29% are in either C4 (7.6%) or in C5 (21.7%) asset condition. GIS bays that is in poor and very poor condition are located at SMTS, SYTS and NPSD.

Figure 5 – Condition Profile of GIS bays by Service Voltage
