# AMS 10-65 Line Easements

## 2023-27 Transmission Revenue Reset

Document number	AMS 10-65
Issue number	9
Status	Approved
Approver	P. Ascione
Date of approval	27/07/20

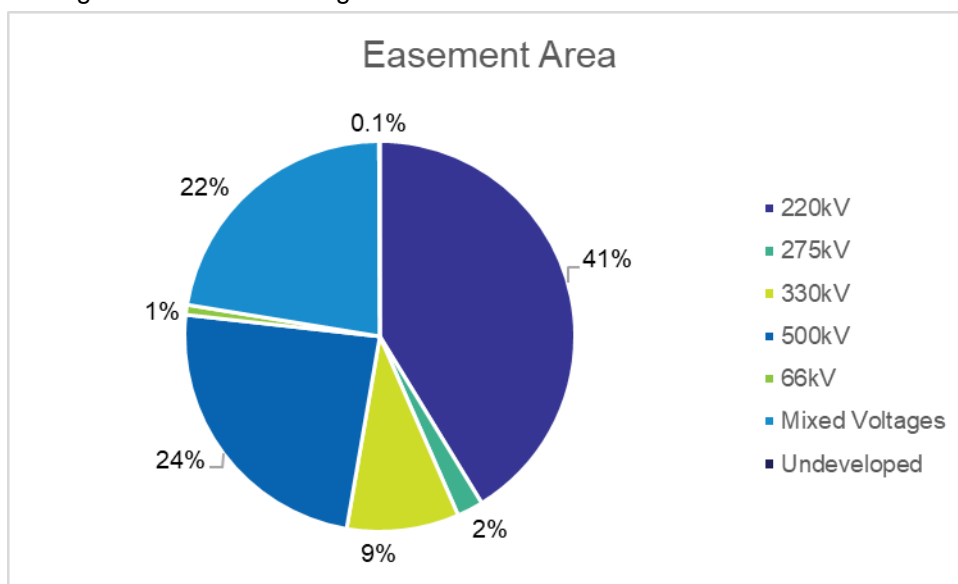
Easements include motor vehicle roads and tracks, bridges, gates and drainage culverts. There are 8,689 transmission lines easement segments with a total length of approximately 3,600 km and 21,600 ha in area. They vary in width from approximately 36 m for some rural 66kV single-circuit tower lines to in excess of 100 m for multiple circuit transmission lines in both rural and urban environments. The percent of total easement area for each network voltage is shown below in Figure 1.

Figure 1 – Easement area (% of total) in hectares (by network voltage)

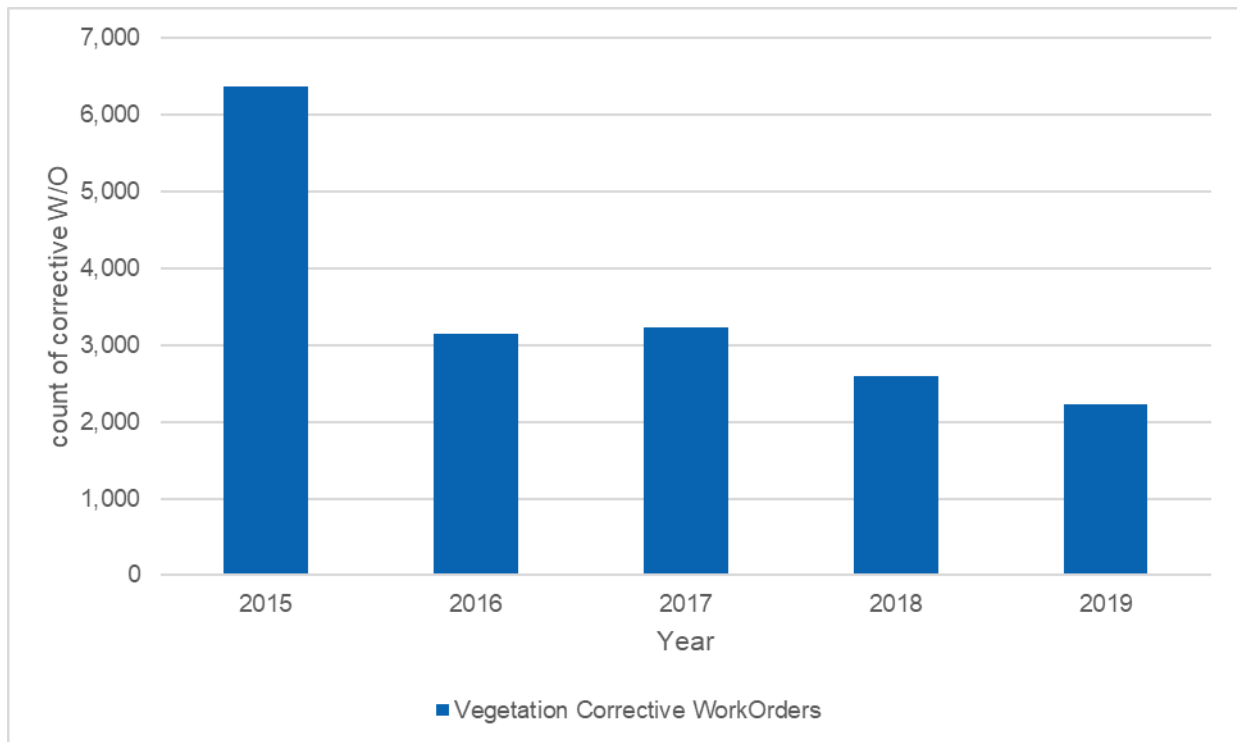
Figure 2 illustrates the corrective work orders relating to vegetation completed over the past 5 years on line easements. Vegetation Corrective W/O represent 97% of the total 18,246 over past five years. The average has been 3,512 vegetation related work orders per annum.

Figure 2– Vegetation management related work orders on line easements

The 2015 spike in corrective maintenance workorder is discussed at the beginning of section 3.3.

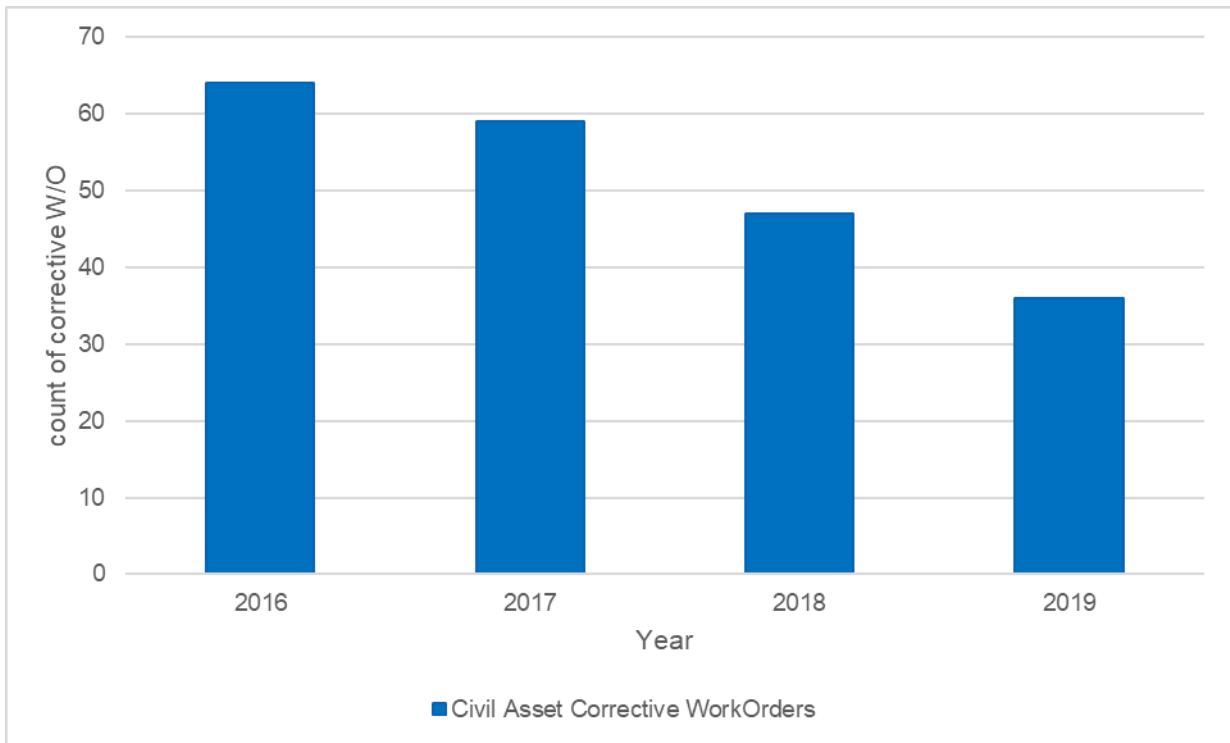
Civil Assets Corrective W/O represent 3% of the total 18,246 over past five years. The average has been 138 work orders per annum. Just over 70% of the civil asset work orders were recorded in 2015, therefore Figure 3 excludes 2015 in order to prevent data skew.

Figure 3 – Civil Assets related work orders on line easements

Figure 3 illustrates the corrective work orders relating to civil assets completed over the past 4 years. The 2015 spike in corrective maintenance workorder is discussed at the beginning of section 3.3.

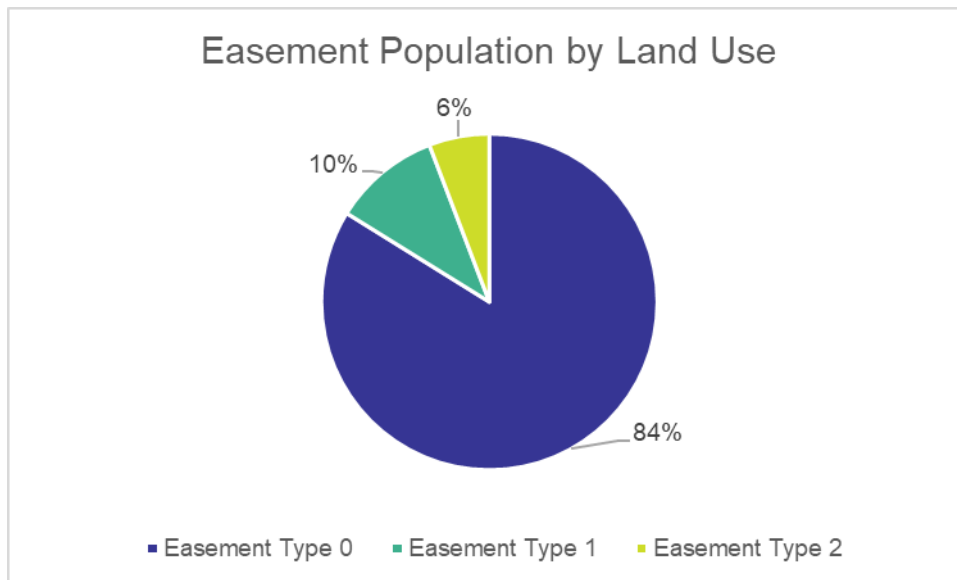
Figure 6 – Easement Population by Easement Use

From land use perspective easements are grouped in three categories described in Appendix1. The consequence of a transmission line component failure is quantified in relation to the easement use i.e. a dropped conductor on an urban built up easement (Type 2) has a higher health and safety and collateral damage consequence than a dropped conductor on an urban easement (Type 1) and a rural easement (Type 0) respectively. Figure 6 illustrates easement segment population by easement type.

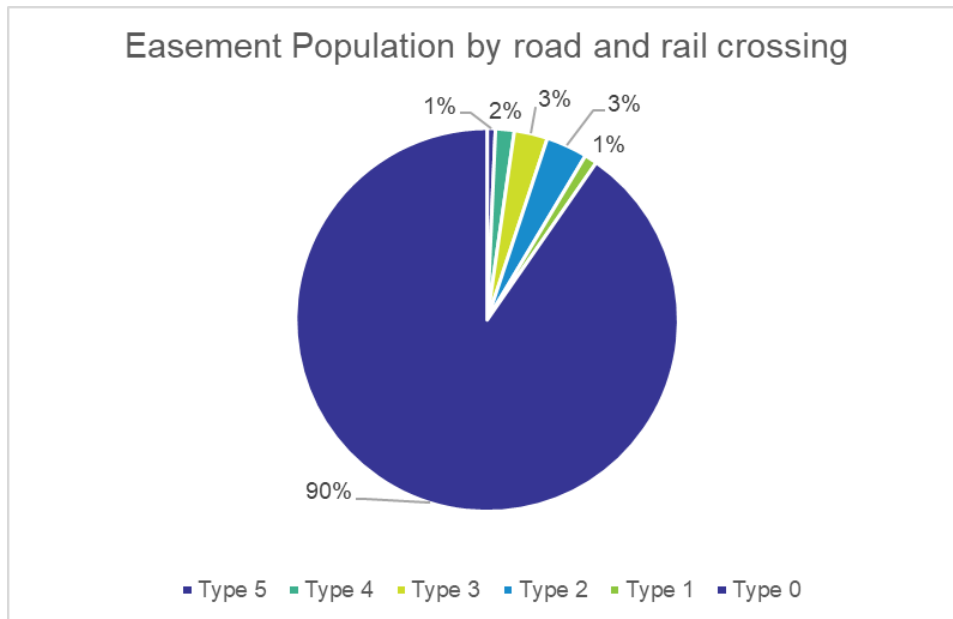
Figure 7 - Easement Population by Road and rail crossing

From a shared use perspective, the easements are grouped in five categories subject to road class and rail crossings. The consequence of a transmission line component failure is quantified in relation to the road class or rail crossing the easement i.e. a dropped conductor on an easement crossed by a highway or railway has a higher consequence than a dropped conductor over a sub-arterial or collector road and again higher than on an easement without shared assets. Figure 7 illustrates easement segment population by easement crossing type.

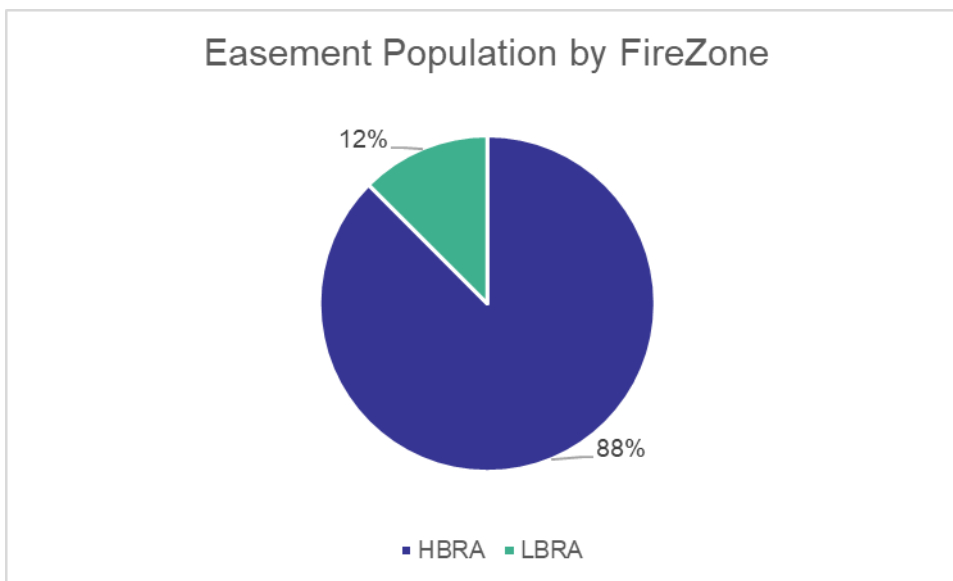
Figure 8 - Easement Population by Fire zone

From a fire zone perspective, easements are grouped in high bushfire risk area (HBRA) and low bushfire risk area (LBRA). The consequence of a transmission line component failure resulting in a fire start is quantified in relation to the easement fire zone i.e. the health and safety, collateral damage and power outage consequence of vegetation breaching the minimum clearance space is higher in HBRA compared to LBRA. Figure 8 illustrates easement segment population by easement fire zone.

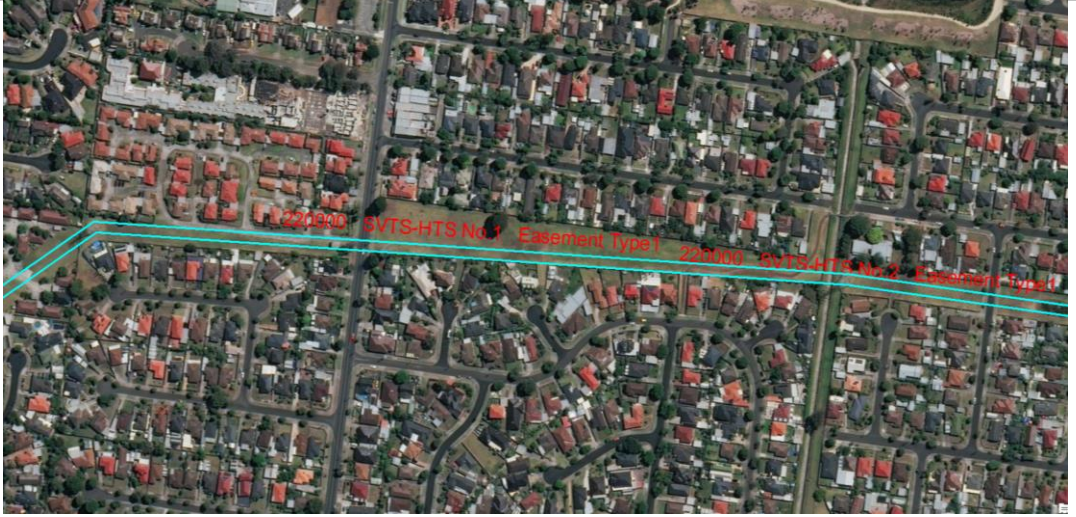
Easement Type	Illustration
Type 0 - Rural area	 
Type 1 - Residential area with cleared easement

Type 2 - Residential area with built up easement
