AMS 10-77 Transmission Line Structures

2023-27 Transmission Revenue Reset

Document number	AMS 10-77
Issue number	3
Status	Approved
Approver	P. Ascione
Date of approval	16/07/2020

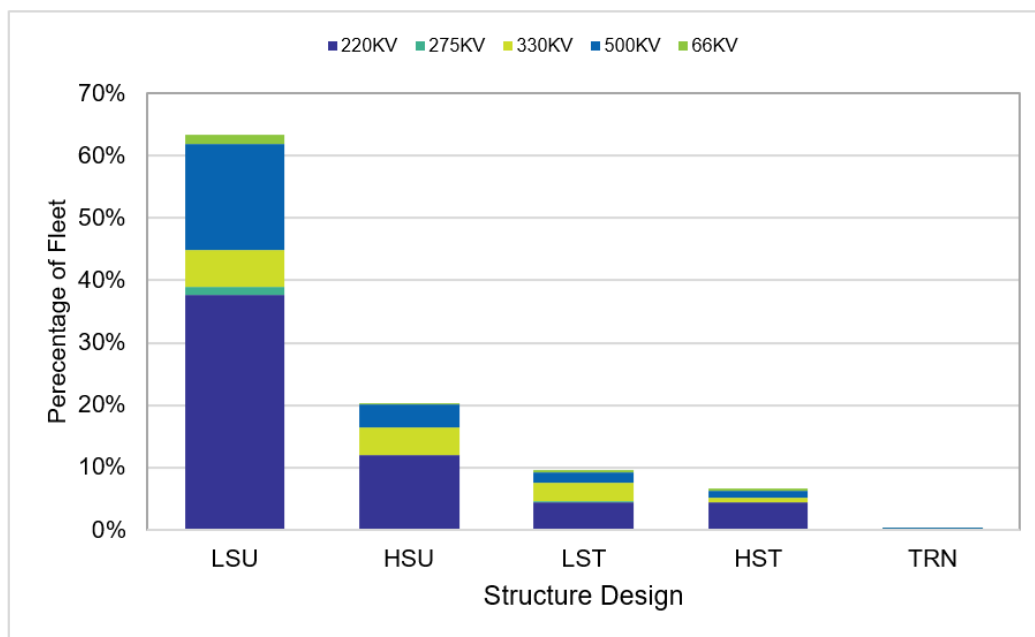
Transmission structures are further categorised based on design characteristics. The design characteristics determine what mechanical load the structure can support. There are five design categories including heavy strain (HST), light strain (LST), heavy suspension (HSU), light suspension (LSU) and transposition (TRN). Figure 4 displays the proportion of the structure fleet within each design category by operating voltage.

Figure 4 – Volumes of structures by design category and voltage

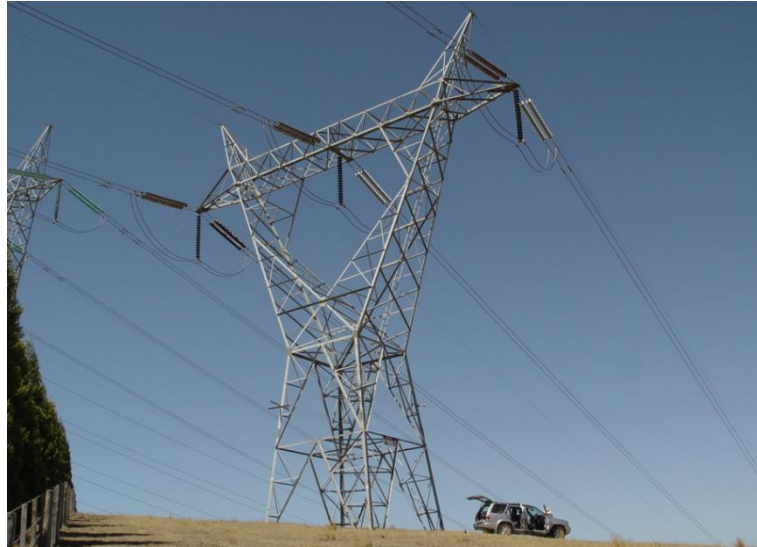
Figure 5 - DDTS-SMTS No. 1 330 kV strain tower

The 330 kV strain tower, 220 kV suspension tower and 500 kV transposition tower are shown in the following figures 5,6 & 7.

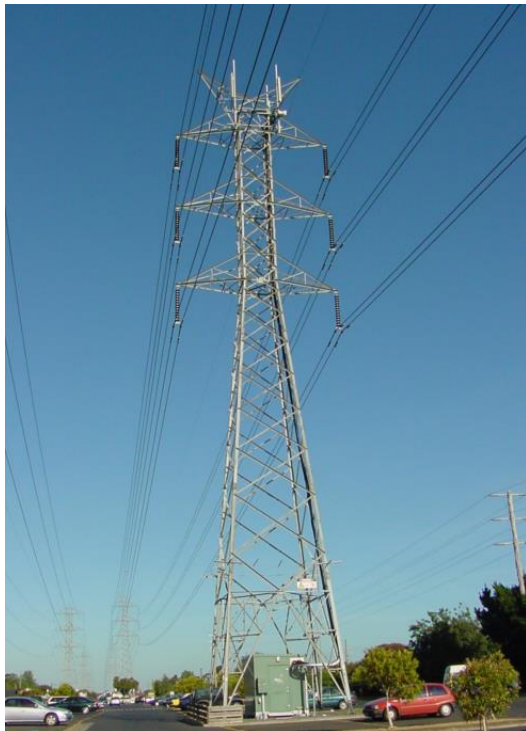
Figure 6 - ROTS-SVTS 220 kV suspension tower

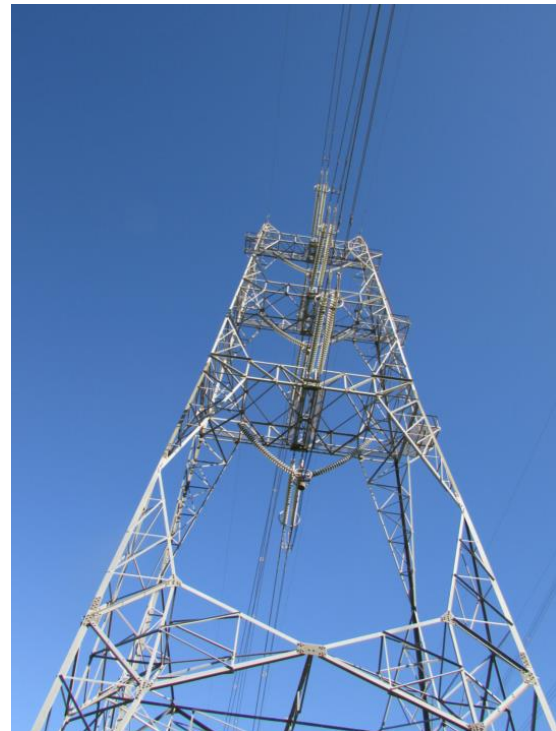
Figure 7 - HWTS-CBTS No. 4 500 kV transposition tower

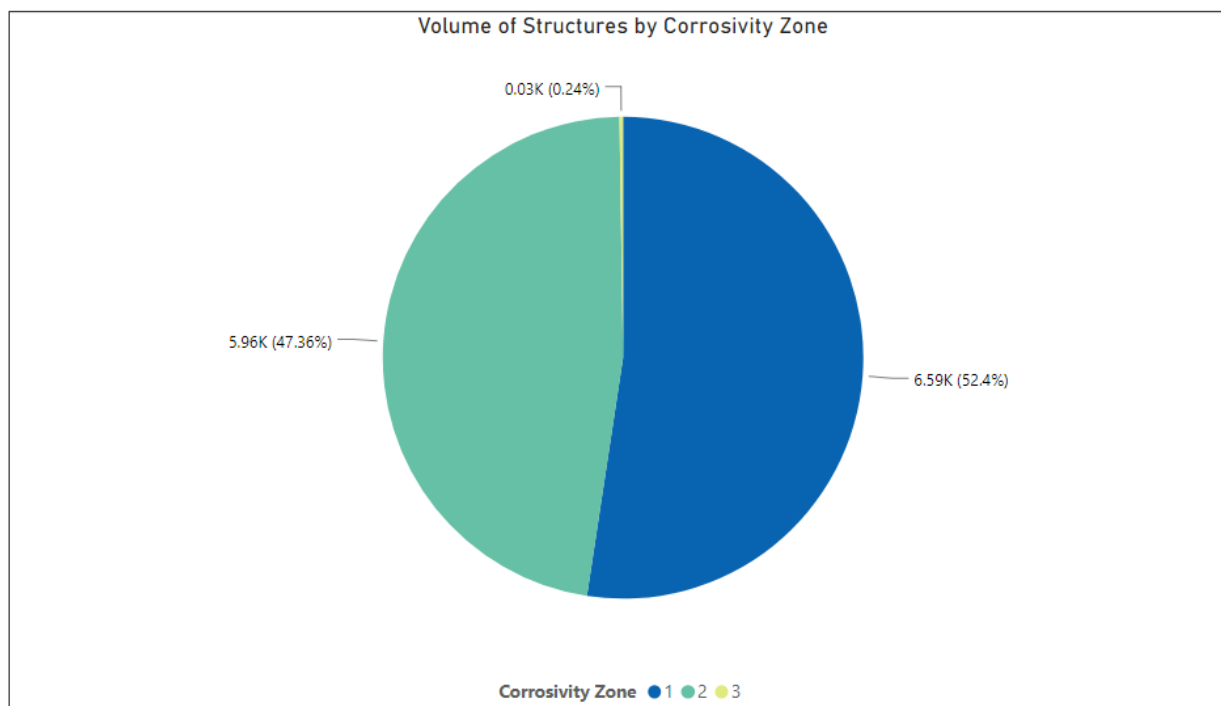
Figure 8 shows the percentage volume of transmission structures located in each of the three corrosivity zones. A map displaying a spatial view of transmission line assets within the four corrosivity zones is included in Appendix A. Fifty-two percent of structures are situated in the low corrosivity zone, while forty-seven percent are in moderate

Figure 8 – Volume of structures by corrosivity zone

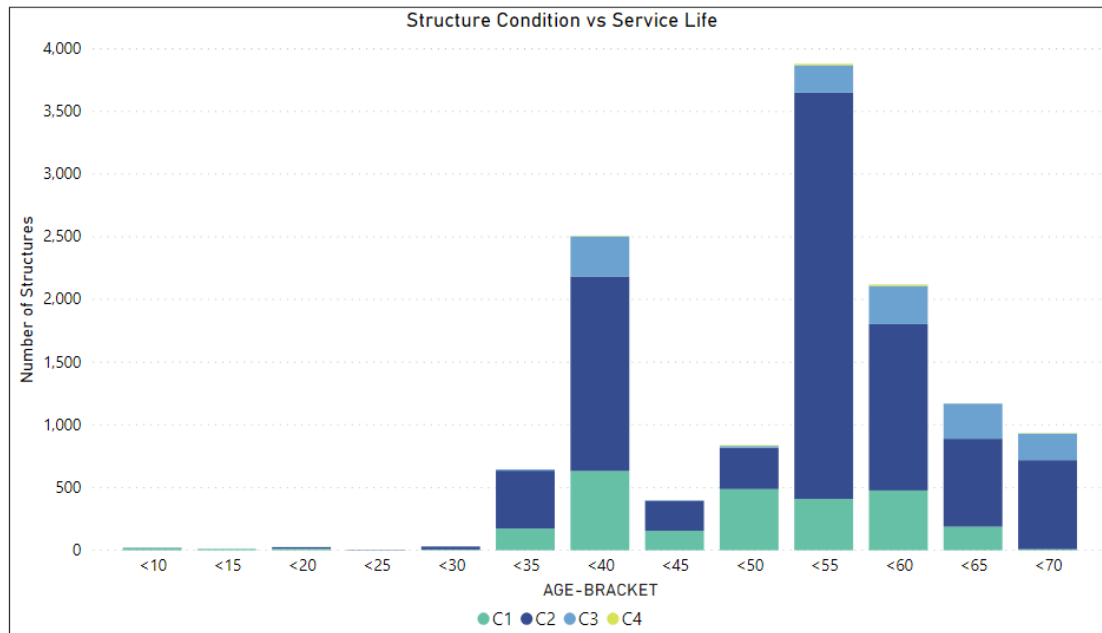
Figure 12 shows the condition of the tower fleet across its service life. C1 condition structures are almost evenly spread across service age brackets 35 years to 65 years, while C2 condition structures are mostly around the 55-year service range. Majority of C3 assets are more than 55 years old while C4 assets have had more than 55-years' service life with the exception on the HYTS-APD structures which are 40 years old.

Figure 12 – Structure Condition Grades across Service Life
