AMS 10-78 Transmission Line Foundations

Document number	AMS 10-78
Issue number	3
Status	Approved
Approver	Paul Ascione
Date of approval	3/07/2020

Transmission Line Structure Foundations

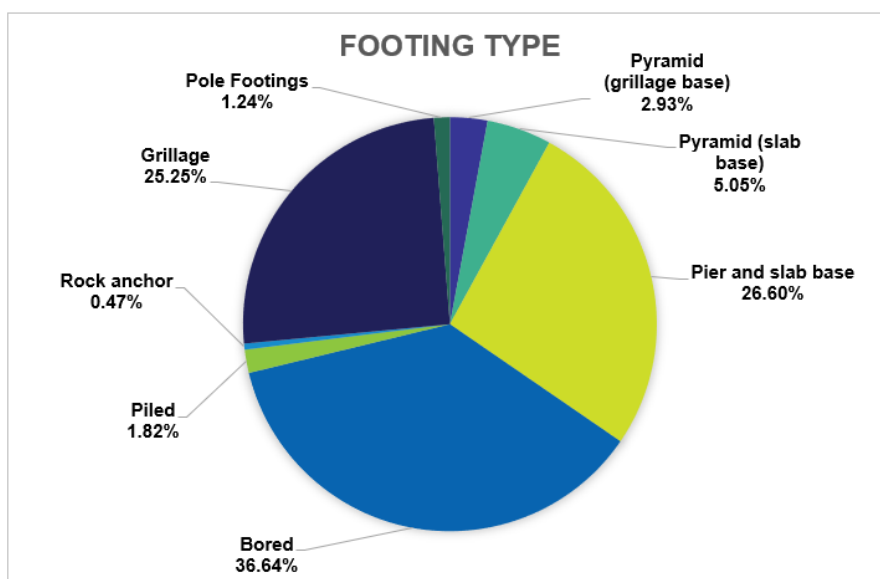
Figure 1 – Structure foundations by type

Bored or augured foundations are the most common types in use on the Victorian network comprising 37% of installations. This type of foundation is the most common due to its relative ease of construction, low cost and high reliability. Grillage, and pier and slab base foundations make up the majority of the remaining foundation type, contributing to 28% and 27% respectively. Figure 1 displays the different types of structure foundations.

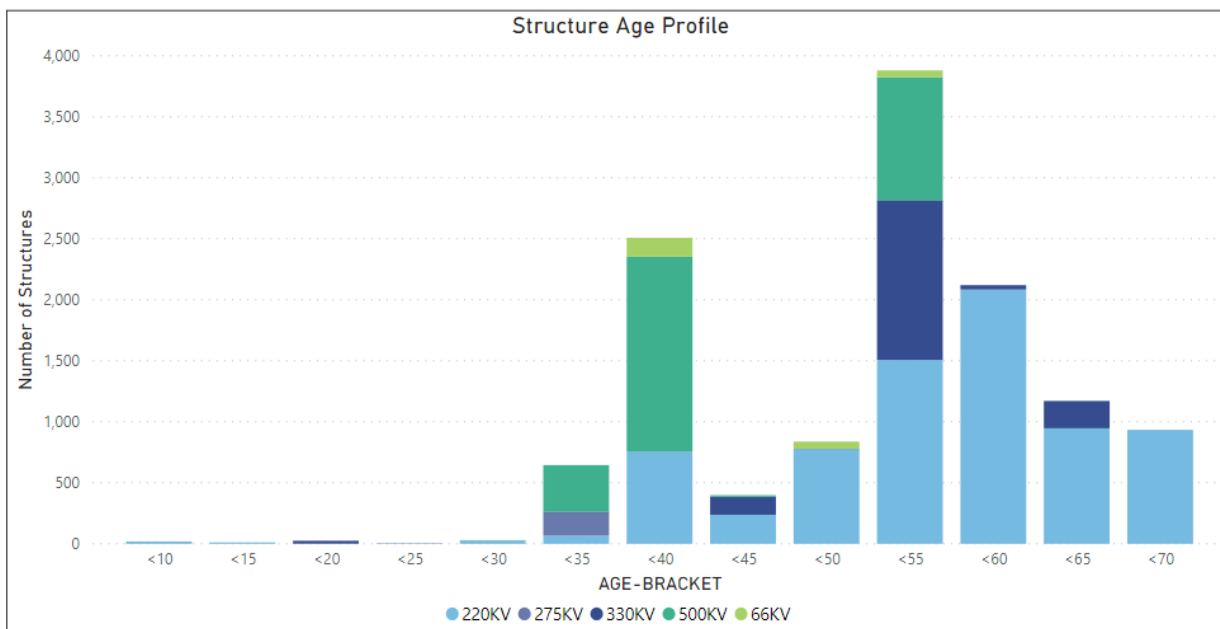
Figure 2 – Structure foundation age profile

Figure 2 displays the age profile of transmission line foundations and their respective structures by voltage class.⁴

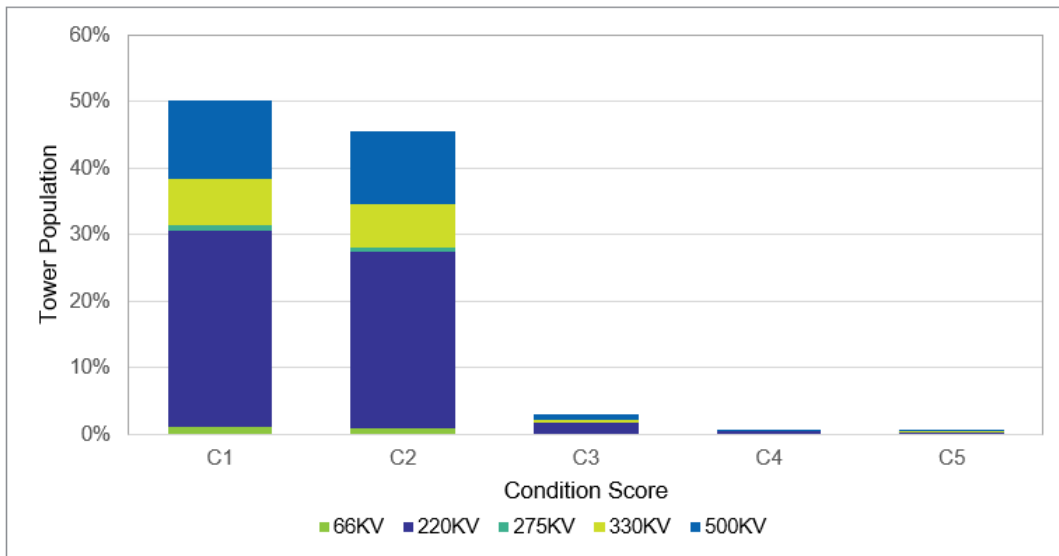
Figure 3 – Structure Foundation Condition

Figure 3 shows that over 96% of the foundations are in a C1 or C2 condition, with 3% in C3 condition, 0.7% in C4 and 0.3% C5 condition.

At present, structure foundations are generally in very good to good condition. Approximately 50 percent of structure foundations has no rust or have been painted, and approximately 46 percent is exhibiting first signs of rust. It should be noted that these results reflect conditions at the footings ground line and may not be representative of below ground conditions.

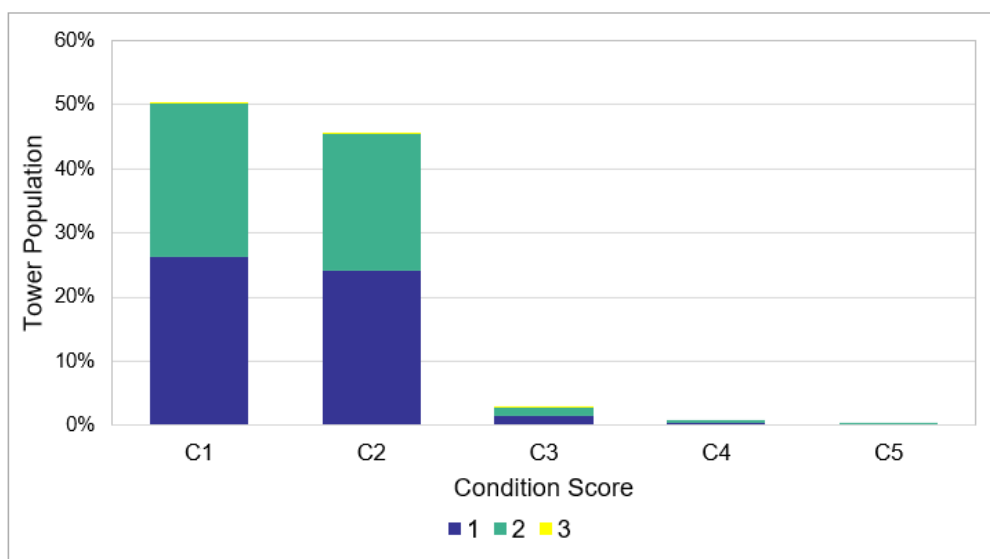
Figure 4: Structure Footing Condition vs Corrosivity Zone

Footings are assigned a condition grade from a scale between C1 and C5 against two grading parameters: leg and bracing members, and if the tower is on concrete foundations, the concrete pedestal. The towers located in Corrosivity Level 3 have foundations in Very Good to Average condition (C1 to C3) because these have been painted together with the tower structure in 2002. Refer Figure 5 for condition profile against the tower population.

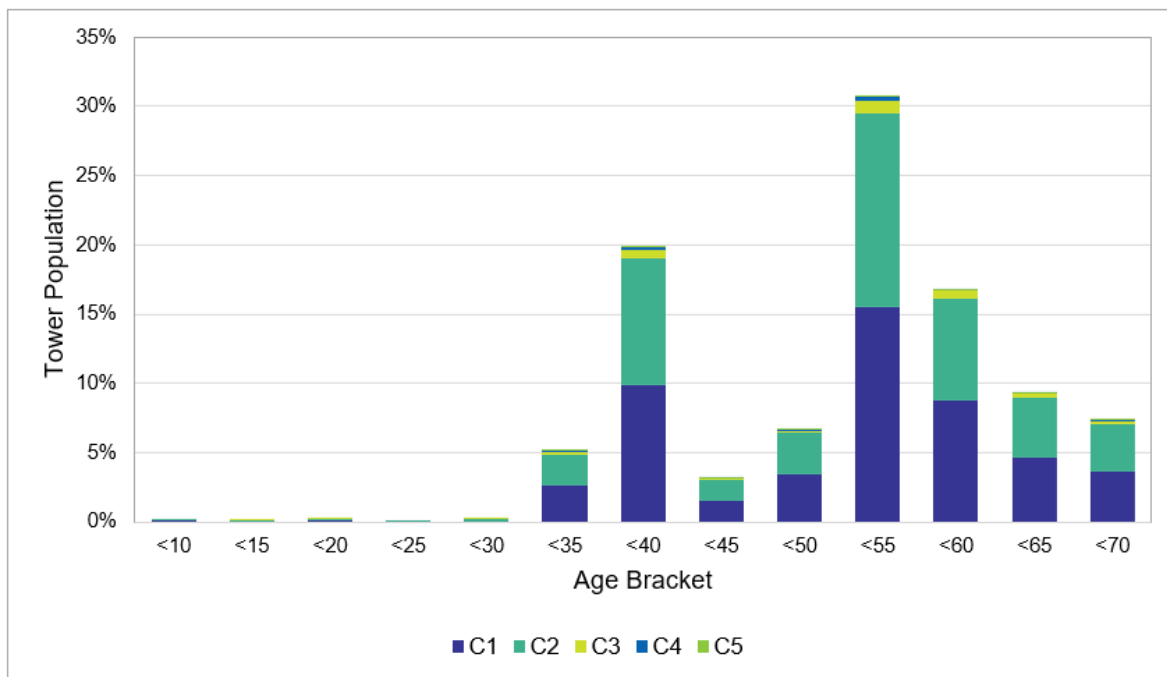
Figure 5 – Structure Condition Footing across Service Life

Figure 5 shows that the transmission line structure footings reflects that of a normal distribution with a mean age of approximately 53 years and a standard deviation of approximately 6 years. The figure shows that even in the advanced age of foundations, most of these are still in very good to good condition (C1 to C2).

This would be attributed to the SOXS program which addressed the issue of degradation due to corrosion, thereby assuring the integrity of the transmission network and therefore, its safety.

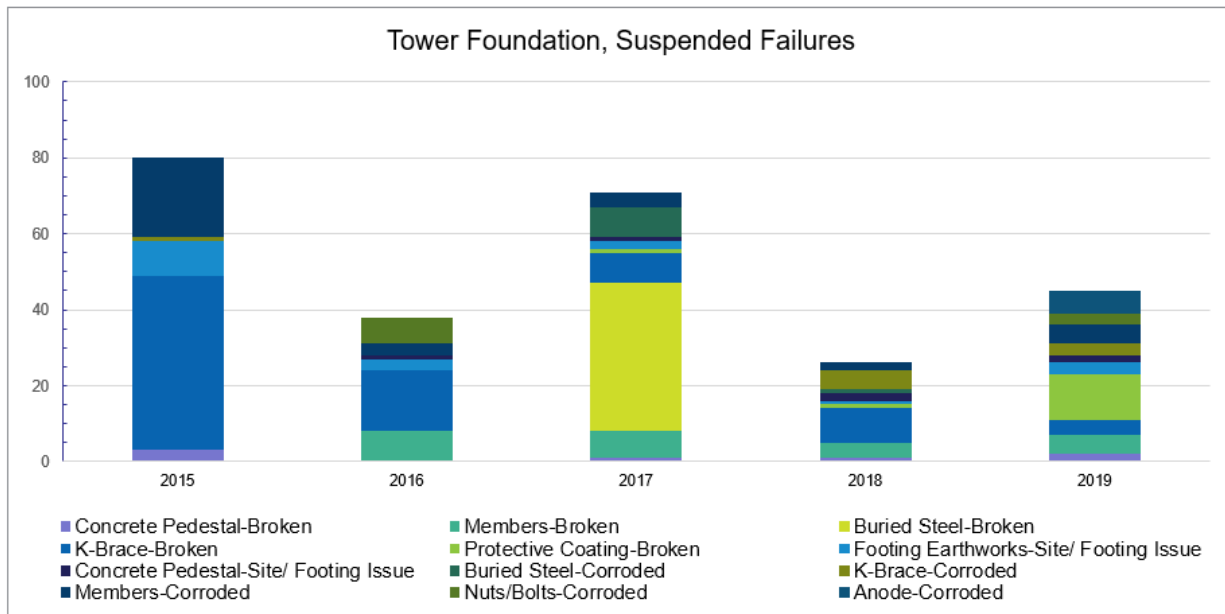
Figure 6 – History of suspended foundation failures

Figure 6 displays suspended failures by cause over the last five years. Peaks in volumes of ZA notifications reflect corrosion and wear-based issues. Failure rates for corroded tower legs and braces have reduced considerably over the last four years.

Over the last five years there have been a total of 339 suspended foundation failures. The majority of the suspended failures were caused by deterioration of legs, k-brace and pedestals. These represent 50% of the total suspended failures while corrosion of members and legs comprise 20%. In most cases rust was found on the tower legs at the ground line where the mix of air and moisture most promotes corrosion. Corrective actions taken to address corroded tower legs involves member strengthening if section loss is identified, cleaning of rusted members and the application of protective paint.

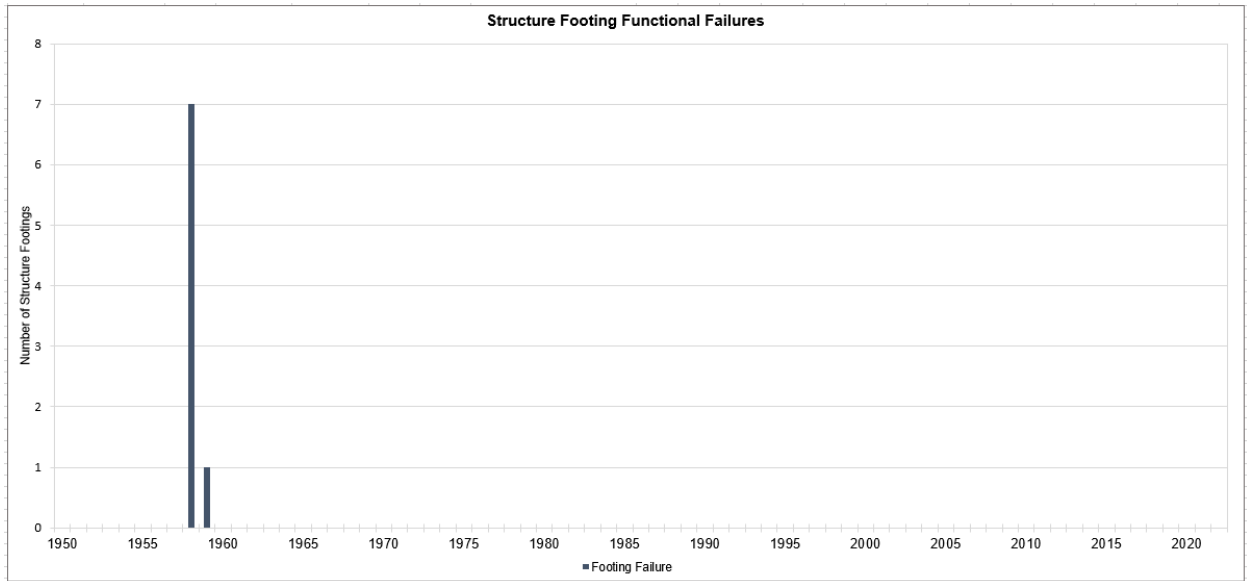
Figure 7: Foundation functional failure history

Since 1958 there have been two incidents of structure foundation functional failures resulting to 8-tower collapses as indicated in Figure 7. In this context a functional failure of the structure’s foundation results in a functional failure of the transmission line. Such a failure prevents the safe flow of electricity from one terminal station to another which has marginal market costs and unserved energy costs to the community. Other risk costs arising from a functional failure of a structure’s foundation include unplanned structure replacement, and potential public safety risks associated with failures near roads, railway lines or in areas defined as a high bush fire risk.

Although unrelated, the two incidents took place within a period of two years in the late 1950's when the transmission network was still under construction. These failures were caused by inadequate strength of grillage type foundation designs. Following these incidents, a program of foundation strengthening works targeting structures with grillage foundation designs was undertaken.

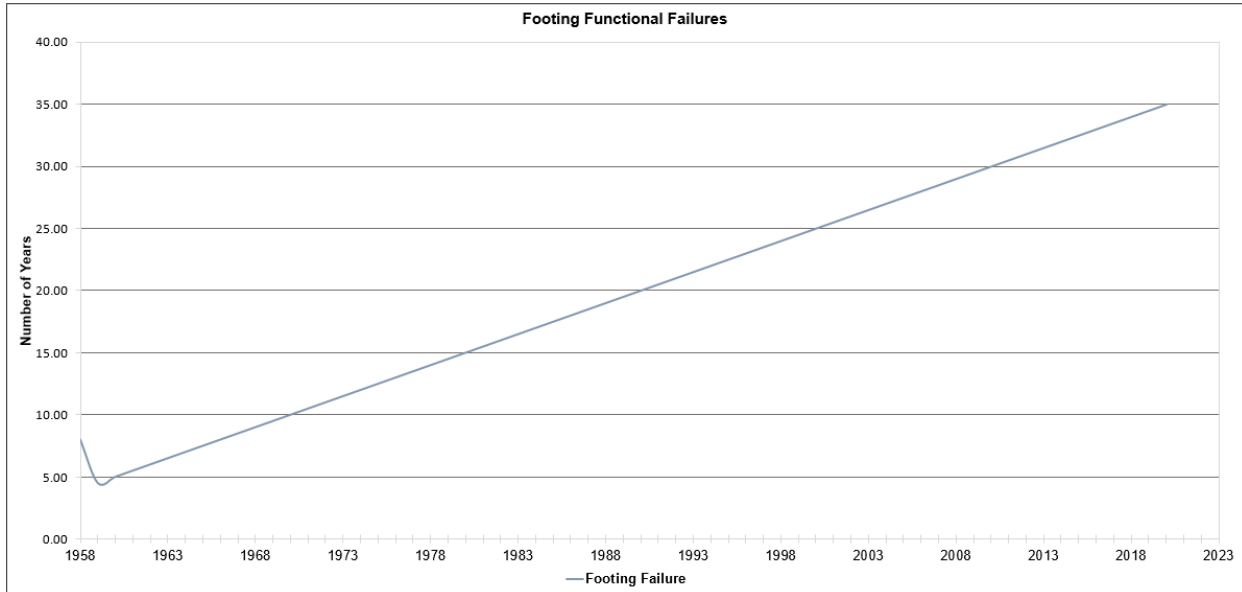
Figure 8: Transmission Structure Foundation MTBF

The mean time between failures of transmission structure foundations has remained very high at 35 years since no foundation has failed since the tower foundation strengthening works were completed by the State Electricity Commission of Victoria (SECV) in 1968. Figure 8 provides the graph showing MTBF of structure foundations.

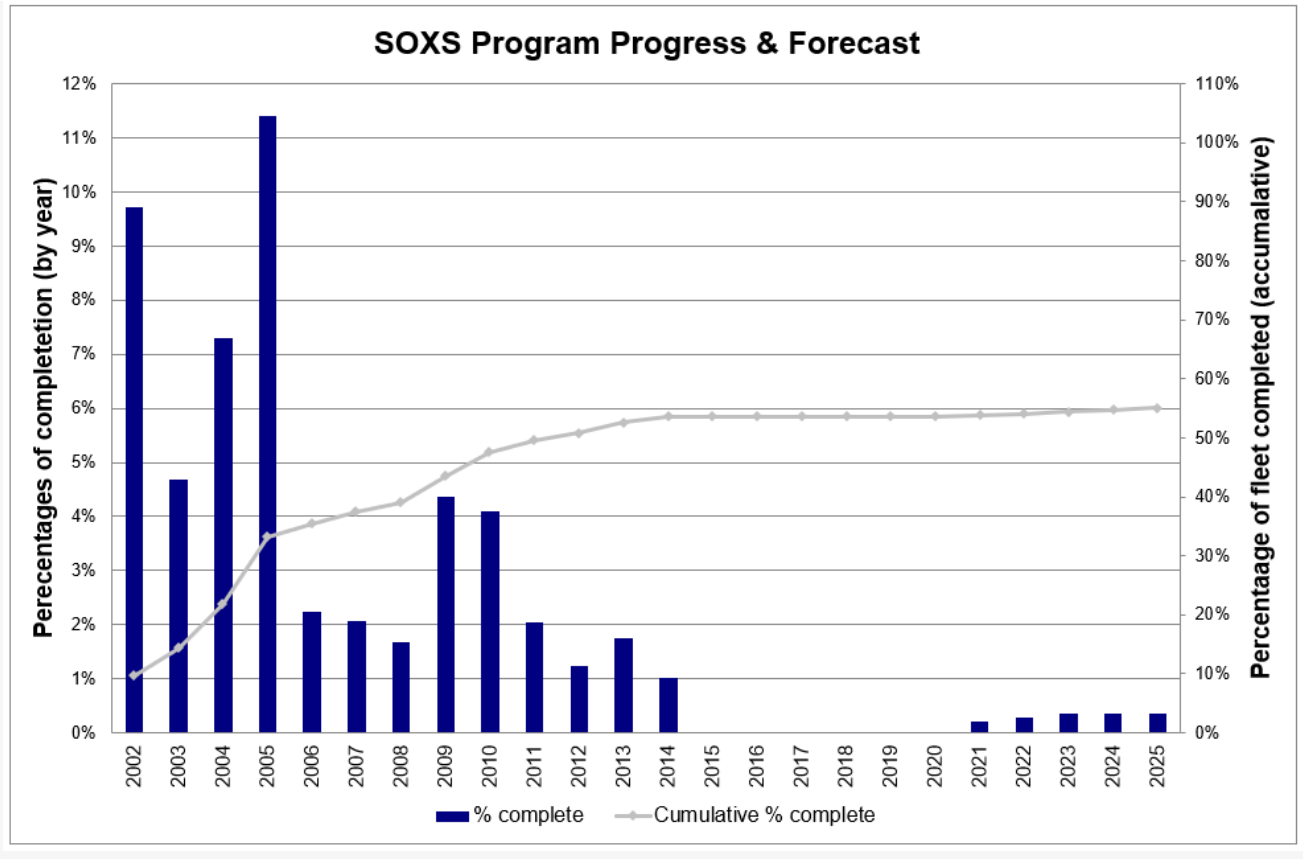
Figure 9: SOXS program progress and forecast

Figure 9 illustrates the percentage of footings completed each year, as an accumulated fleet total and the future forecasts of the SOXS program. Approximately 50% of footings were completed by the end of the 2011/12 financial year.

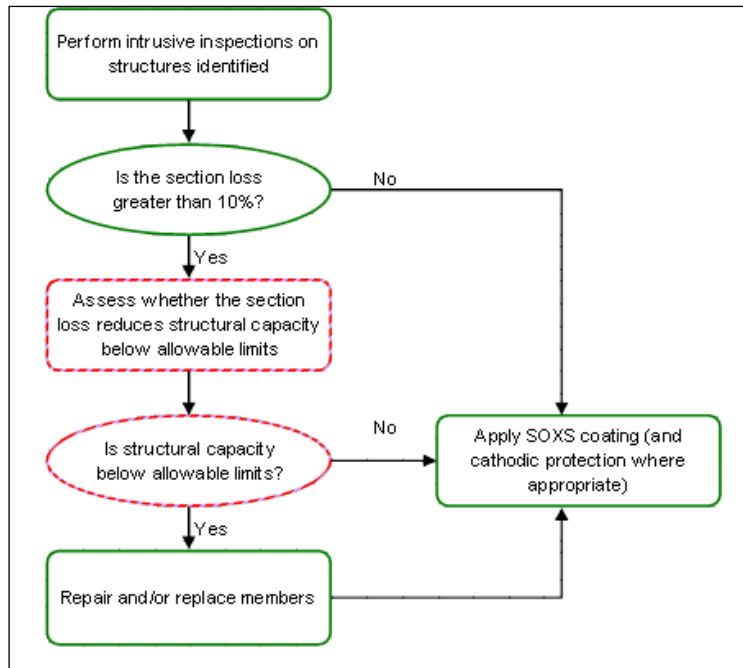
Figure 10: Intrusive inspection of structure foundations decision-making process

A risk-based decision making process map is used as part of the intrusive and testing process is shown in Figure 10.

The first key decision in the process relates to the need to perform a structural capacity assessment, this decision is made based on the amount of metal section loss measured on the structure foundation members.
