5.13.C

Project justifications for
overhead conductors
replacement programs

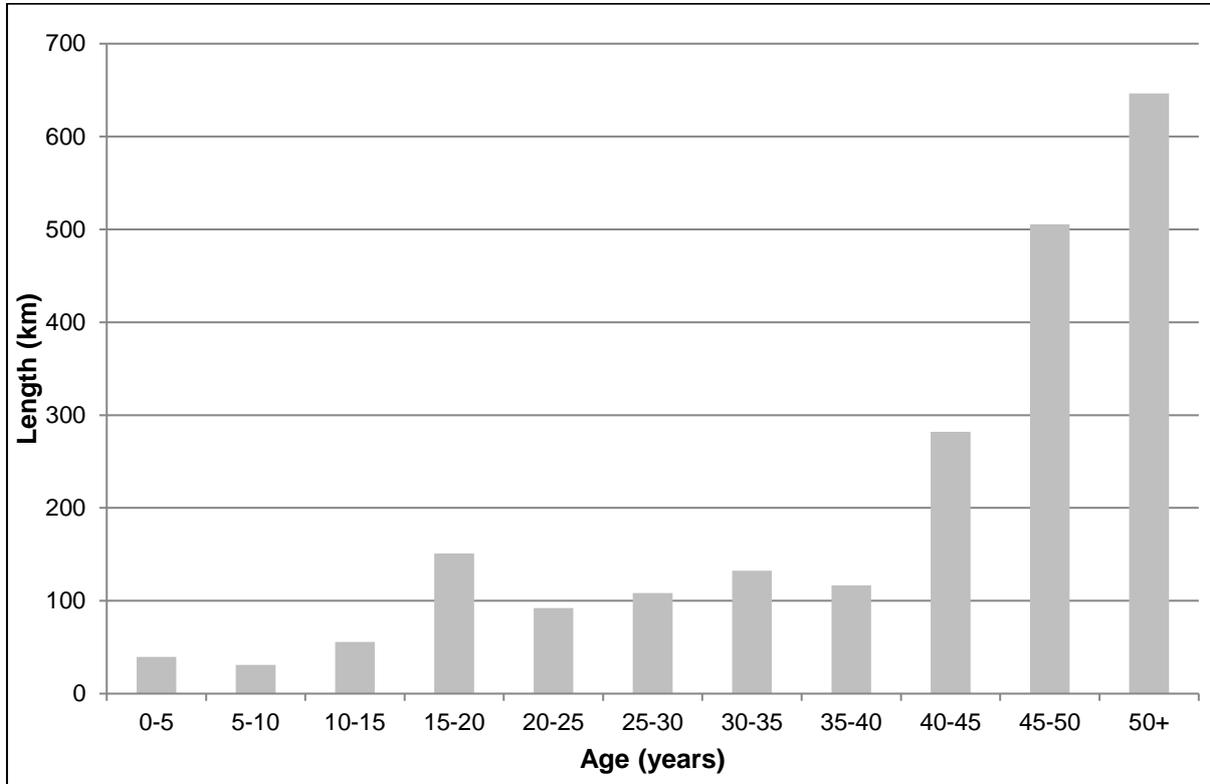
75% of this total length is located in bushfire prone areas. The average age of these overhead conductors is 37 years, with 53% over their standard technical life of 45 years. The age profile of these overhead conductor types is shown in Figure 1.

Figure 1. Age profile of steel mains and ACSR (as at June 2017)]

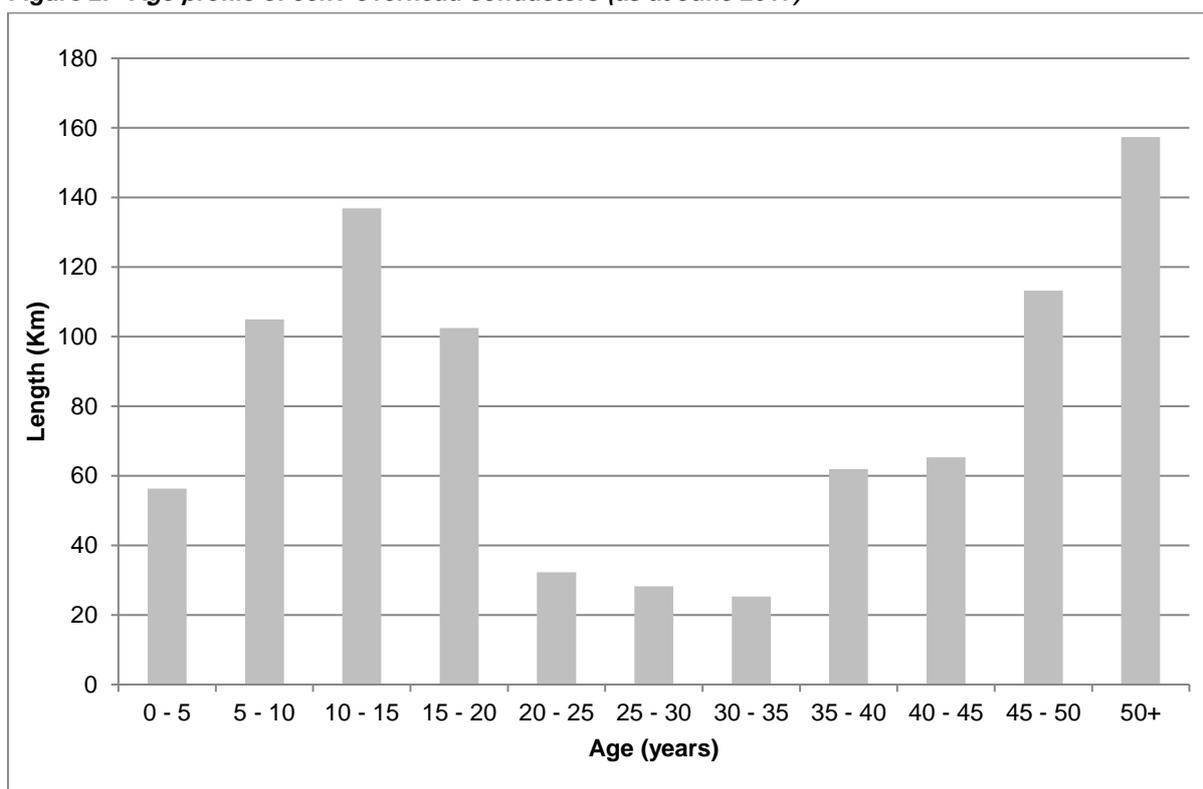
Ausgrid has 1,235km of overhead conductors operating at 33kV. The average age of these overhead conductors is 36 years, with 41% over their standard technical life of 45 years. The age profile of these overhead conductor types is shown in Figure 2.

Figure 2. Age profile of 33kV overhead conductors (as at June 2017)

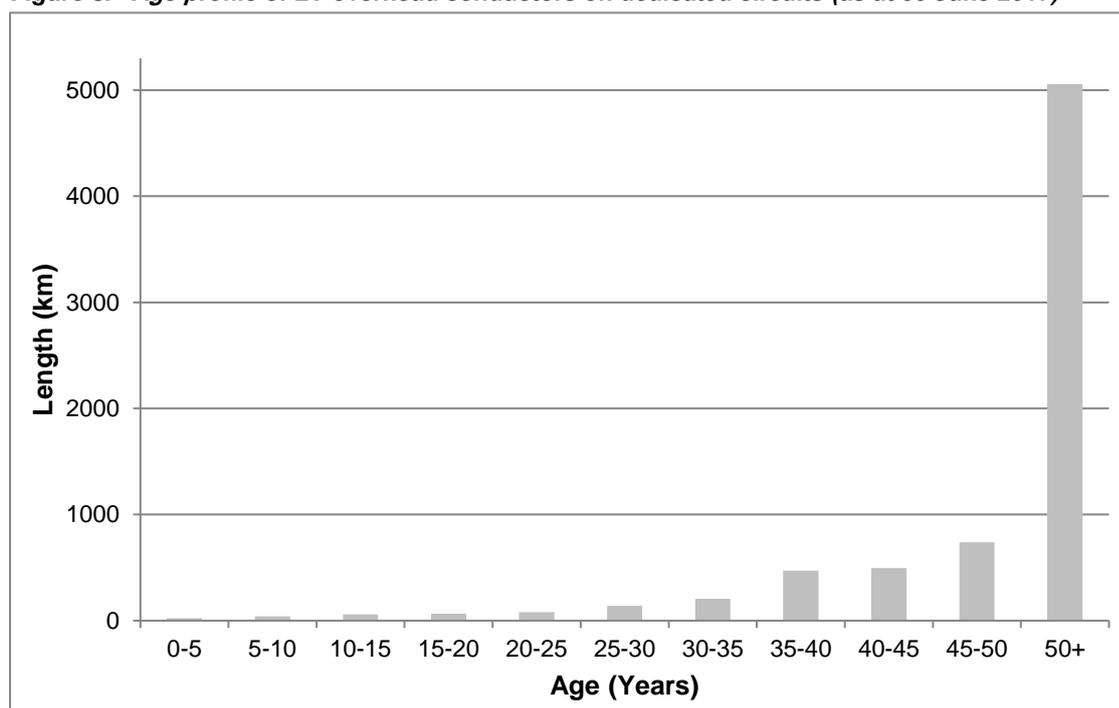
The age profile of LV overhead conductors used on dedicated circuits is shown in Figure 3. 79% of these assets are more than 45 years old.

Figure 3. Age profile of LV overhead conductors on dedicated circuits (as at 30 June 2017)

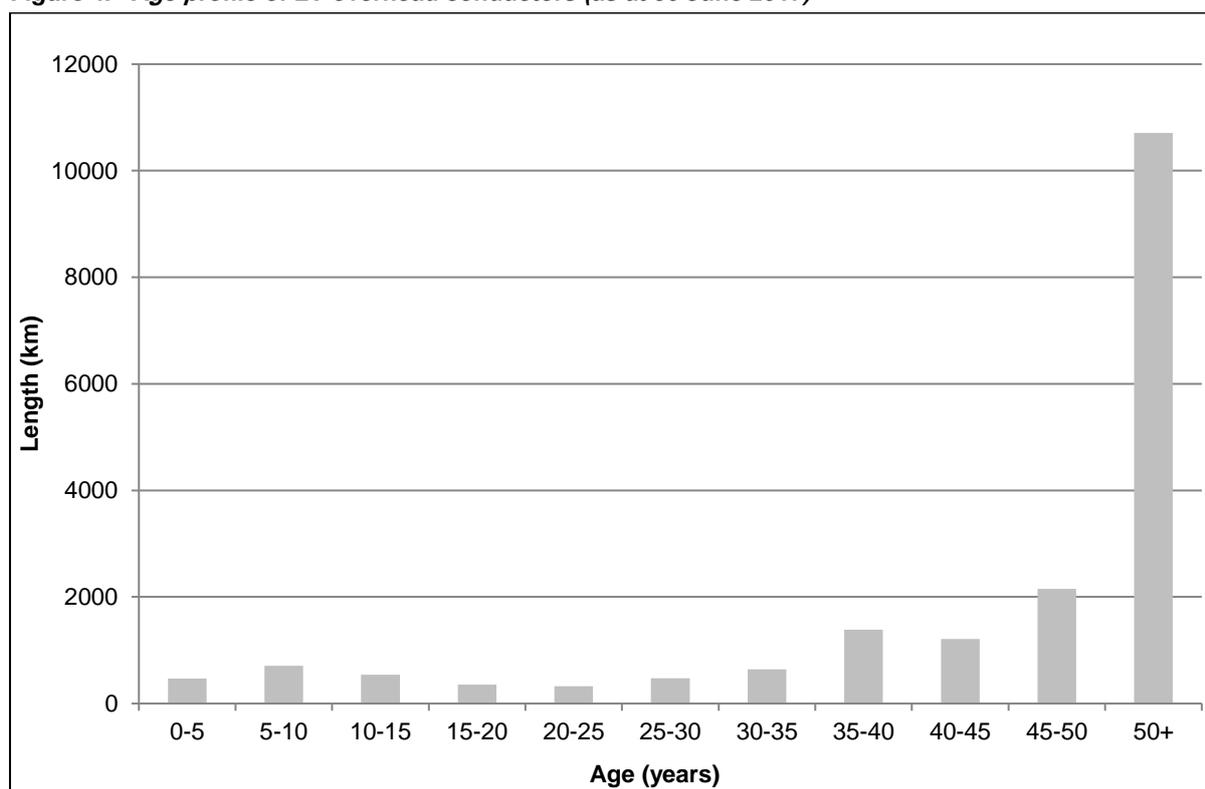
The age profile of all LV overhead conductors is shown in Figure 4.

Figure 4. Age profile of LV overhead conductors (as at 30 June 2017)

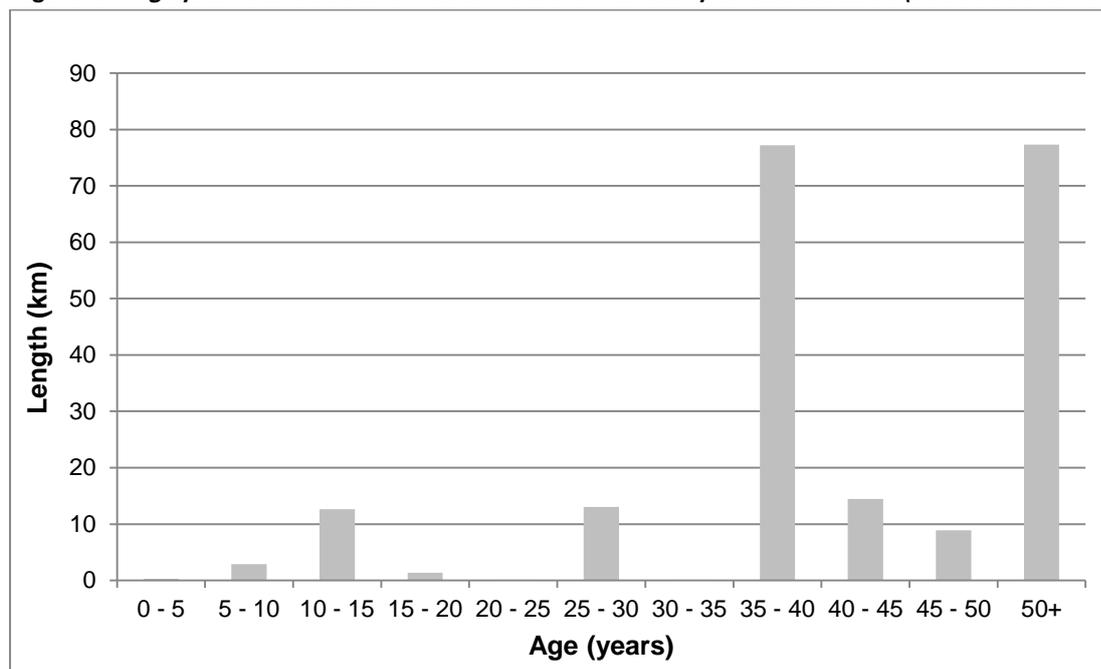
Ausgrid does not record earthing system asset details to such a level that individual component age is known. The average age of the earthing systems has been estimated using the age profile of the identified feeders with star picket earth electrodes. The average age of these feeders is 28 years. The age profile of the identified feeders (and inherently their associated earthing systems) is shown in Figure 5.

Figure 5. Age profile of sub-transmission feeders with star picket electrodes (as at 30 June 2017)
