5.13.B

Project justifications
for pole top structures
replacement programs

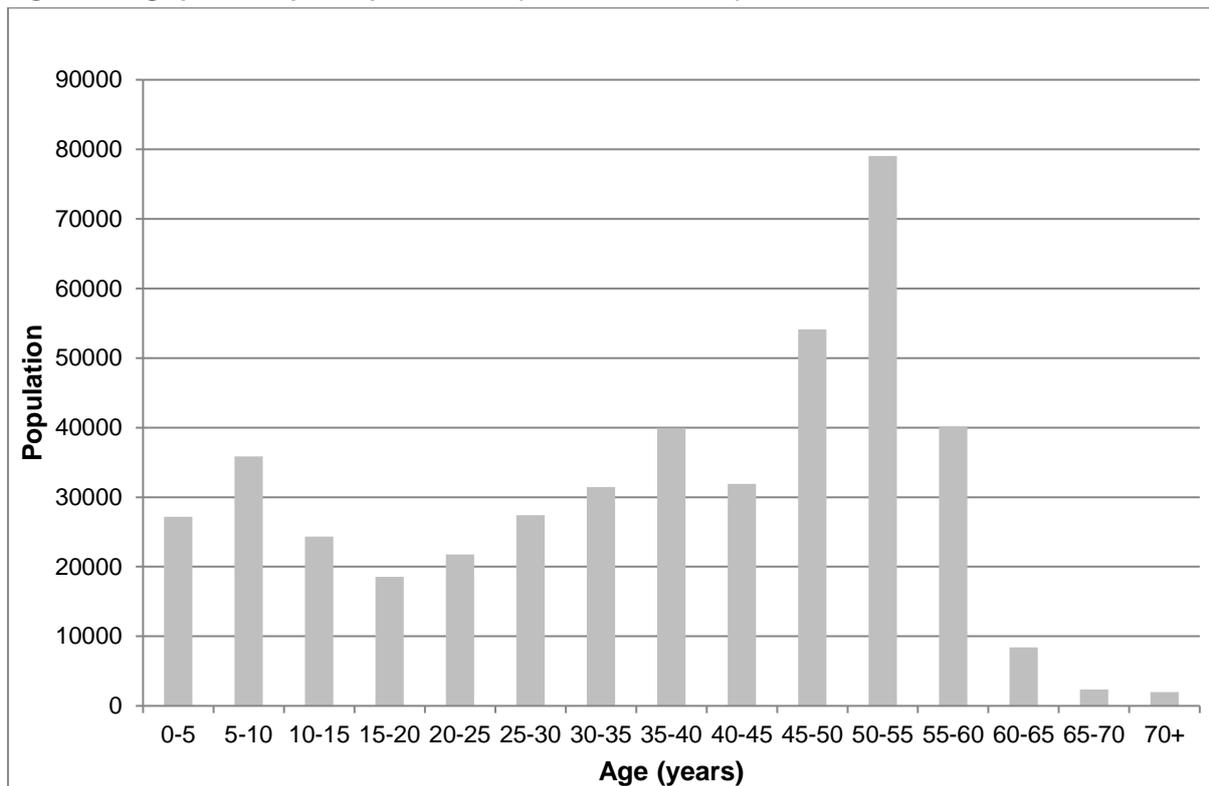
Figure 1. Age profile of pole top structures (as at 30 June 2017)

Ausgrid does not record pole top structure asset details to such a level that individual component age is known. The average age of pole top structures has therefore been estimated using the Ausgrid pole age profile as a pseudo. The age profile of Ausgrid poles is shown in Figure 1. The average age of poles is 35 years, with 42% over their standard technical life of 45 years.
