2016 Safety Performance Report on Victorian Electricity Networks

30 September 2016

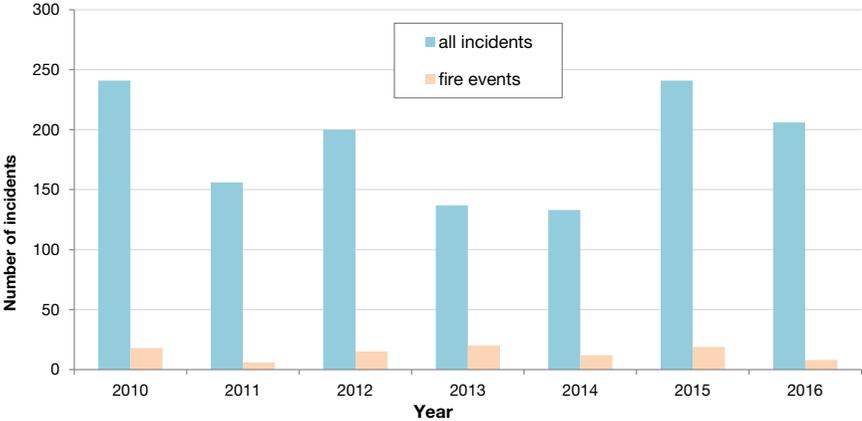
Figure 1 Vehicle collisions

As noted in Section 5.4, vehicle impacts are the most common incident on the electricity networks reported to ESV. There is a large interannual variation in vehicle collisions with electrical infrastructure (Figure 1),¹⁰ but no apparent trend in incidents observed between 2010 and 2016.

¹⁰ This predominantly is due to car collisions with electricity poles, but it also includes truck and farm/construction equipment with overhead powerlines.

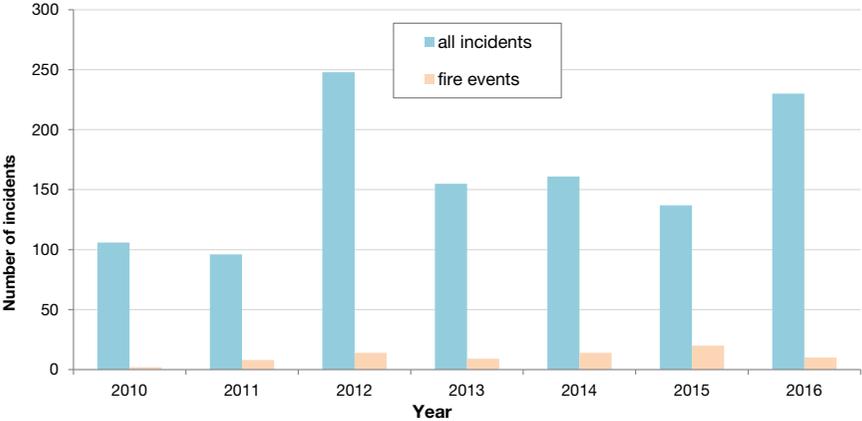
Figure 2 Other contact events

Other contact events include copper theft, vandalism and No Go Zone infringements. Excluding the peak in 2012, there has been an upward trend in such events between 2010 and 2016 (Figure 2). ESV has particularly noticed a high level of such events, particularly copper theft, within the Powercor network (see Section E6).

The events include copper theft, vandalism, No Go Zone infringements

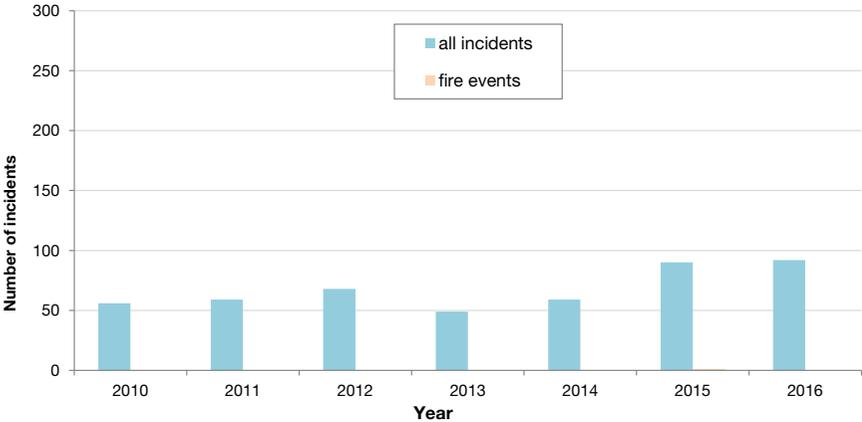
Figure 3 Dug-up cables

While less common than the other two events, dug-up cable events have been increasing since 2010 (Figure 3). Ongoing brownfield development in Melbourne and Geelong continues to expose underground cables to the risk of impact during foundation excavation and service trenching. The upward trend is therefore likely to continue.

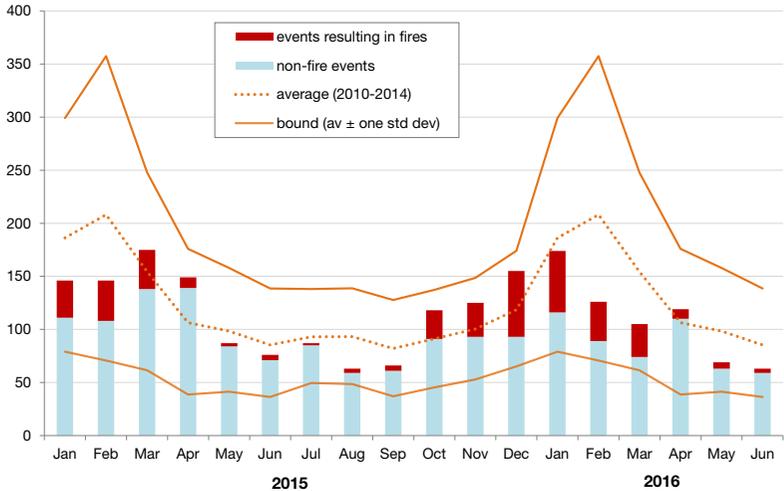
Figure 4 Fire and non-fire events by month

Figure 4 shows all the electrical infrastructure safety incidents reported to ESV between January 2015 and June 2016 for all the distribution businesses (namely AusNet Services Distribution, CitiPower, Jemena, Powercor and United Energy). It differentiates the non-fire events from those resulting in a fire.

In general, the incidents reported are slightly lower than the historical average from the previous five years (2010-2014). Figure 4 also shows the following general trends:

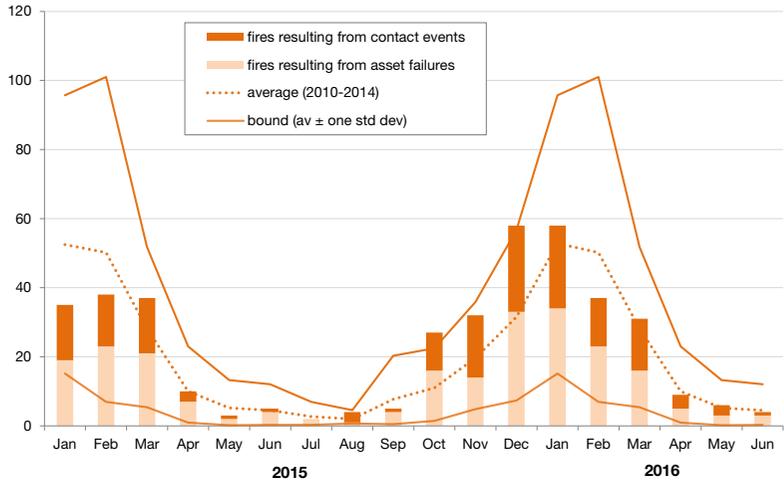
Figure 5 Contact and asset fire events by month

Figure 5 provides further detail on the subset of incidents that resulted in a fire event. This shows a pronounced spring/summer increase in such events, with performance in the 2015-2016 period generally within one standard deviation of the historical average from the previous five years.

There is also a difference between the 2014-2015 and 2015-2016 summers. Generally incident levels peak in January and February; however, the peak in 2014-2015 was delayed until February/March and brought forward into December/January in 2015-2016. The early summer in 2015-2016 saw monthly incident levels exceed one standard deviation from the historical average, although this was below the normal summer peak.

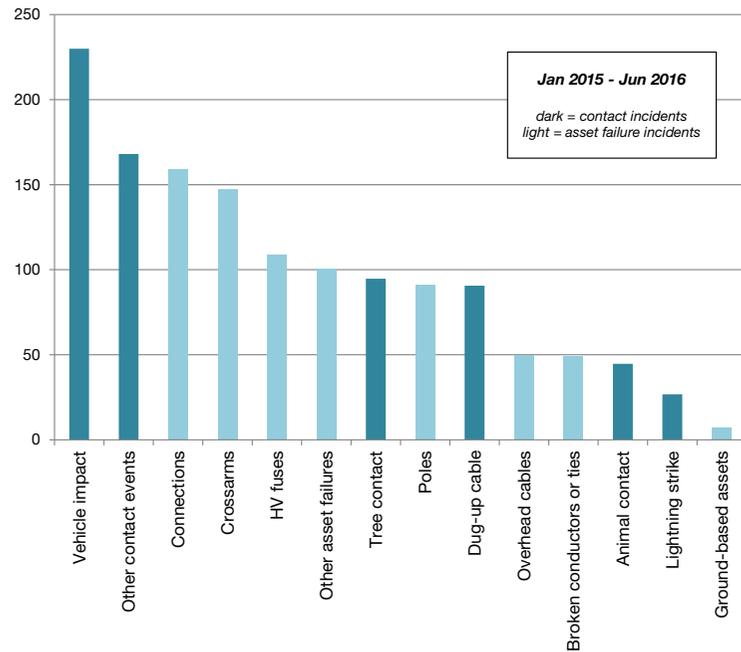
Figure 6 Incidents occurring on Victorian networks (per year)

Figure 6 shows the annualised number of incidents on the Victorian networks from most common to least common. Figure 7 does the same for those incidents that result in fires.

Over the 2015-2016 period, two of the five most common events were outside the direct control of the networks to manage. Vehicle collisions with power poles and street lights has escalated to the most commonly reported event from fifth place in 2010-2014. The number of other contact events annually (including vandalism, copper theft and No Go Zone infringements) has increased in 2015-2016, pushing this into second place.

Connection failure, the most common incident in 2010-2014, has fallen back to third position and the number of events annually has fallen by 31 per cent. Crossarm and fuse incidents have also dropped from second to fourth place and fourth to fifth respectively, with reductions of 20 per cent and 19 per cent respectively.

As shown in Figure 6, the most common incident occurring on the Victorian distribution networks is vehicle collision with distribution and lighting poles.

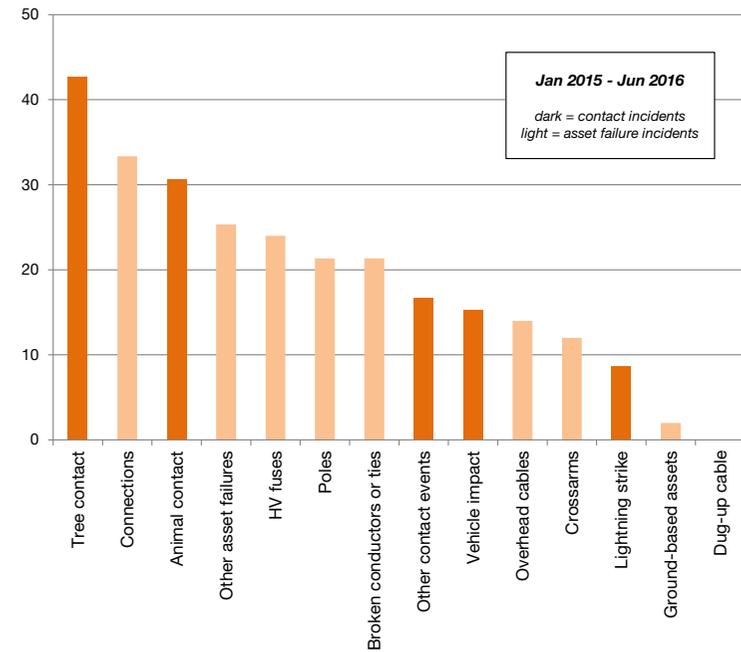
Figure 7 Fire-related incidents occurring on Victorian networks (per year)

Tree contact continues to be the most common fire event, with average annual incidents increasing 11 per cent between the 2010-2014 and 2015-2016 periods. Fires from connection failures have increased by 75 per cent, lifting this into second place. Animal contact in third place has also experienced an increase of 32 per cent. All of the five most common events are controllable.

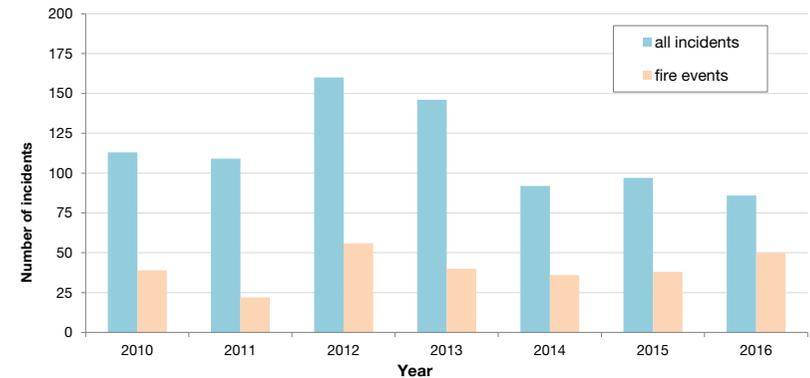
Figure 8 Tree contact events and fires

While the fire events for these three incident categories are higher than the average for 2010-2014, the peaks in tree contact fires (Figure 8), connection failure fires (Figure 9) and animal contact fires (Figure 10) indicate that the elevated levels observed in the 2015-2016 period are similar to the maximum level in the 2010-2014 period. This could be due to the influence of weather on network assets and the environment. This is discussed further in Section 5.3.

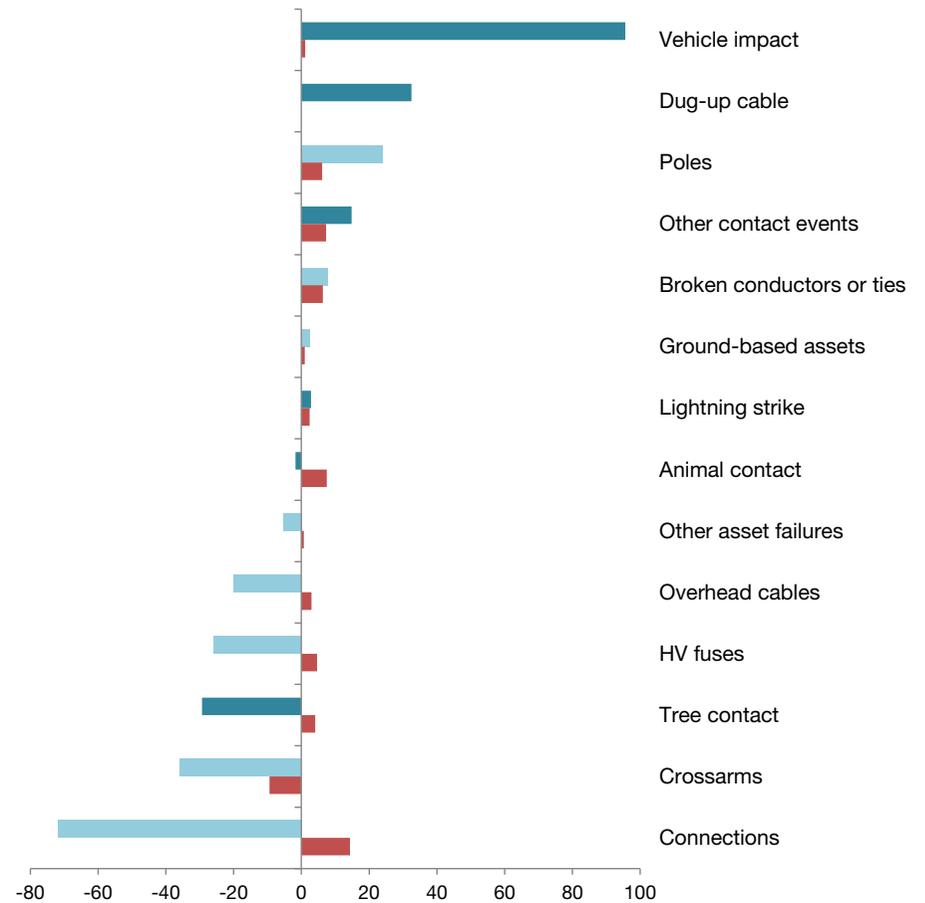
Figure 11 provides more details on the changes in annual incident rates between the 2010-2014 and 2015-2016 periods. Of the seven types of event that experienced an increase in frequency, four are outside the direct control of the distribution businesses. This includes three of the four largest increases. Those events that are within management control include pole failures, broken conductors and ties, and a very small increase in ground-based asset failures.

It would appear that targeted works have reduced the incidence of tree contact (a potential bushfire risk) and connection and crossarm failures (the two most common events in the 2010-2014 period).

Figure 11 also shows that fires resulting from asset failure and contact events have increased for all events except for crossarm failures. Unfortunately while connections failures have seen the largest decrease since 2010-2014, connection-related fires have seen the largest increase in fire incidence. As stated earlier, this may be due to the influence of weather conditions in increasing fire risks on the networks and to the relatively benign conditions in 2010-2011 (Figure 12) reducing the average number of incidents in the 2010-2014 period. The smart meter roll-out has helped reduce the number of connection failures and should reduce the number of connection fires below the levels that would have occurred without the roll-out. This is discussed further in Section 5.5.

Figure 11 Changes in numbers of incidents by event type
 Blue = all incidents, red = incidents resulting in fires

These reductions are already tangible, with observed reductions in connection and fuse failures (see Figure 11) being attributable (at least in part) to the improved monitoring made possible by the smart meter program.

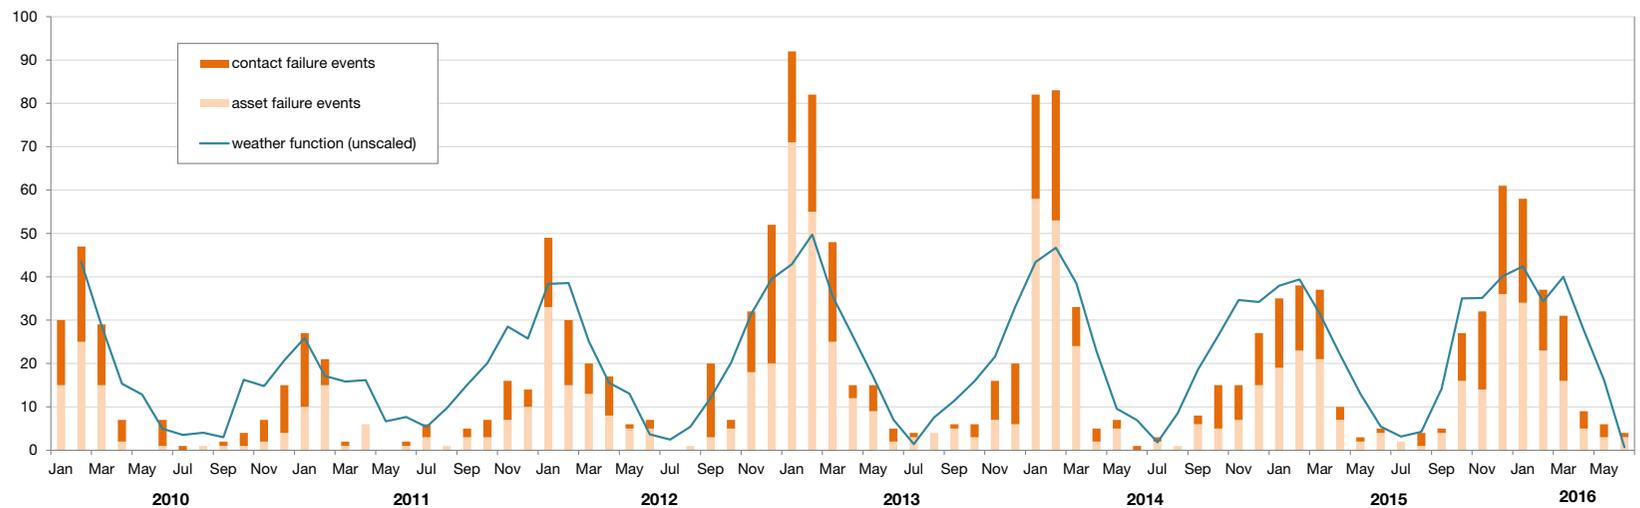
Figure 12 Monthly fire incidents from 2010 to 2016

Figure 12 shows the monthly fire incidents between 2010 and 2016 broken into those resulting from contact and asset failure events (column data). This shows a clear seasonal pattern driven by higher temperatures and lower rainfall over the summer period.

Figure 12 includes a weather function curve that is a simple measure of the monthly averaged maximum temperature across six sites, with these adjusted for the average monthly rainfall. This provides a reasonable correlation ($R^2 = 0.72$) to the fire events on the Victorian networks. Even so, further investigation of other influences (such as wind speed and multiple days with high temperatures) is needed to account fully for the 2013, 2014 and 2015/2016 peaks.

Figure 12 confirms that weather is a dominating feature affecting the number of fire incidents experienced on the network. It is potentially affecting not just the likelihood of a fire spreading once on the ground, but that likelihood a fire is even initiated on the assets themselves.

The more benign weather conditions from April 2010 to December 2011 (see Figure 12) may have contributed to lower levels of incidents in this period. In turn, this has lowered the annual average for the 2010-2014 period relative to the 2015-2016 period. The increased levels of the aforementioned fire incidents are more likely to be due to the effect of the weather than of the operation and maintenance of the networks. ESV is seeking to better understand these influences on the electricity networks so that it can regulate the electricity networks more effectively, including being informed about what outcomes can reasonably be achieved.

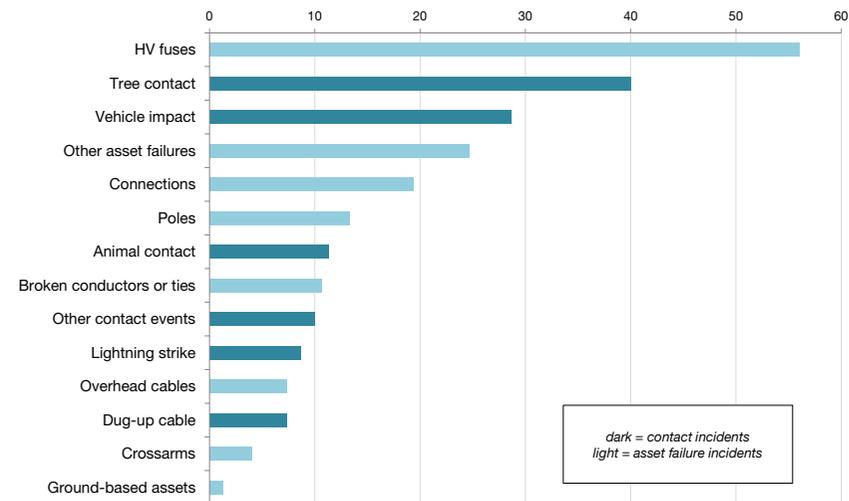
Figure 14 Incidents on the AusNet Services network (per year)

Figure 14 shows the annualised number of all serious electrical incidents reported to ESV by AusNet Services, with the data sorted from most frequent to least frequent. Figure 15 shows the same for those incidents that result in an asset or ground/vegetation fire.

It is not surprising that AusNet Services had more of these incidents than other distribution businesses given that it has a larger service area and more assets than all the other companies (with the exception of Powercor). Even so, Powercor only experienced 73 per cent of the fuse failures that AusNet Services did despite its larger asset base. This may possibly be due to the impact of vegetation on its fuse fleet. ESV will discuss this with AusNet Services to better understand the reasons for its higher fuse failure rate.

More concerning than fuse failures is the high number of tree contact events, of which 55 per cent result in a fire. During the 2015-2016 period AusNet Services experienced more than twice the number of fires from tree contact than Powercor, the next highest reporter. This is not unexpected given the more mountainous terrain and higher tree densities across the AusNet Services network area.

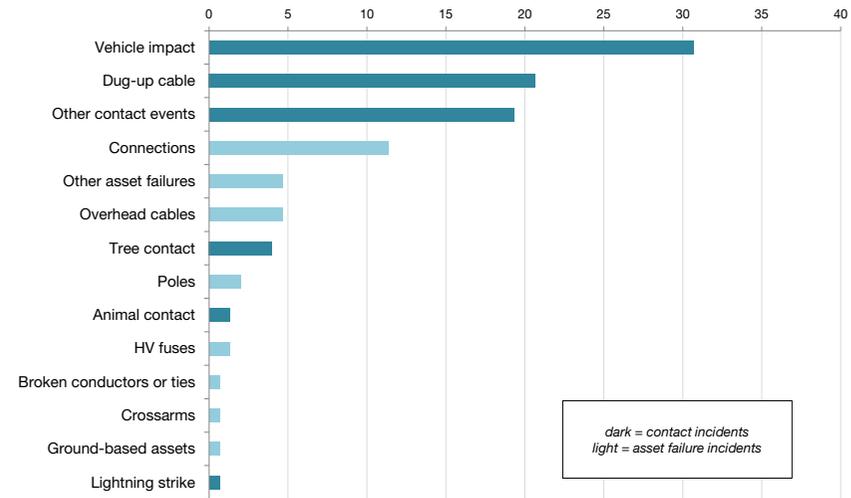
Figure 18 Incidents on the CitiPower network (per year)

Figure 18 shows the annualised number of all serious electrical incidents reported to ESV by CitiPower, with the data sorted from most frequent to least frequent. Figure 19 shows the same for those incidents that result in an asset or ground/vegetation fire.

- ▶ the extremely high levels of traffic within, into and transiting through the Melbourne CBD and inner suburbs contribute to higher levels of vehicle impacts
- ▶ the high levels of brownfield development in the Melbourne CBD and inner suburbs where excavation and trenching can potentially impact underground assets.

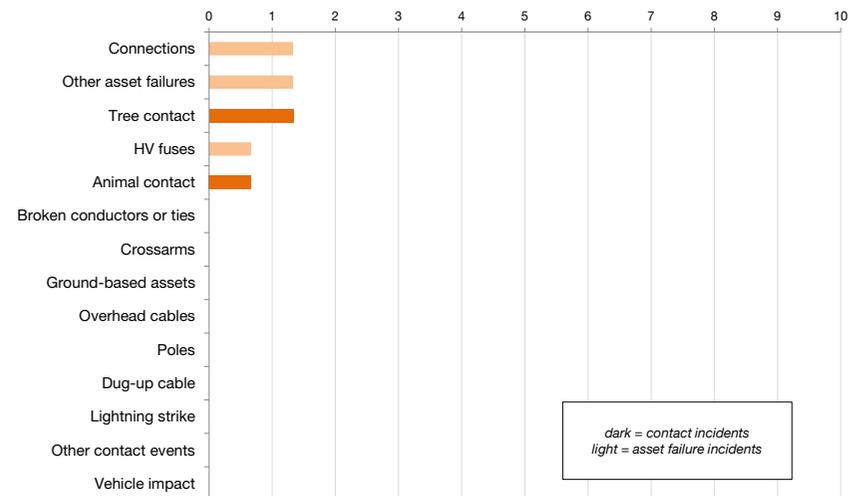
Figure 19 Incidents on the CitiPower network resulting in fires (per year)

All of the five most common fire-related incidents are manageable by CitiPower. These were the only incident types for which CitiPower experienced fires, and the number of fires annually from these sources is low at less than two fires per year from each source.

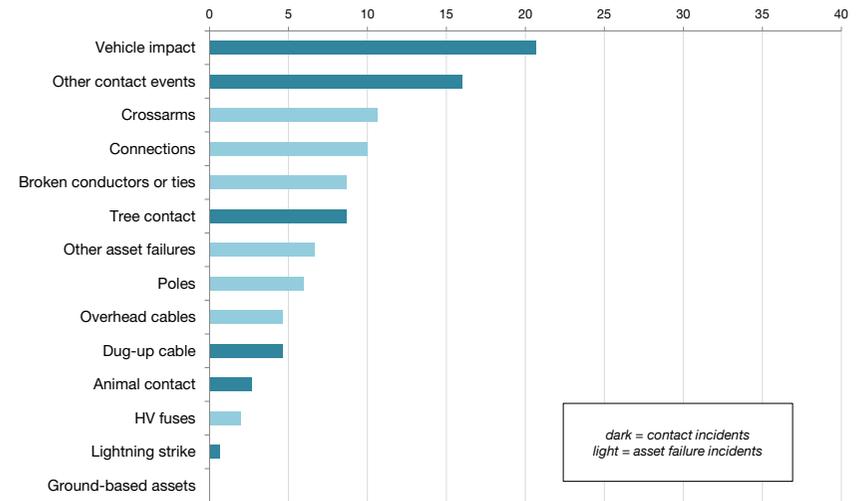
Figure 21 Incidents on the Jemena network (per year)

Figure 21 shows the annualised number of all serious electrical incidents reported to ESV by Jemena, with the data sorted from most frequent to least frequent. Figure 22 shows the same for those incidents that result in an asset or ground/vegetation fire.

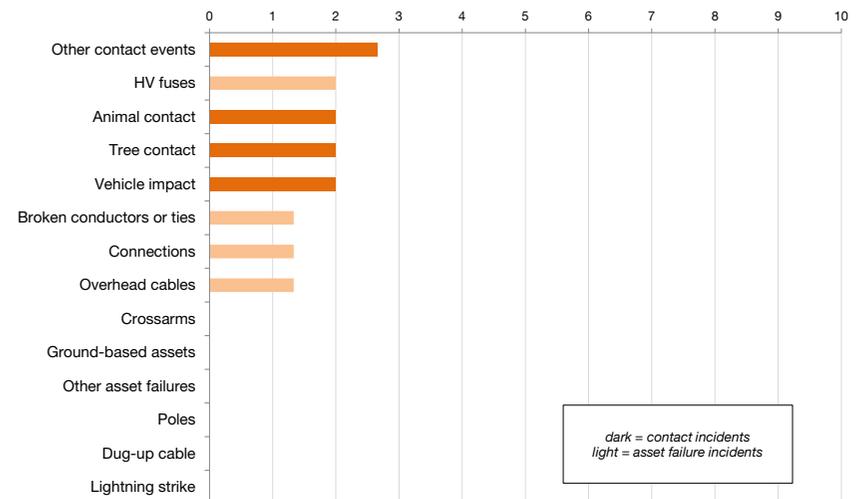
Figure 22 Incidents on the Jemena network resulting in fires (per year)

That said, Jemena has been active in allocating resources to manage its risks in HBRA and is the only business that has replaced all wooden crossarms in HBRA with steel crossarms to prevent crossarm fires. This is a positive outcome that has been reflected in Jemena having no crossarm fires (see Figure 22).

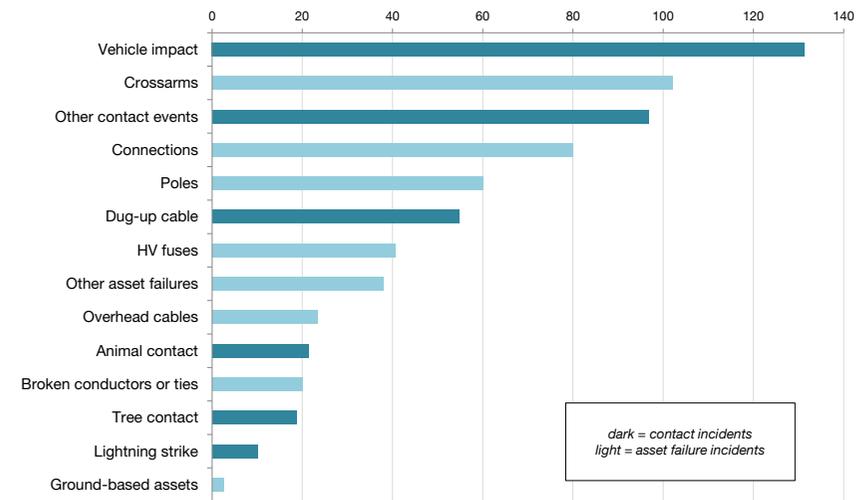
Figure 24 Incidents on the Powercor network (per year)

Figure 24 shows the annualised number of all serious electrical incidents reported to ESV by Powercor, with the data sorted from most frequent to least frequent. Figure 25 shows the same for those incidents that result in an asset or ground/vegetation fire.

In contrast, Powercor experienced fewer tree contact events and HV fuse failures than AusNet Services (see Section A6). Fewer tree contacts are to be expected given the lower vegetation density across the Powercor network (see Appendix H). Conversely, Powercor has a larger network with more fuses and, therefore, more HV fuse failures would be expected on its network. This is a positive result for which Powercor should be commended.

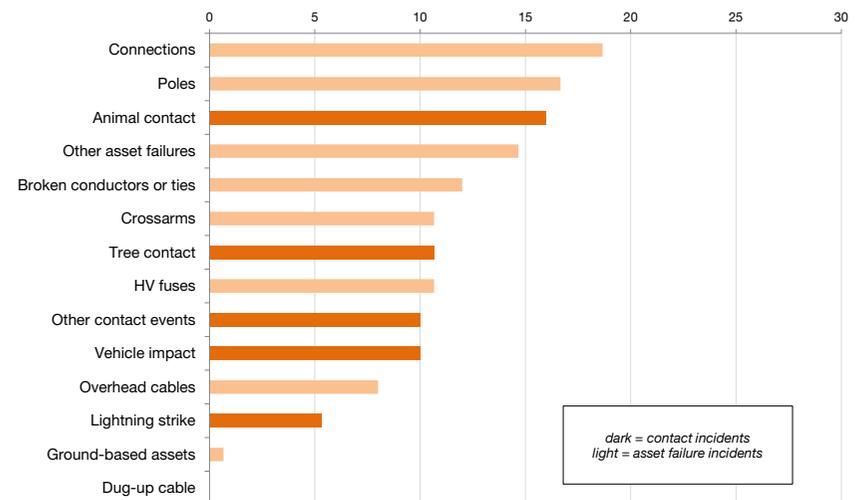
Figure 25 Incidents on the Powercor network resulting in fires (per year)

Powercor also experienced more fire events than the other businesses across all categories except two. AusNet Services had the largest number of fires from tree contact.

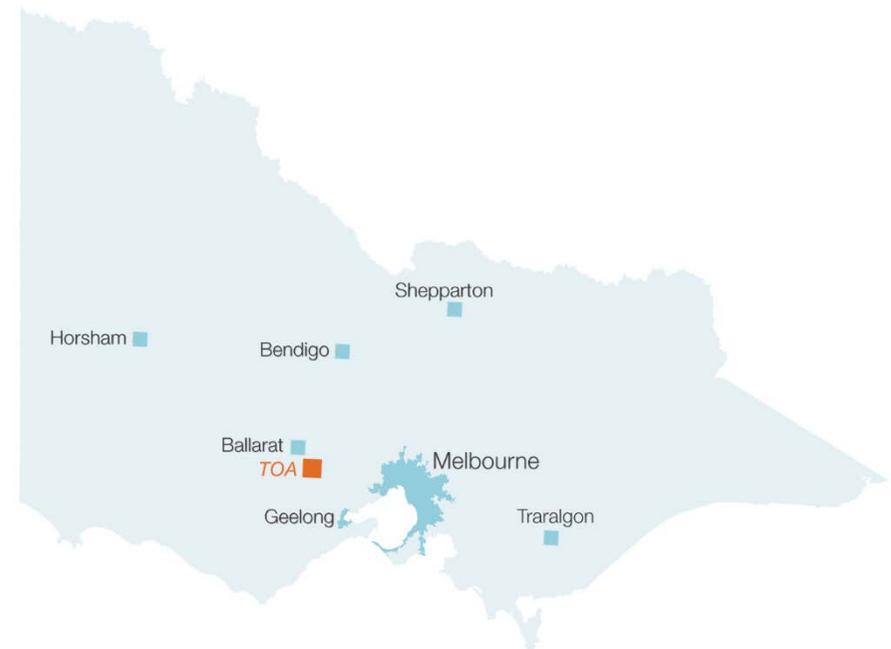
Figure 26 Location of TOA transmission assets (orange square)

TOA owns and operates the connection from the Mt Mercer Wind Farm to the electrical transmission network (Figure 26). This includes a 22km 132kV powerline and the Elaine Terminal Station, which steps the voltage up from 132kV to 220kV for injection into the AusNet Services transmission network.

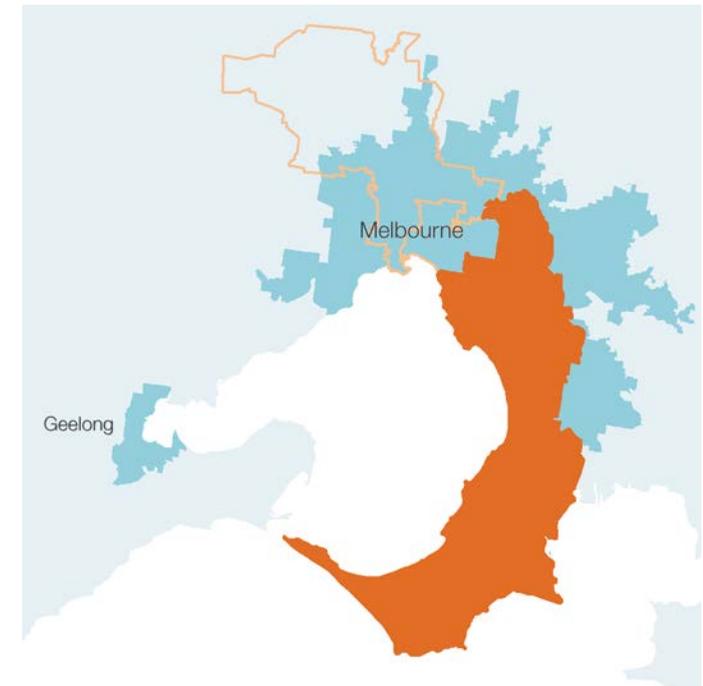
Figure 27 Service area for the United Energy distribution network (orange area)

The distribution network covers an area of approximately 1470km² across Melbourne's eastern and south-eastern suburbs and the Mornington Peninsula (Figure 27). It comprises approximately 10,300km of overhead line, 2600km of underground cable and 204,000 poles. Most of this network (75 per cent) is in rural areas.

Jemena and CitiPower service boundaries are shown in orange

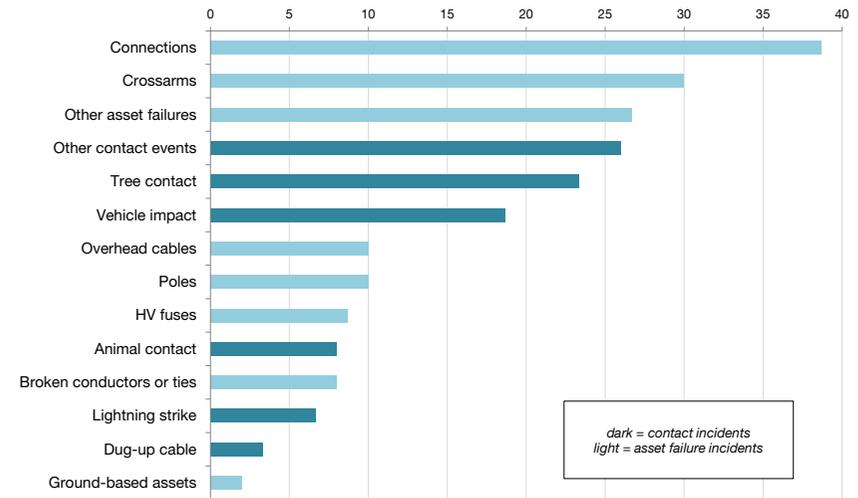
Figure 28 Incidents on the United Energy network (per year)

Figure 28 shows the annualised number of all serious electrical incidents reported to ESV by United Energy, with the data sorted from most frequent to least frequent. Figure 29 shows the same for those incidents that result in an asset or ground/vegetation fire.

Across the fourteen types of contact and asset failure events, United Energy experienced the highest number of ground-based asset failures and the second-highest number of failures in six other categories. The categories in which United Energy experienced elevated incident levels were tree contact, other contact events and connection, crossarm, overhead cable and other asset failures.

The high levels of other contact events (including No Go Zone infringements and copper theft) may be explained by United Energy having large areas of peri-urban development in its service area. However, rating highly in half of the categories is unusual given United Energy has a significantly smaller asset base than Powercor and AusNet Services.

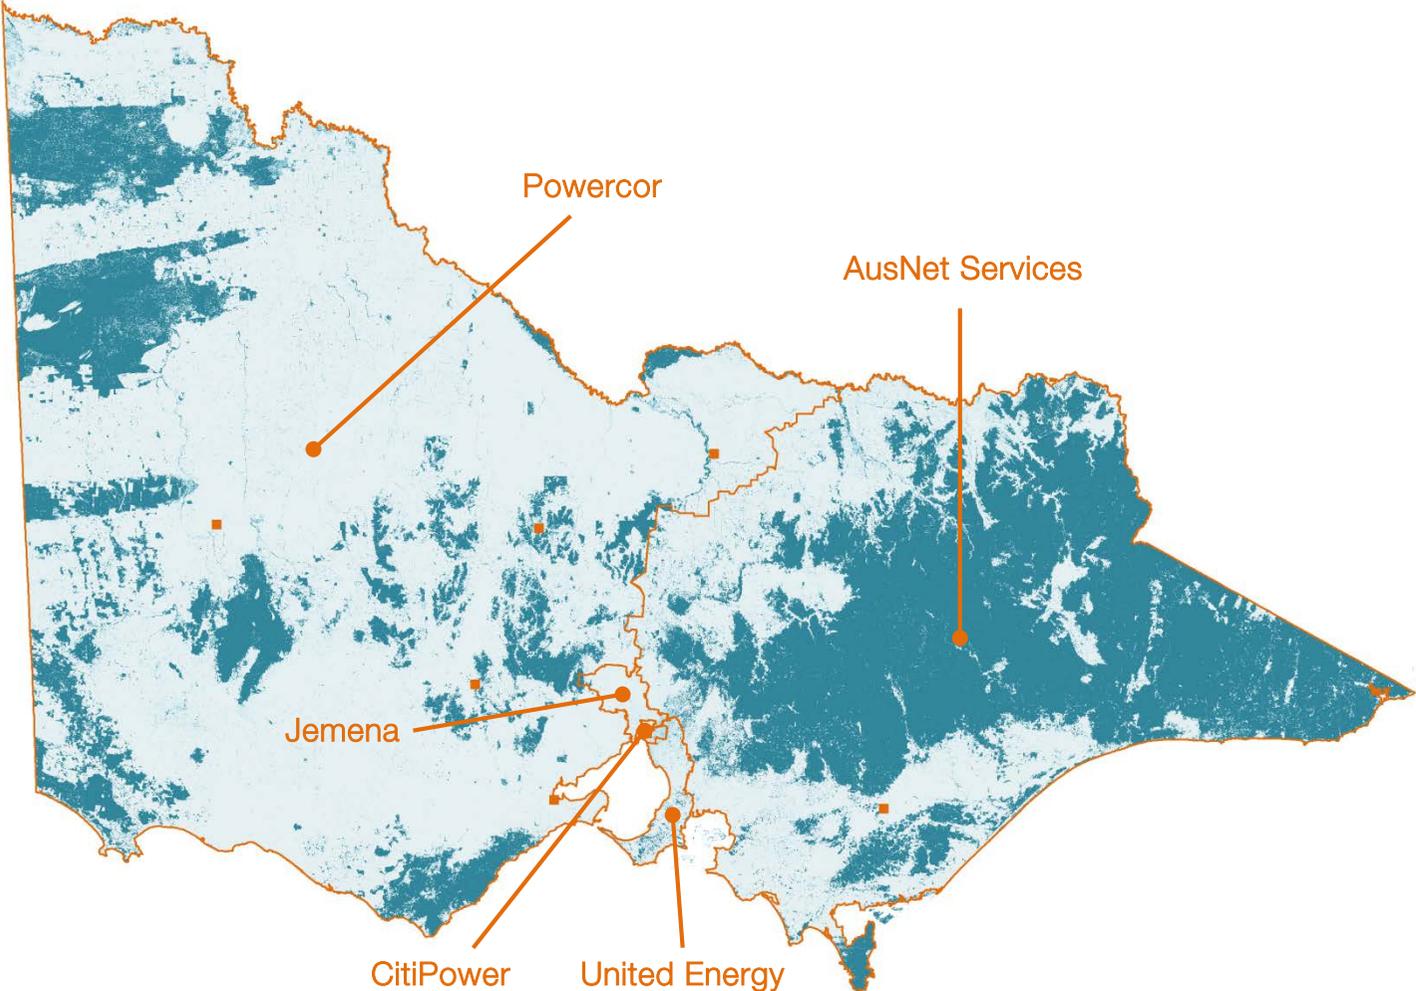
The figure below maps tree density across Victoria with the boundaries of the five distribution businesses in orange. Of the businesses, AusNet Services is most exposed to a high density of tree cover.
