# Safety performance report on Victorian electricity networks

October 2019

This report has been endorsed by the Director of Energy Safety in Victoria.

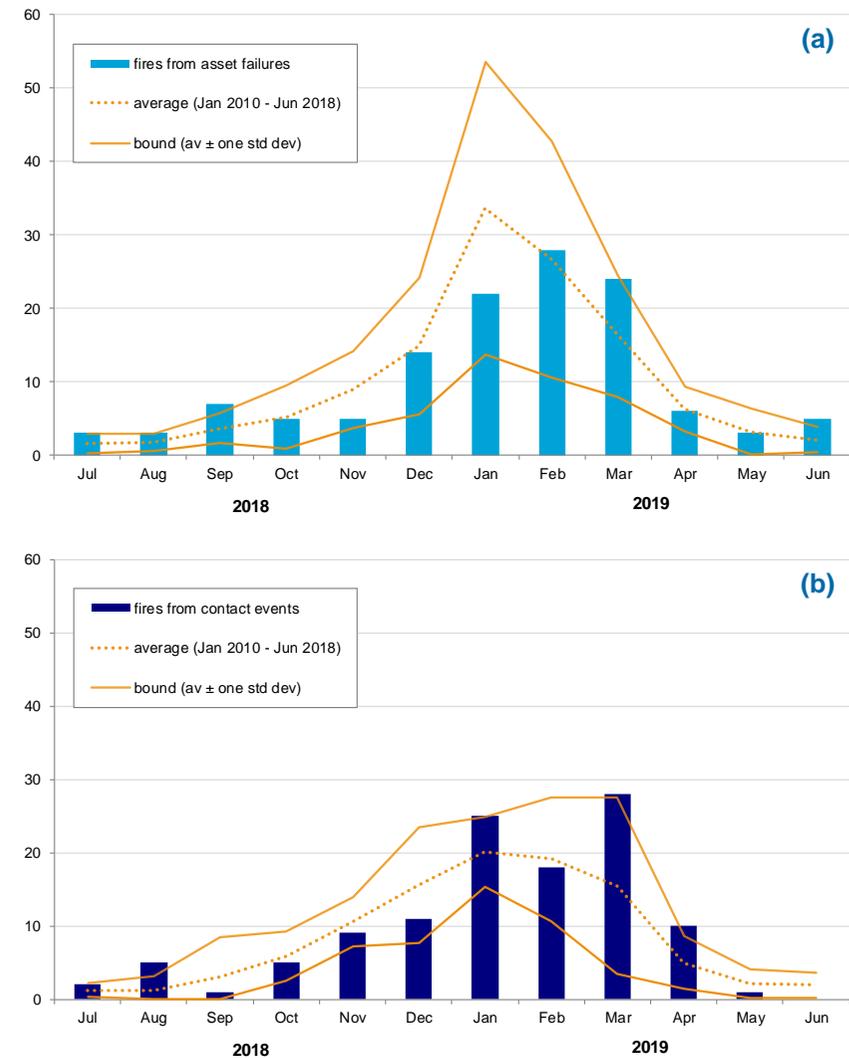
The averages and bounds in Figure 1 show a clear seasonal trend in ground fires due to both asset failures/faults and contact events. Throughout most of the year, there are similar numbers of both types of events; however, the peak in asset-related ground fires is more pronounced historically and has dominated the summer period.

This year, the numbers of asset-related ground fires (blue bars in Figure 1a) were within one standard deviation of the 2010-2018 average; however, the peak in fires that normally occurs in early January was shifted to February/March. In contrast, Figure 1b shows that the numbers of contact-related fires were well in excess of the historic numbers in August, January, March and April.

Figure 1 Ground fire incidents due to (a) asset failures and (b) contact events

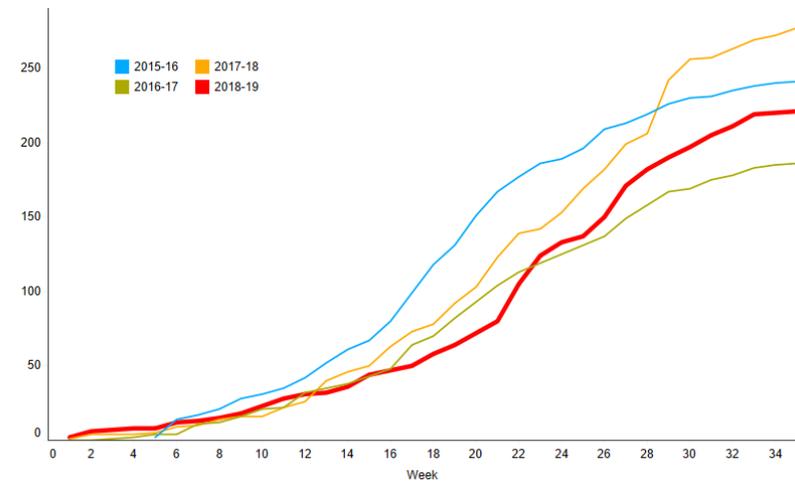
Figure 2 shows the cumulative number of ground fires throughout the year. While the total fires climbed to a level similar to 2015-2016, this was mainly due to fires occurring much later in the fire season.

Figure 2 Cumulative fires across the fire season

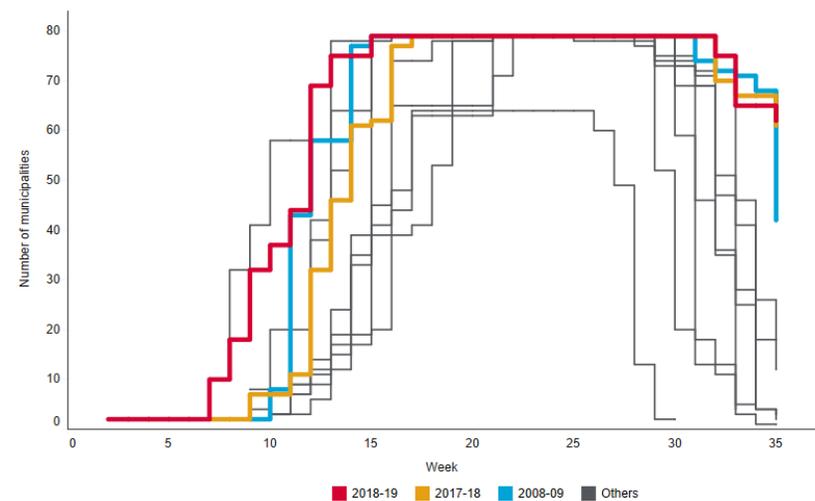
The first declarations for this year's season started on 10 September 2018, several weeks earlier than all previous seasons (Figure 3); however, the escalation of declarations was in line with similar early summers. Declarations continued ahead of the Black Saturday fire season (2008-2009), and full declaration was achieved at the same time as the Black Saturday season.

Figure 3 Summary of CFA fire declarations from 2008 to 2019

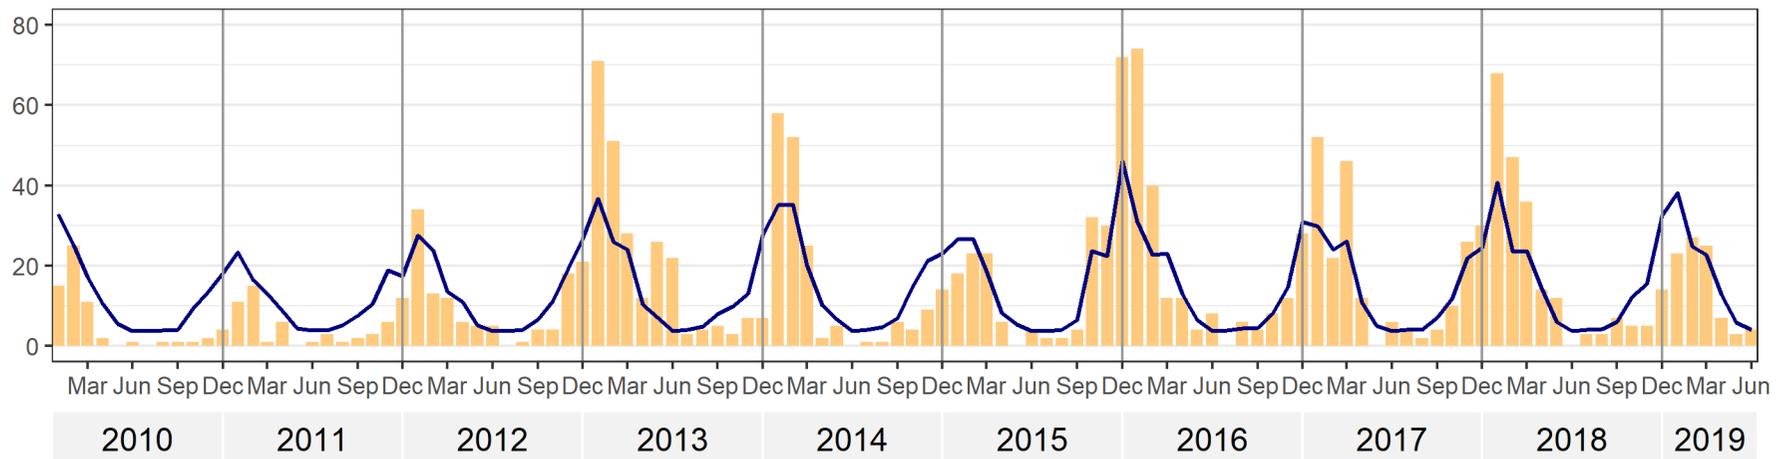
Figure 4 Influence of weather on ground fires due to asset failures

The main factor affecting asset-related fires (Figure 4) is air temperature, with a smaller contributions from morning wind speed, humidity, maximum gust speed and maximum temperature differential between days. For contact fires (Figure 5), the main contributions come from air temperature, maximum wind gust speed, afternoon wind speed and maximum temperature differential.

The ground fires due to asset failures (Figure 4) were considered separately from fires due to contact events (Figure 5).

There are noticeable exceedances across both types of incident in 2012-2013 and 2013-2014, and for contact fires in 2017-2018. These variances may be due, in part or whole, to the practices of one or more of the distribution businesses or to causes other than direct weather influences.

Of note is that the numbers of asset-related and contact fires this season were lower than the number expected based on our modelling, with the exception of the contact events in March 2019.

ESV identified the days when the weather conditions exceeded the thresholds for the individual factors used to compile Figure 4 and Figure 5 — the days when there was the highest risk of ground fires being ignited. We then mapped the number of these ‘at risk’ days each year against the numbers of ground fires experienced on those days.

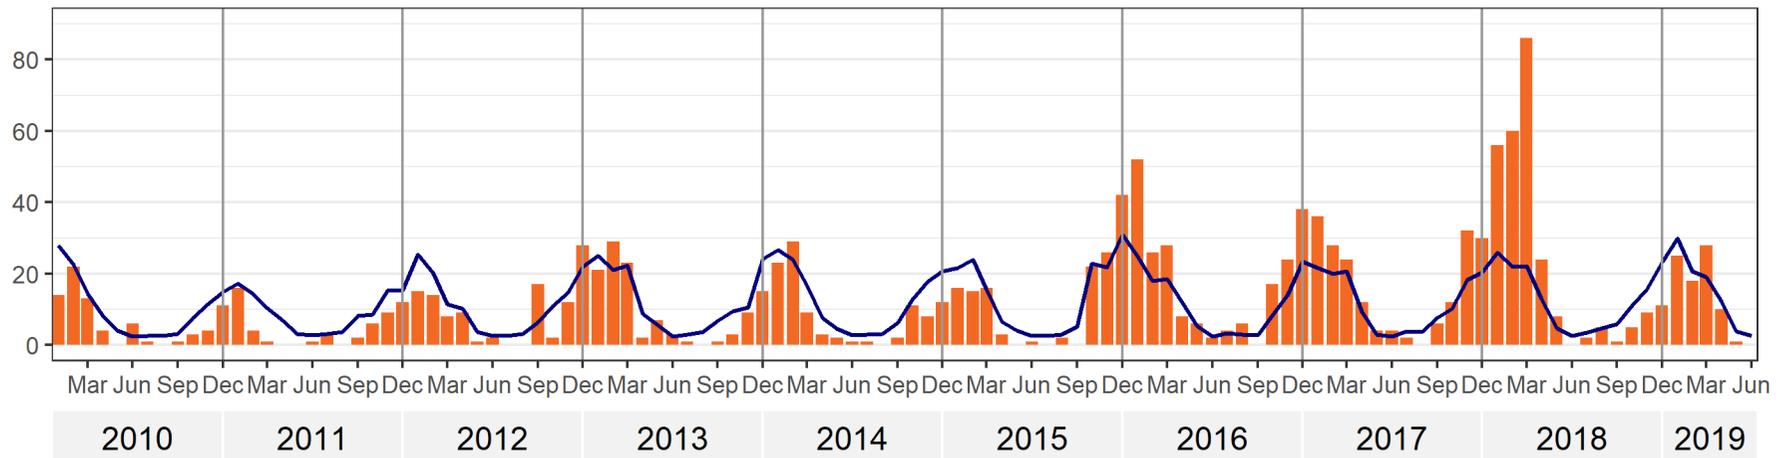
Figure 5 Influence of weather on ground fires due to contact events

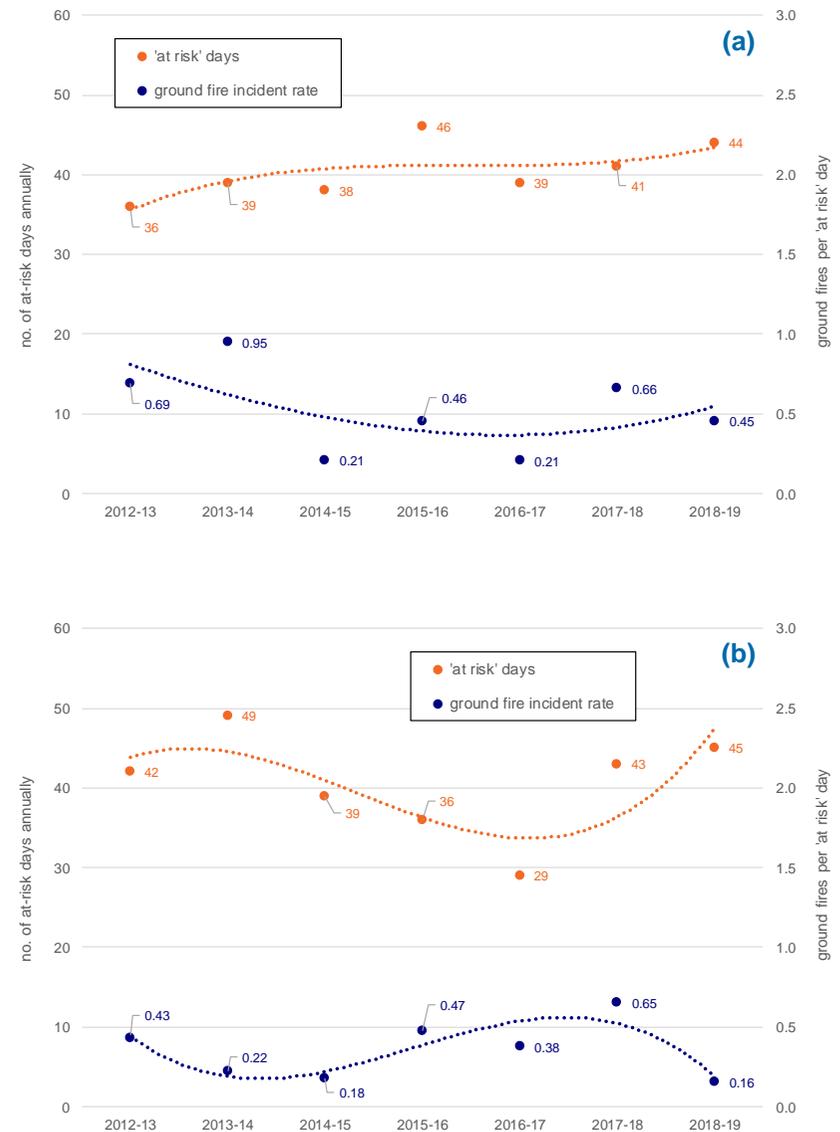
Figure 6(a) shows the numbers of ‘at risk’ days for ground fires due to asset failures against the number of fires per ‘at risk’ day in HBRA. This shows that the numbers of at-risk days for asset failure fires has been slowly increasing, whereas the rate of fires from asset failures has generally decreased.

Figure 6(b) shows the same for fires due to contact events. The numbers of contact-related ‘at risk’ days show greater variability. There may be a longer term cycle underpinning this, or the variability may be due to changes in vegetation management practices. This warrants further analysis.

**Figure 6 Numbers of ‘at risk’ days each year and the associated rate of incidents in HBRA on those days for (a) asset failures and (b) contact events**

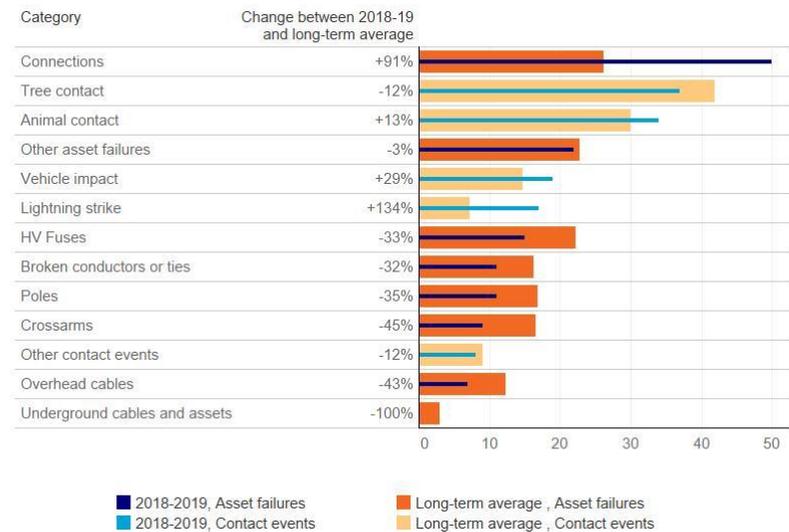
Figure 7 shows the number of ground fire events on the Victorian networks from most common to least common (blue bars) relative to the long-term average for the 2010-2018 period (orange bars).

The four most common causes of fires were connection faults,<sup>8</sup> tree contact, animal contact, and other asset failures. All four events are largely within the control of the networks.

Figure 7 Ground fire-related incidents occurring on Victorian networks

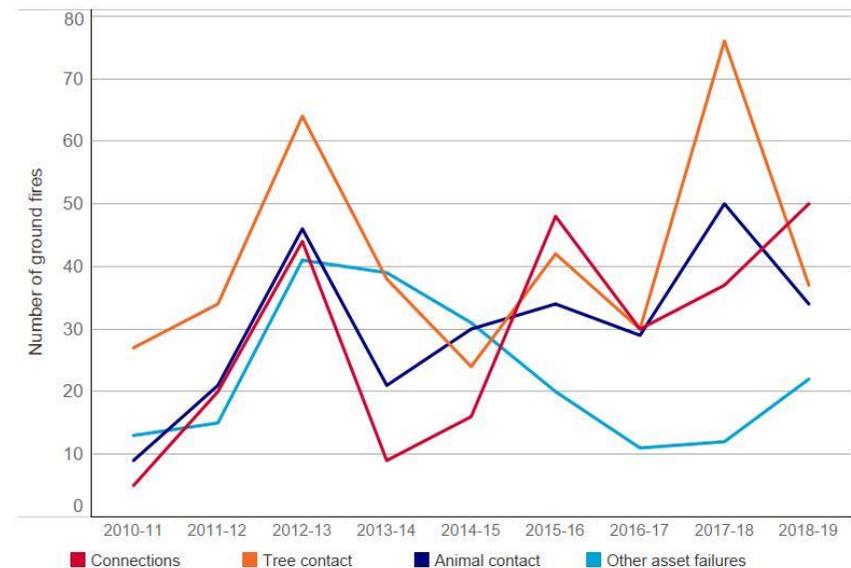
Figure 8 shows the trend over the last nine years for the top four fire events above. This indicates that:

- fires from connection faults have been rising steadily for five years and are now well above the historic average (91 per cent higher)
- fires from tree contact have decreased markedly this year and are now twelve per cent below the historic average
- animal contact fires decreased this year and are thirteen per cent above the historic average
- fires due to other asset failures have increased but are still three per cent below the historic average.

Figure 8 Historic trends for common ground fire events

Of particular note is that asset-related ground fires have fallen across all categories apart from connection faults. This is a generally positive result that is only marred by connection-related fires rising for a second year in a row to 91 per cent above the long-term average (Figure 8).

While tree contact fires are the second-most common fire event, the number of such incidents has halved over the last twelve months (Figure 8). This is due to the additional resourcing in the Line Clearance Assurance team, ESV’s recent enforcement actions and efforts by the distribution businesses to address issues on their networks.

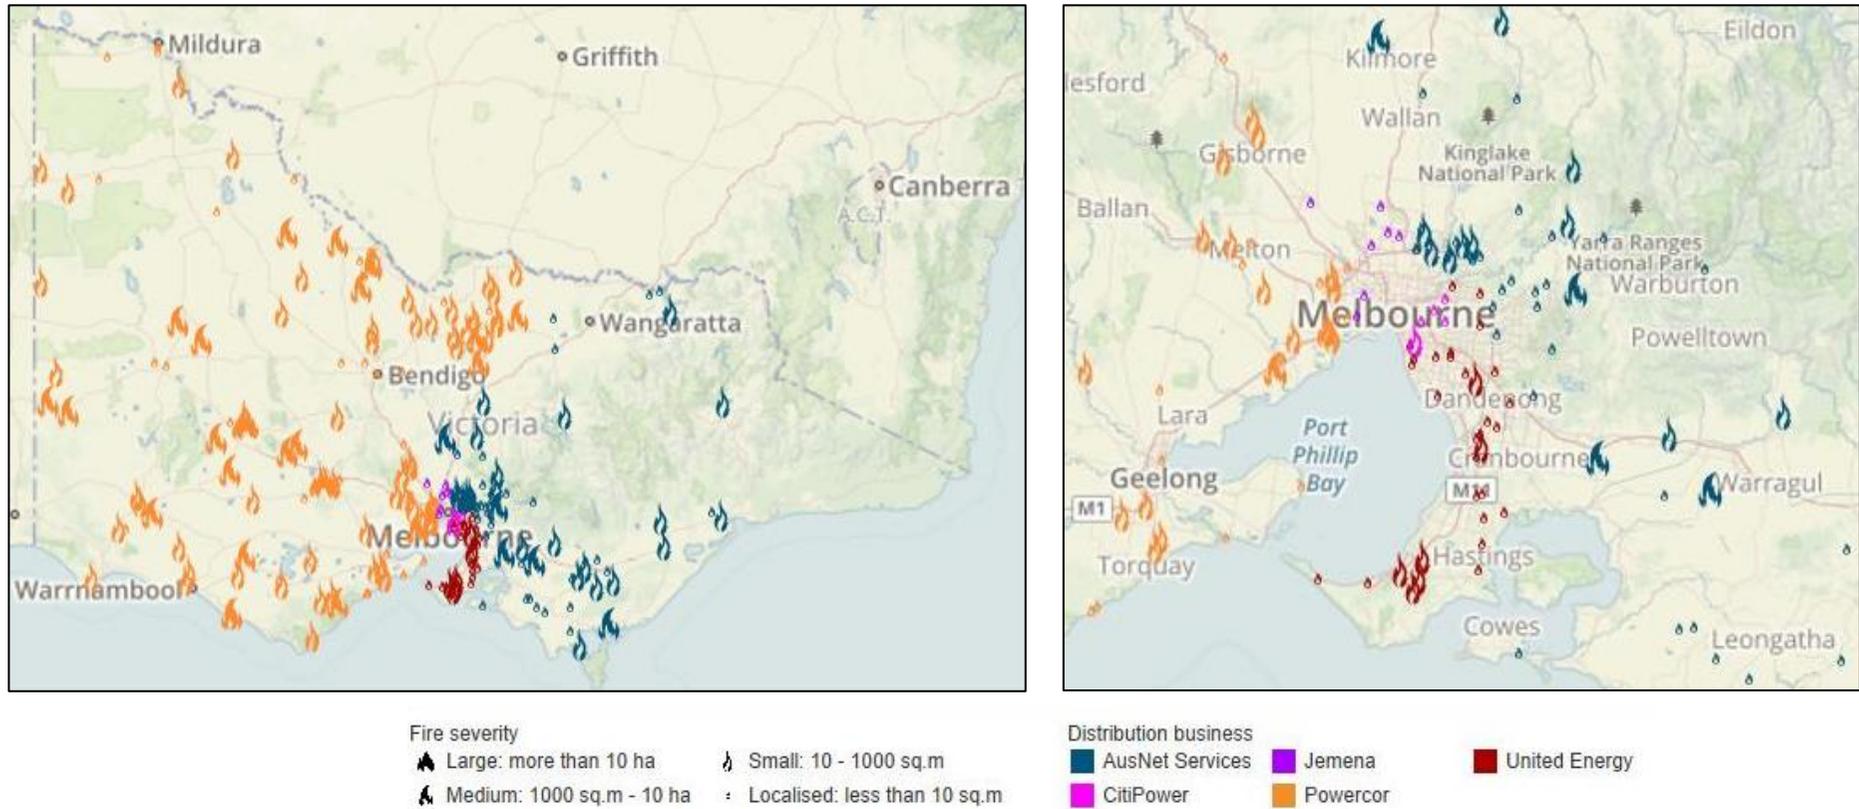
Figure 9 Distribution of ground fires across the Victorian networks

Figure 9 shows where ground fires occurred on the electricity networks across regional Victoria and within the Greater Melbourne region.

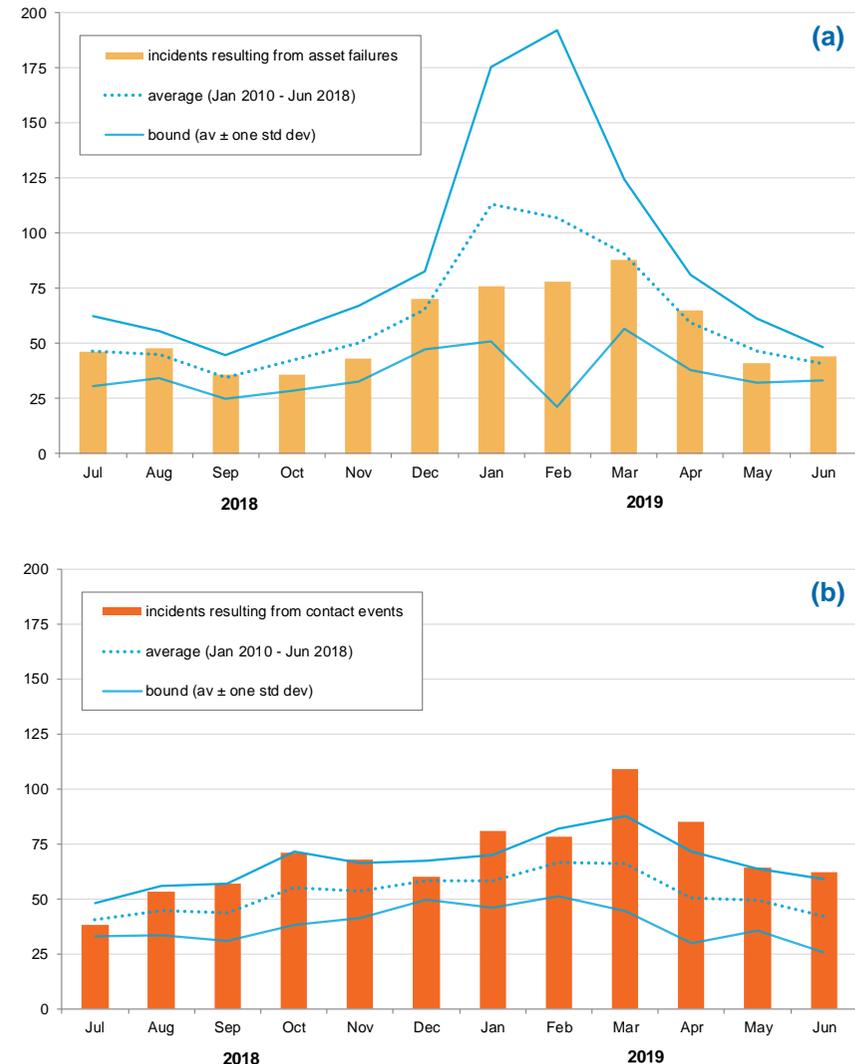
Figure 10 shows the number of network safety incidents on the Victorian networks. The numbers of asset failure incidents and contact events are reported separately.

The historical average for the period January 2010 to June 2018 shows a seasonal trend with increased asset failures over the summer period (Figure 10a). In general, the numbers of asset failures in the last year were well below the average. The annual peak that normally occurs in January and February did not occur; the “peak” in March was just below the historic average for this month.

In contrast, the numbers of contact events show less seasonality and more inter-month variability (Figure 10b). Contact events this year also showed a high degree of variability and were generally close to one standard deviation above the historical average. January, March, April and June saw the numbers of contact events exceed one standard deviation above the historical average.<sup>9</sup>

Figure 10 All incidents in the period due to (a) asset failures and (b) contact events

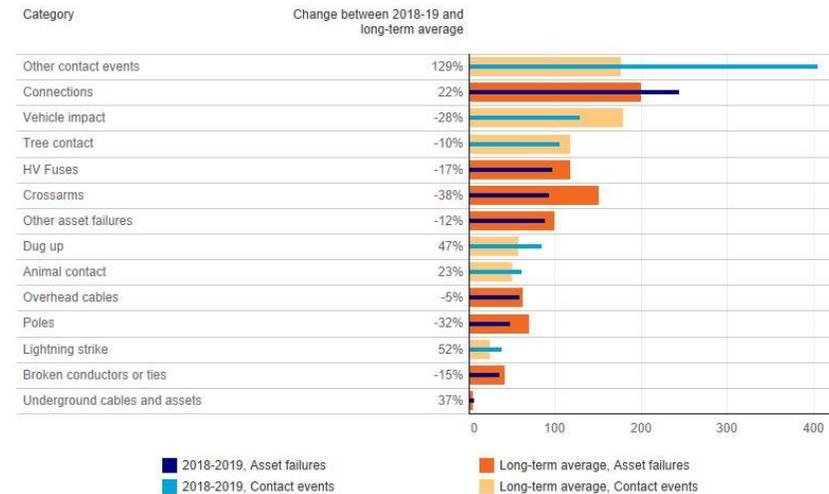
Figure 11 shows the number of incidents on the Victorian networks from most common to least common (blue bars) relative to the long-term average for the 2010-2018 period (orange bars).

Figure 11 Incidents occurring on Victorian networks

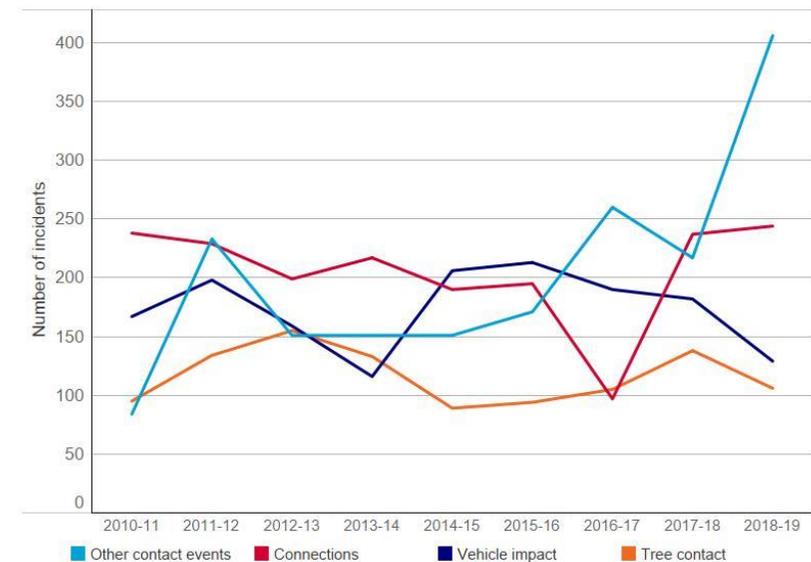
Figure 12 shows the trend over the last nine years for the top four events above. This indicates that:

- other contact events have increased markedly this year
- connection faults have slightly increased and are at peak levels
- vehicle impacts<sup>10</sup> on overhead lines and poles have reduced for the third year in a row
- tree contact incidents have decreased this year.

Figure 12 Historic trends for common incident events

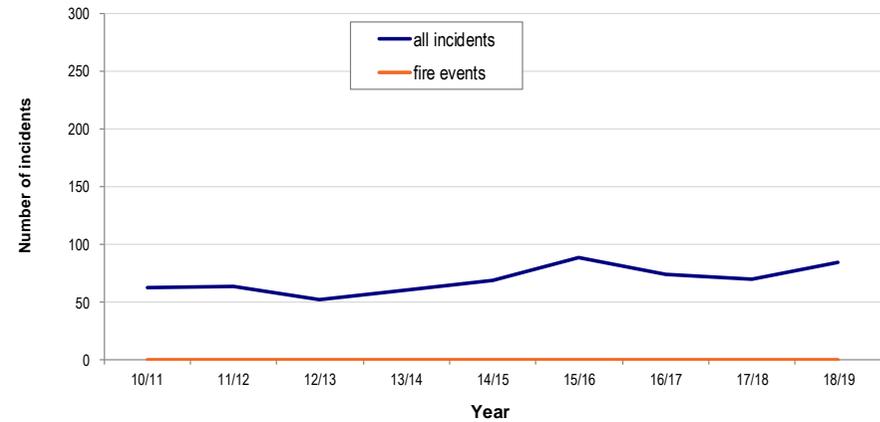
Figure 13 shows that the incidences of underground cables being dug-up or contacted during excavation works have increased this year.

Figure 13 Dug-up cable incidents across the networks

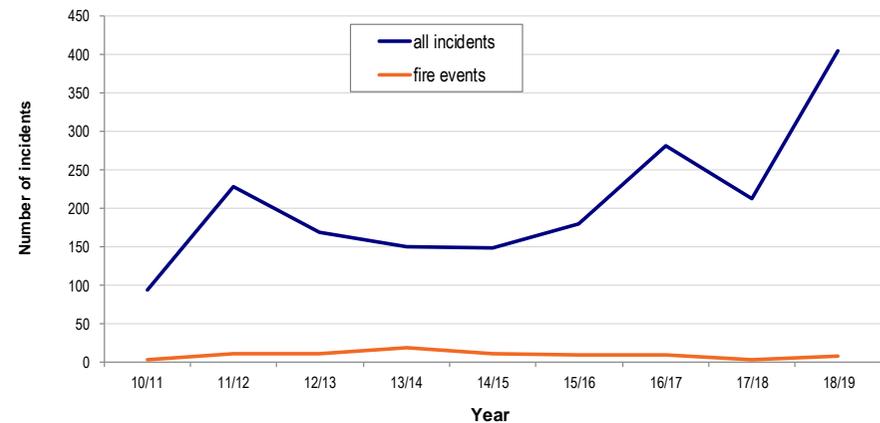
Other encroachment and contact events was the most common category of events placing members of the public at risk last year. Figure 14 shows that these events have increased significantly since 2014-2015 and that last year's decrease was only temporary.

Figure 14 Other encroachment and contact events

These events include copper theft, vandalism, No Go Zone infringements

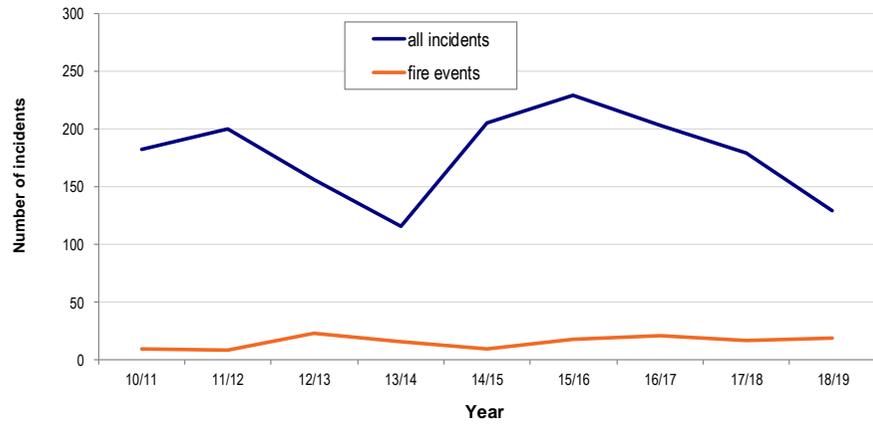
Vehicle impacts come from two main sources (Figure 15). The first is impacts from vehicles in transit, being either collisions with poles or large vehicles (trucks, rubbish trucks) snagging overhead lines.<sup>11</sup> The second source is cranes and other farming and construction equipment contacting overhead powerlines.<sup>12</sup> Such impacts have decreased for a third year in a row, while the numbers resulting in fires have increased this year.

Figure 15 Vehicle impacts on electrical infrastructure

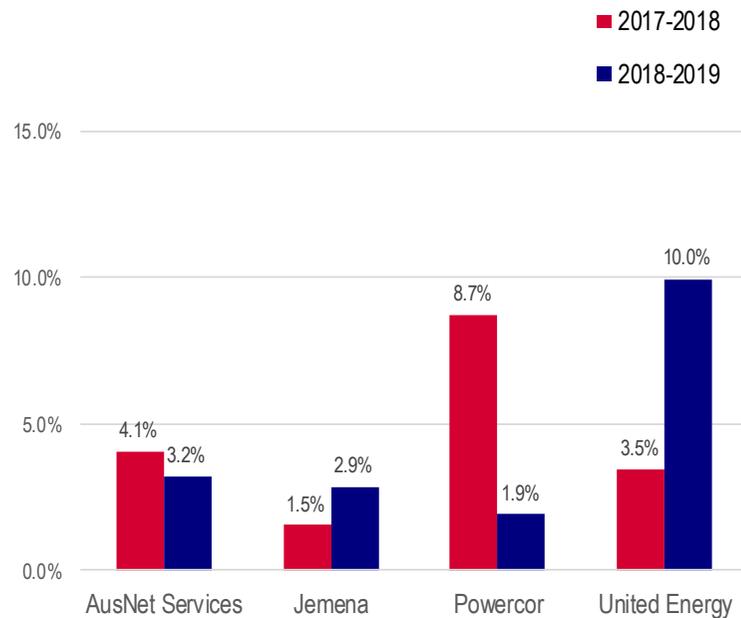
Figure 17 and Figure 18 depict the results of these inspections for HBRA and LBRA respectively. This shows that Powercor had the best compliance in HBRA, while United Energy had the worst compliance. Jemena had the best compliance in LBRA, while Powercor and United Energy had unacceptable levels of noncompliance in LBRA. This is the subject of ongoing monitoring and potential enforcement action.

Figure 17 Noncompliance rates in HBRA

It must be noted the Powercor compliance in HBRA was significantly improved from recent years. This is attributed to ongoing ESV investigation and enforcement action, and the subsequent actions by Powercor to rectify its poor vegetation management performance.

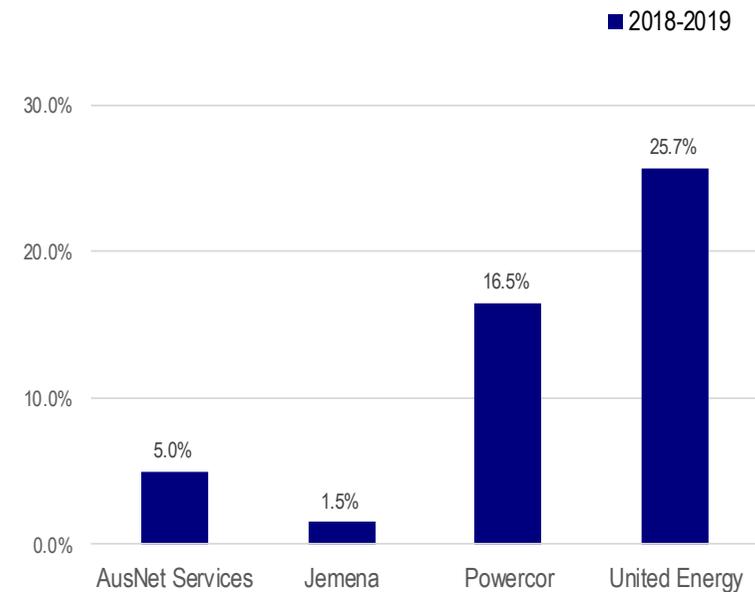
Figure 18 Noncompliance rates in LBRA

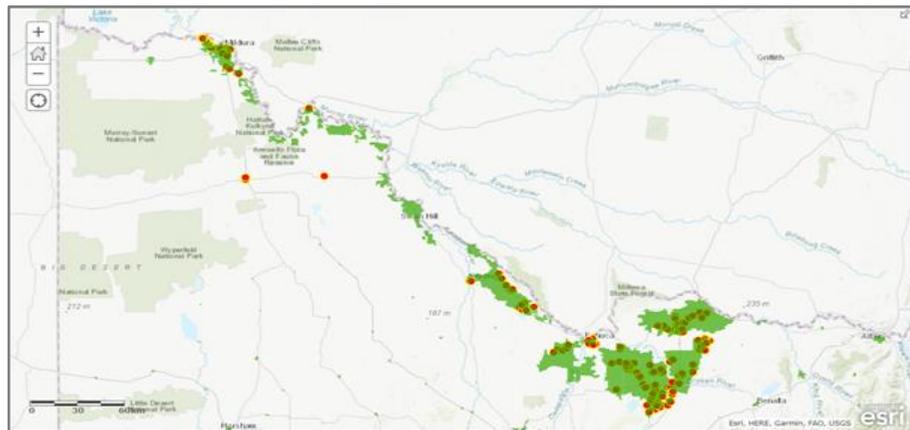
The areas of LBRA affected by this issue are highlighted green in Figure 19.

**Figure 19 At-risk LBRA**

The areas highlighted in green show LBRA areas with elevated risk. The red icons show the locations where ESV identified noncompliant spans in LBRA.

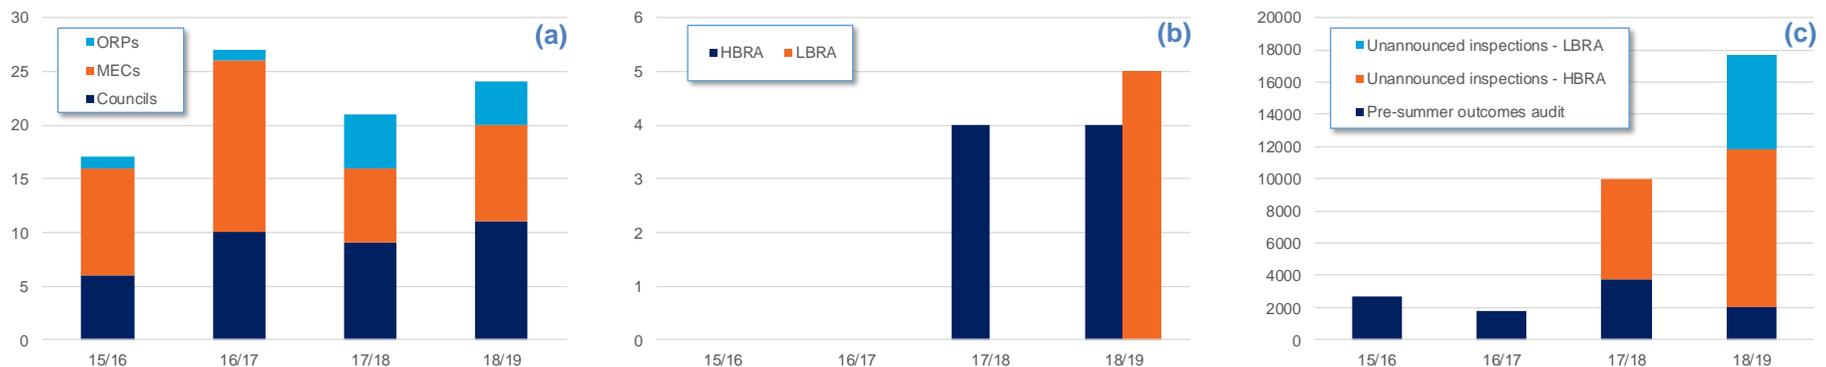
Figure 27 Electric line clearance audits and inspections showing (a) the number of pre-summer outcomes audits, (b) the number of unannounced inspections and (c) the volume of spans inspected during these audits and inspections

Figure 27 shows the numbers of electric line clearance audits and inspections undertaken in the last four years. This clearly demonstrates the impact of the additional resources in the Line Clearance Assurance team.

While Figure 27(a) shows that the numbers of pre-summer audits have remained relatively stable over the last four years, these audits have been complemented by the unannounced inspections in 2017-2018 and 2018-2019 in Figure 27(b).

More significantly, the volume of spans inspected in these audits has increased from 2000-3000 spans in 2015-2016 and 2016-2017 to close to 18,000 spans in 2018-2019. This is a six-fold to nine-fold increase in the volumes inspected.

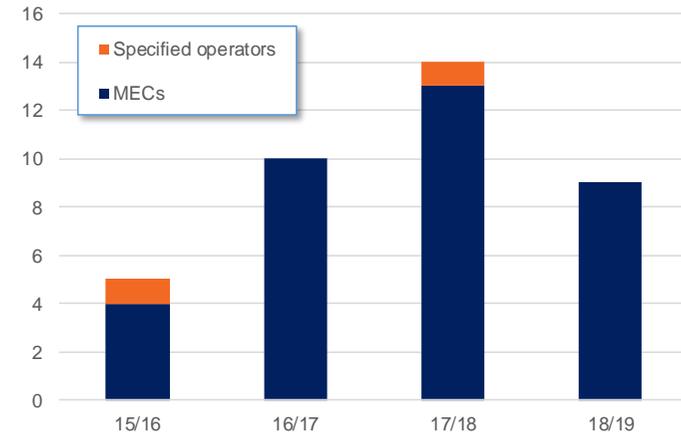
Figure 28 Numbers of bushfire mitigation audits

Figure 28 shows the numbers of bushfire mitigation audits undertaken each year. Each of the nine major electricity companies is audited each year. The peak in 2017-2018 resulted from secondary pole audits of four of the distribution businesses due to stakeholder concerns.

While Figure 28 only identifies two audits of specified operators in the last four years. This is due to these businesses being regulated under multiple roles within the regulations. To reduce the regulatory burden on these businesses, ESV does not undertake separate bushfire mitigation audits but instead covers the elements of bushfire mitigation within broader audits of their specific installations.

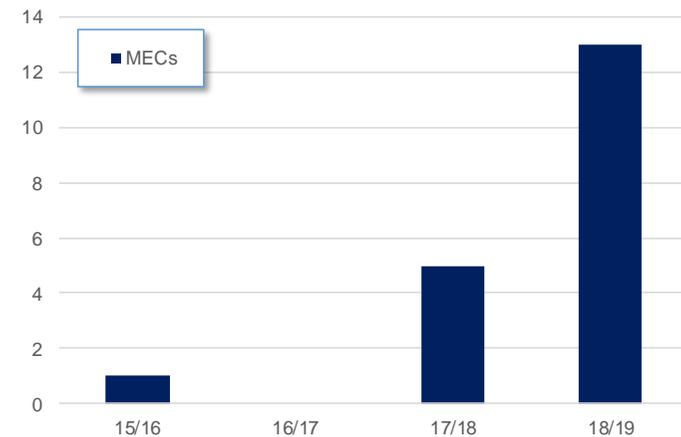
Figure 29 Numbers of ESMS audits

Figure 29 shows the numbers of ESMS audits undertaken each year.

In 2015-2016, ESV introduced the requirement to produce a safety case as part of the ESMS acceptance process. Implementing this new regime extended into 2017-2018. Our efforts during this period were focused on implementing this new regime, so we chose to not undertake audits of already mature systems in 2015-2016 and 2016-2017.

The multiple audits of the electricity companies in 2018-2019 is due to the tail end of the validation audits of the new safety cases/ESMSs carrying into the start of the period, and routine ESMS audits occurring later in the period.

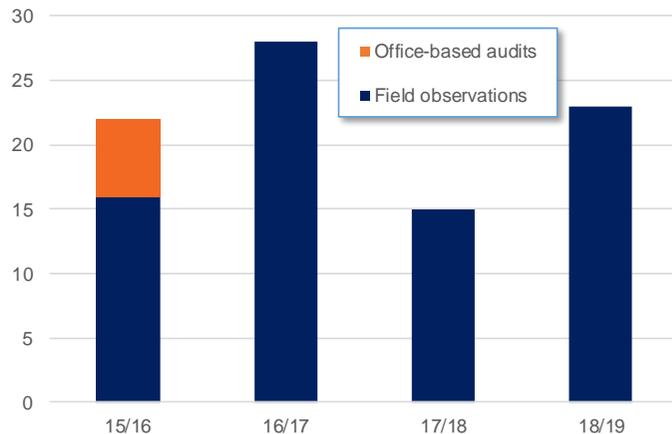
Figure 30 Numbers of works practice observations

Figure 30 shows the number of works practice observations undertaken each year. ESV's two works practice advisors conducted a total of 23 field-based observations this year, interspersed with their education and consultation duties working with industry committees, urban and rural businesses, and other relevant organisations across the state.

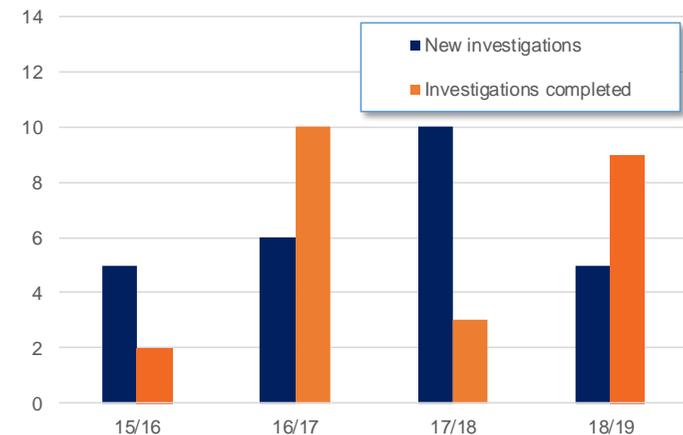
Figure 31 Numbers of new and completed investigations

Figure 31 shows the numbers of new investigations opened each year and the number that have been completed. Given the level of detail required to support an enforcement action, many of these investigations may extend into subsequent years.

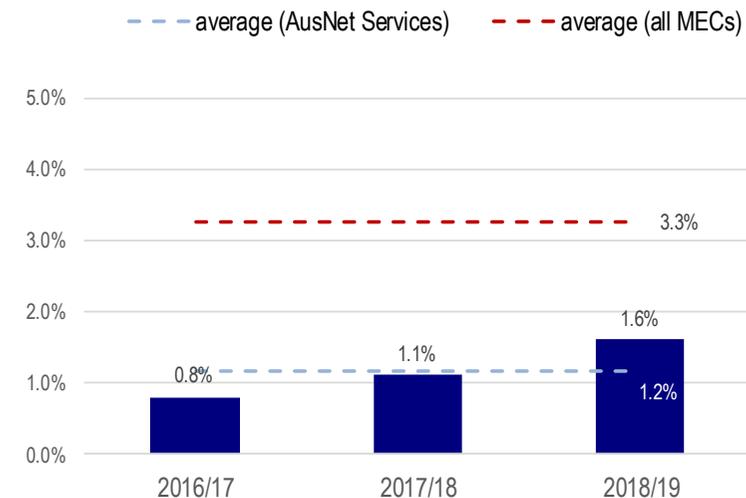
Figure 33 Noncompliance rates for AusNet Services Distribution

Inspections occurred at 370 randomly-selected spans in different HBRA regions of the network. A total of six noncompliant spans were identified, for a noncompliance rate of 1.6 per cent. ESV considered this noncompliance rate acceptable despite the slight increase from that observed in 2017-2018 (Figure 33).

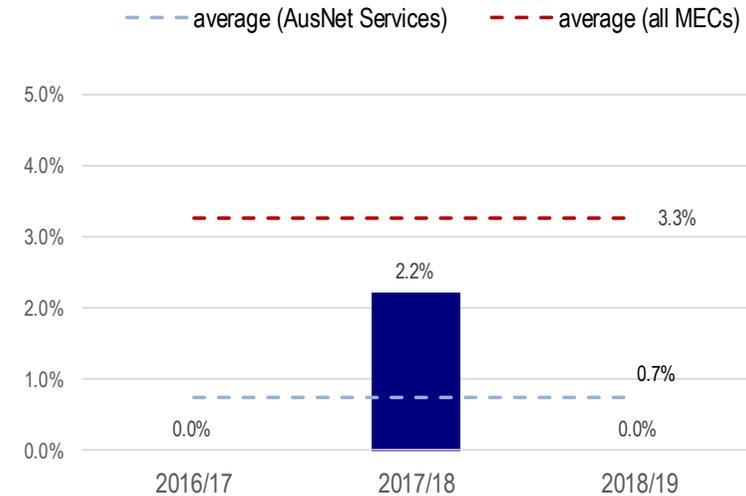
Figure 34 Noncompliance rates for AusNet Services Transmission

A total of 472 electricity spans were inspected during the audit; all of the spans were located in HBRA. No noncompliant spans were identified, for a noncompliance rate of 0.0%. ESV considered this noncompliance rate to be very good given the decrease from that observed in 2017-2018 (Figure 34).

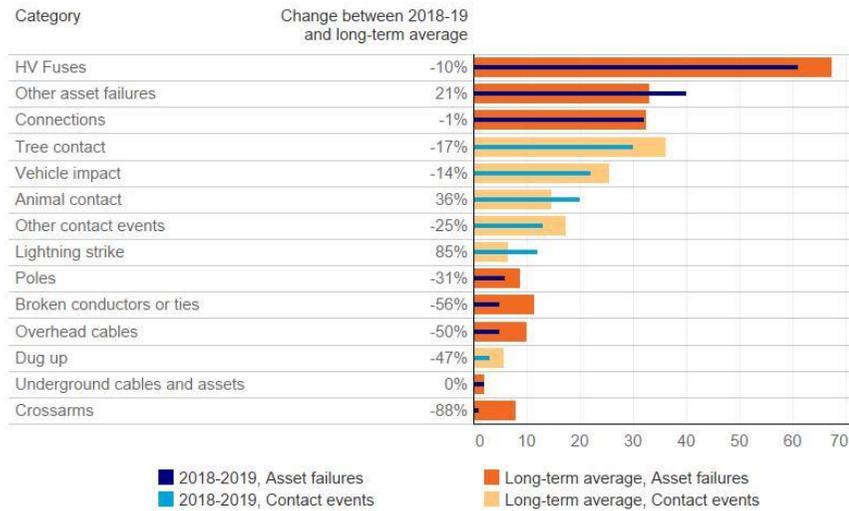
Figure 35 Incidents on the AusNet Services network

Figure 35 shows the number of all serious electrical incidents reported to ESV by AusNet Services during the 2018-2019 period, with the data sorted from most frequent to least frequent (blue bars). Figure 36 shows the same for those incidents that result in a ground or vegetation fire. Both graphs also show the change in incident numbers from the 2010-2018 averages (orange bars).

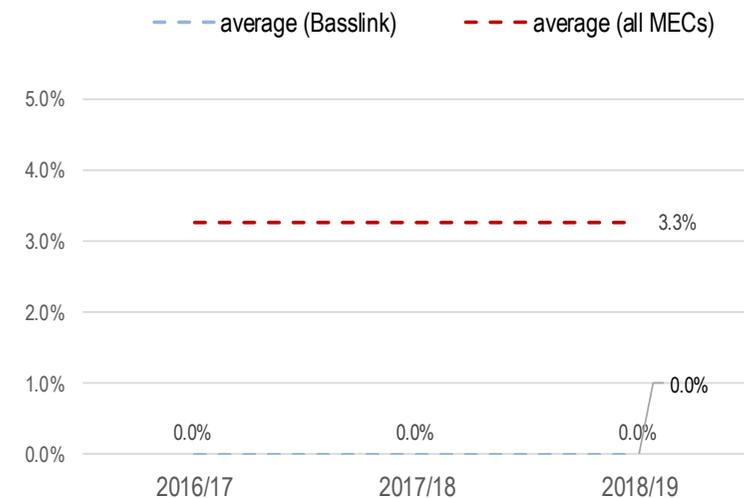
Figure 38 Noncompliance rates for Basslink

Inspections occurred at 58 randomly selected spans on the network easement, which exists entirely in HBRA. No noncompliant spans were identified, for a noncompliance rate of 0.0%. ESV considered this noncompliance rate to be excellent, particularly given this has been repeated three years in a row (Figure 38).

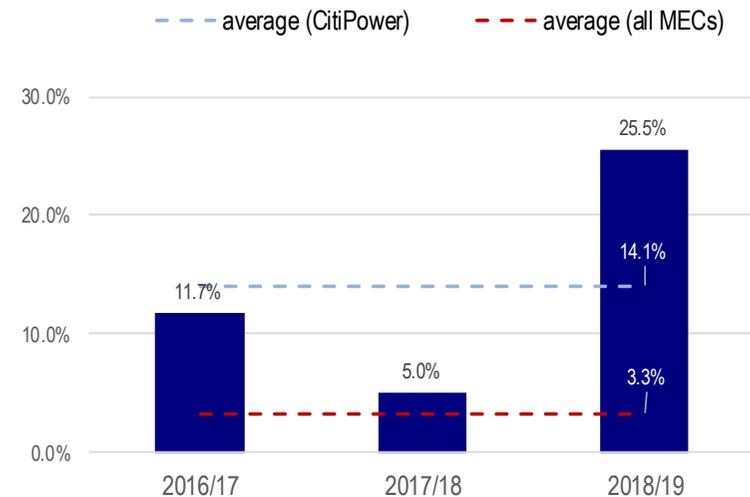
Figure 40 Noncompliance rates for CitiPower

Inspections occurred at 208 randomly selected spans, which are entirely in LBRA. A total of 53 noncompliant spans were identified, for a noncompliance rate of 25.5 per cent. ESV considered this noncompliance rate to be very poor, which is a significant increase from that observed in 2017-2018 (Figure 40).

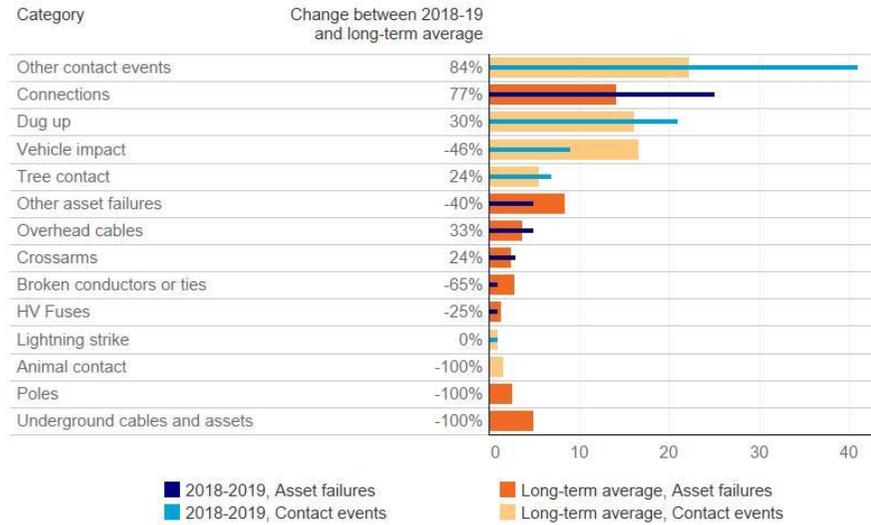
Figure 41 Incidents on the CitiPower network

Figure 41 shows the number of all serious electrical incidents reported to ESV by CitiPower during the 2018-2019 period, with the data sorted from most frequent to least frequent (blue bars). Figure 42 shows the same for those incidents that result in a ground or vegetation fire. Both graphs also show the change in incident numbers from the 2010-2018 averages (orange bars).

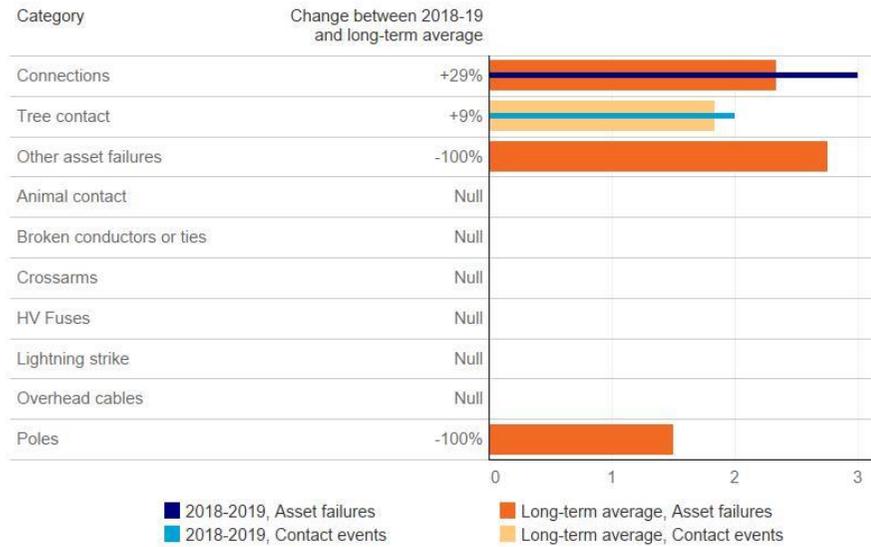
Figure 42 Incidents on the CitiPower network resulting in ground fires

Connection faults and tree contact were the cause of all ground fires on the CitiPower network this year. The numbers of both were higher than the long-term average.

Of the five ground fires on the CitiPower network this year, all five were smaller than 1,000 m<sup>2</sup> (100 per cent); none were larger than 1000 m<sup>2</sup>. A further seven fires were contained to the network assets and didn't result in a ground fire.

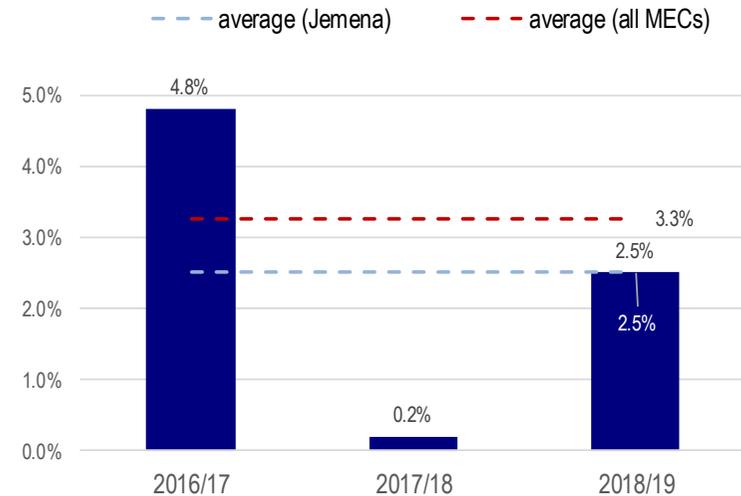
Figure 44 Noncompliance rates for Jemena

Inspections occurred at 239 randomly-selected spans; all of the spans were located in HBRA. A total of six noncompliant spans were identified, for a noncompliance rate of 2.5 per cent. ESV considered this noncompliance rate to be acceptable despite the increase from that observed in 2017-2018 (Figure 44).

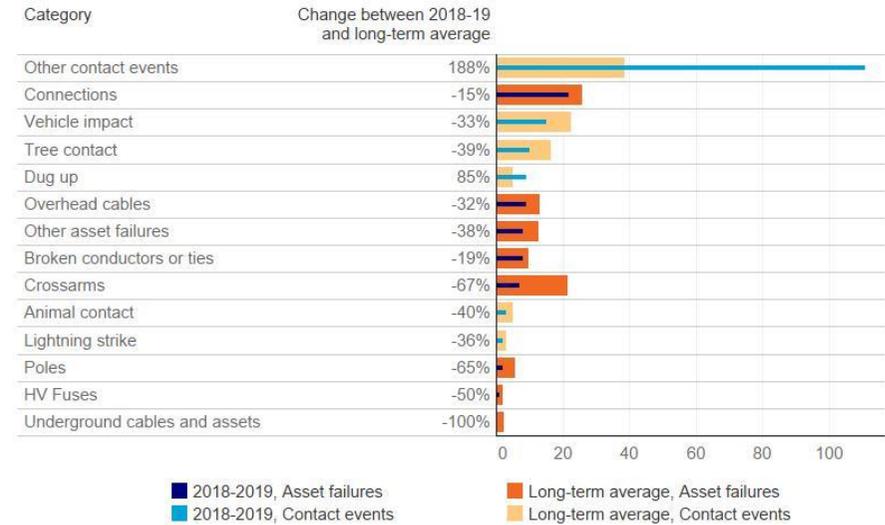
Figure 45 Incidents on the Jemena network

Figure 45 shows the number of all serious electrical incidents reported to ESV by Jemena during the 2018-2019 period, with the data sorted from most frequent to least frequent (blue bars). Figure 46 shows the same for those incidents that result in a ground or vegetation fire. Both graphs also show the change in incident numbers from the 2010-2018 averages (orange bars).

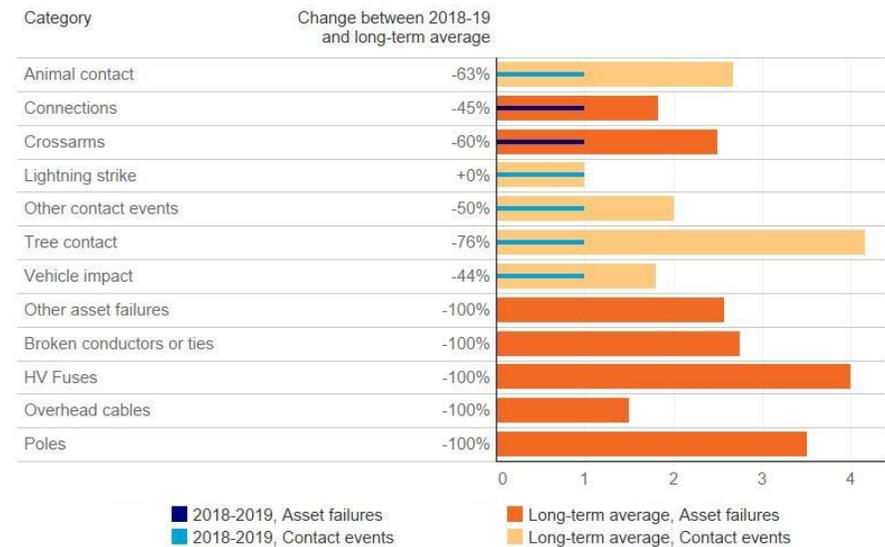
Figure 46 Incidents on the Jemena network resulting in ground fires

Seven separate causes were responsible for the seven fires on the Jemena network this year. Six were lower than the long-term average and one was equal with the long-term average. Four of the causes were largely or partly within the control of the Jemena to manage. Jemena is to be commended for the reduction in fires on its network.

Of the seven ground fires on the Jemena network this year, all five were smaller than 10 m<sup>2</sup> (100 per cent); none were larger than 10 m<sup>2</sup>. A further twelve fires were contained to the network assets and did not result in a ground fire.

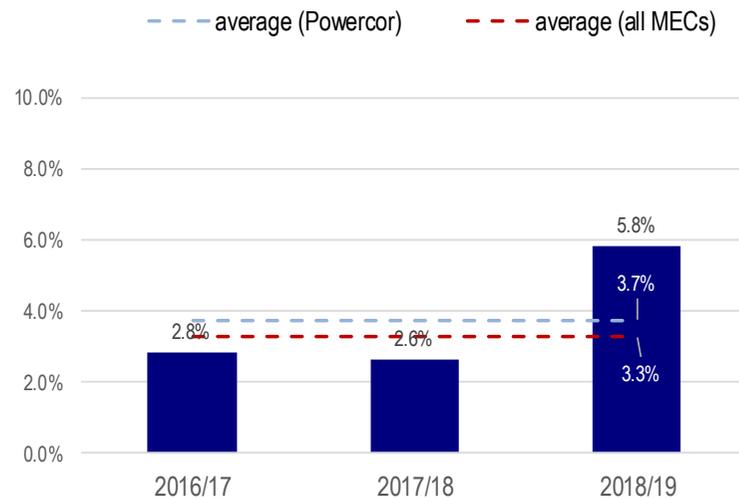
Figure 48 Noncompliance rates for Powercor

Inspections occurred at 467 randomly-selected spans in different HBRA regions of the network. A total of 27 noncompliant spans were identified, for a noncompliance rate of 5.8 per cent. ESV considered this noncompliance rate to be acceptable; however, this result warranted additional observation through the ESV HBRA inspection program. The rate indicated a significant increase from that observed in 2017-2018 (Figure 44).

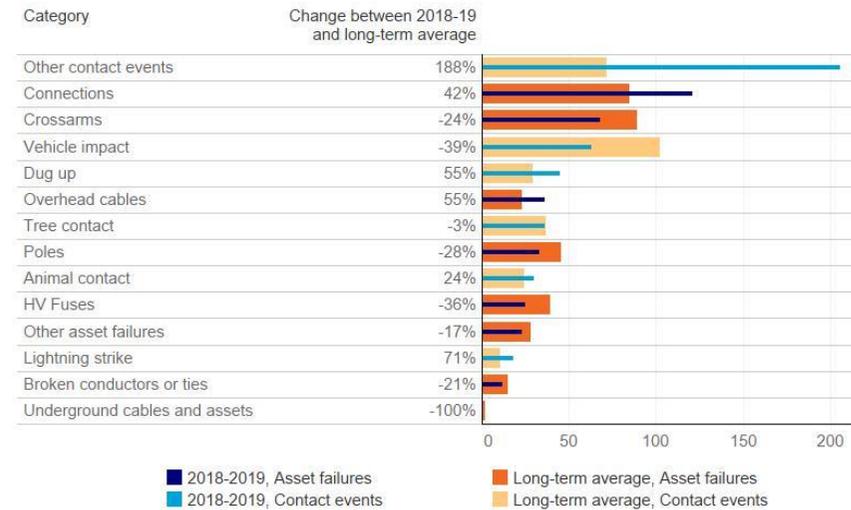
Figure 49 Incidents on the Powercor network

Figure 49 shows the number of all serious electrical incidents reported to ESV by Powercor during the 2018-2019 period, with the data sorted from most frequent to least frequent (blue bars). Figure 50 shows the same for those incidents that result in a ground or vegetation fire. Both graphs also show the change in incident numbers from the 2010-2018 averages (orange bars).

Connection faults, animal contact, tree contact and lightning strike were the most common causes of network-related fires. In two instances (connection faults and lightning strike), the numbers of fires in the period were higher than the long-term average. The numbers of fires this year across most of the other categories were also lower than the long-term average.

Of the 127 ground fires on the Powercor network this year, 105 were smaller than 1,000 m<sup>2</sup> (83 per cent), twenty were between 1,000 m<sup>2</sup> and 10 hectares (16 per cent) and two were larger than 10 hectares (1.6 per cent). A further 151 fires were contained to the network assets and didn't result in a ground fire.
