# Safety performance report on Victorian electricity networks

October 2019

This report has been endorsed by the Director of Energy Safety in Victoria.

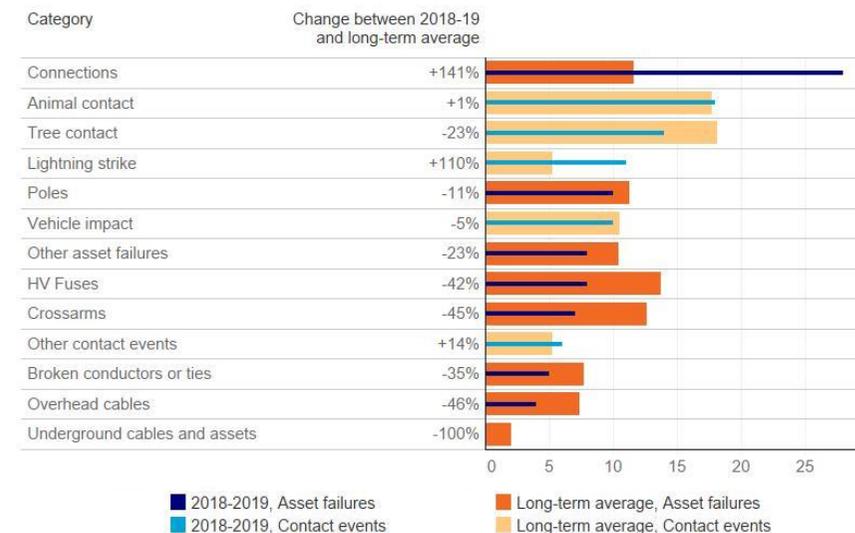
Figure 50 Incidents on the Powercor network resulting in ground fires

Figure 49 shows the number of all serious electrical incidents reported to ESV by Powercor during the 2018-2019 period, with the data sorted from most frequent to least frequent (blue bars). Figure 50 shows the same for those incidents that result in a ground or vegetation fire. Both graphs also show the change in incident numbers from the 2010-2018 averages (orange bars).

Connection faults, animal contact, tree contact and lightning strike were the most common causes of network-related fires. In two instances (connection faults and lightning strike), the numbers of fires in the period were higher than the long-term average. The numbers of fires this year across most of the other categories were also lower than the long-term average.

Of the 127 ground fires on the Powercor network this year, 105 were smaller than 1,000 m<sup>2</sup> (83 per cent), twenty were between 1,000 m<sup>2</sup> and 10 hectares (16 per cent) and two were larger than 10 hectares (1.6 per cent). A further 151 fires were contained to the network assets and didn't result in a ground fire.

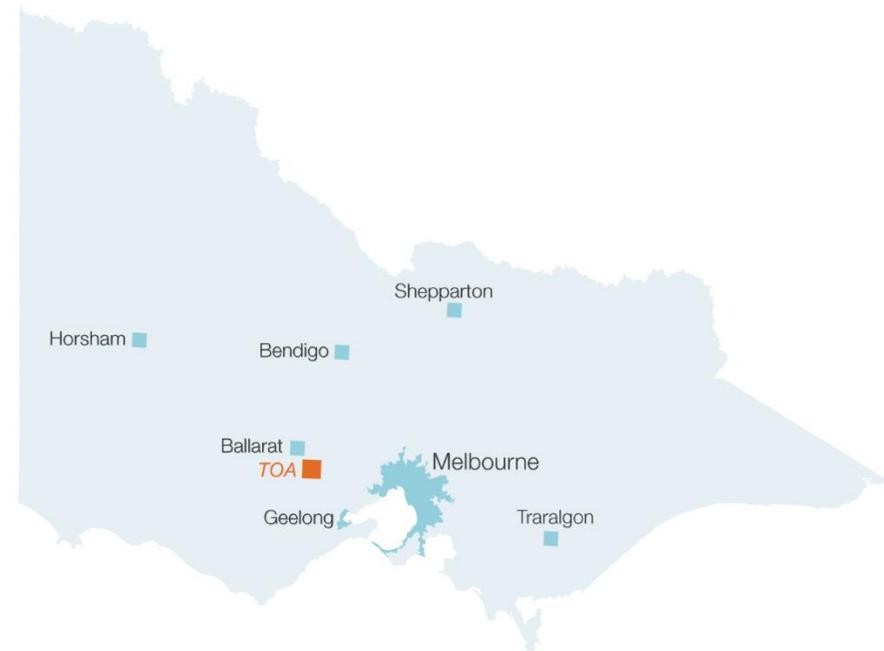
Figure 51 Location of TOA transmission assets (orange square)

TOA owns and operates the connection from the Mt Mercer Wind Farm to the electrical transmission network (Figure 51). This includes a 22km 132kV powerline and the Elaine Terminal Station, which steps the voltage up from 132kV to 220kV for injection into the AusNet Services transmission network.

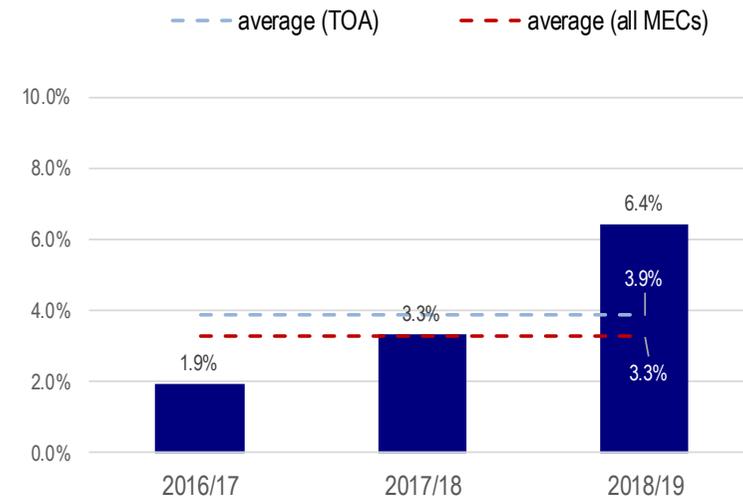
Figure 52 Noncompliance rates for TOA

Inspections occurred at 96 randomly-selected spans in different HBRA regions of the network. A total of six noncompliant spans were identified, for a noncompliance rate of 6.4 per cent. ESV considered this noncompliance rate to be acceptable despite the increase from that observed in 2017-2018 (Figure 52). This position is partially informed by the large clearance distances that must be applied to trees to keep them clear of transmission lines.

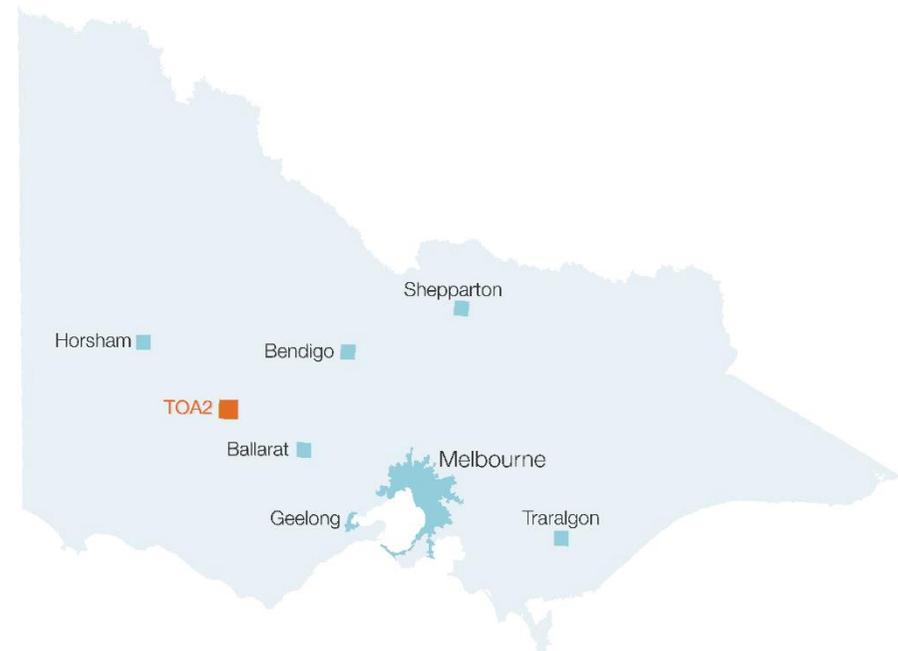
Figure 53 Location of TOA2 transmission assets (orange square)

TOA2 owns and operates the connection from the Ararat Wind Farm to the electrical transmission network (Figure 53). This includes a 21 km 132kV powerline and the Ararat Terminal Station, which steps the voltage up from 132kV to 220kV for injection into the AusNet Services transmission network.

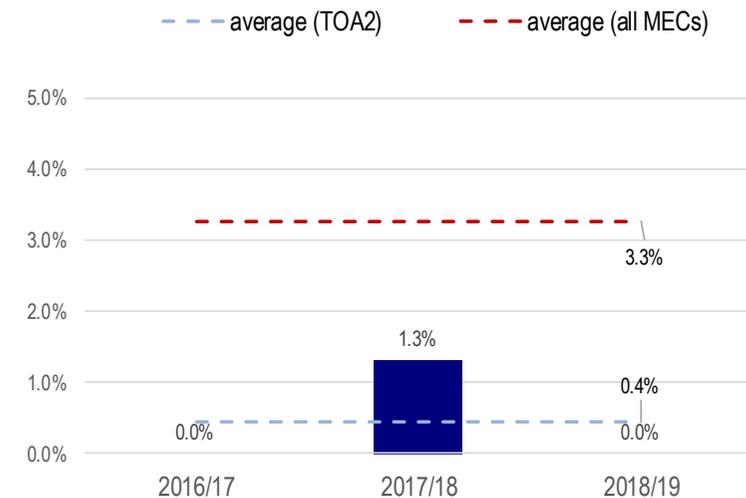
Figure 54 Noncompliance rates for TOA2

Inspections occurred at 69 randomly-selected spans in different HBRA regions of the network. No noncompliant spans were identified, for a noncompliance rate of 0.0 per cent. ESV considered this noncompliance rate to be excellent, and a decrease from that observed in 2017-2018 (Figure 54).

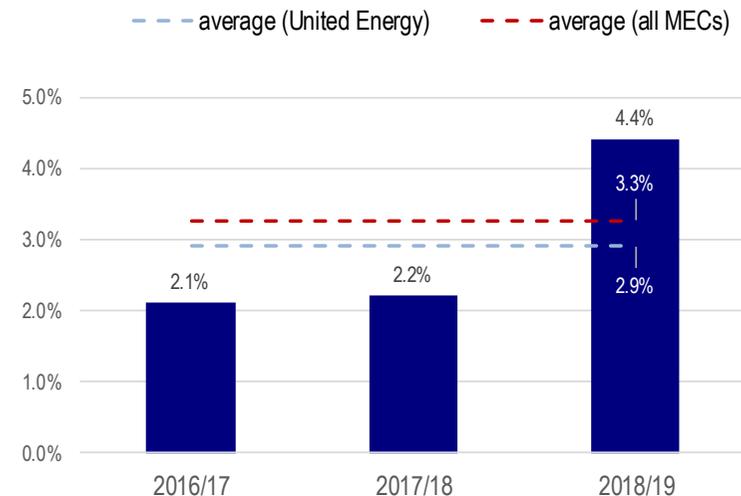
Figure 56 Noncompliance rates for United Energy

Inspections occurred at 68 randomly-selected spans in different HBRA regions of the network. A total of three noncompliant spans were identified, for a noncompliance rate of 4.4 per cent (Figure 56).

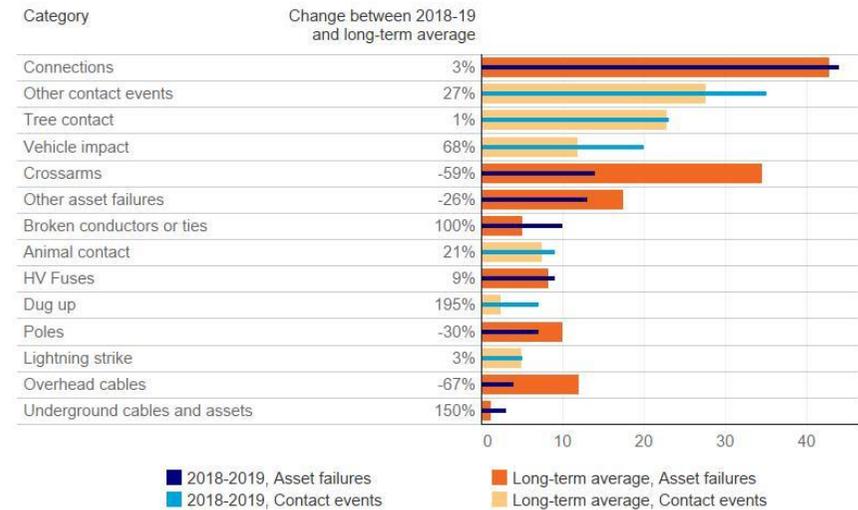
Figure 57 Incidents on the United Energy network

Figure 57 shows the number of all serious electrical incidents reported to ESV by United Energy during the 2018-2019 period, with the data sorted from most frequent to least frequent (blue bars). Figure 58 shows the same for those incidents that result in a ground or vegetation fire. Both graphs also show the change in incident numbers from the 2010-2018 averages (orange bars).

Connection faults, vehicle impacts, broken conductors/ties and tree contact were the most common causes of network-related fires. Fires from connection faults and tree contact have reduced from the long-term average, whereas fires from vehicle impacts and broken conductors/ties have increased significantly (178 per cent and 23 per cent respectively). The numbers of fires this year across most of the other categories were also lower than the long-term average.

Of the 33 ground fires on the United Energy network this year, all were smaller than 1,000 m<sup>2</sup> (100 per cent); none were larger than 1000 m<sup>2</sup>. A further 69 fires were contained to the network assets and didn't result in a ground fire.

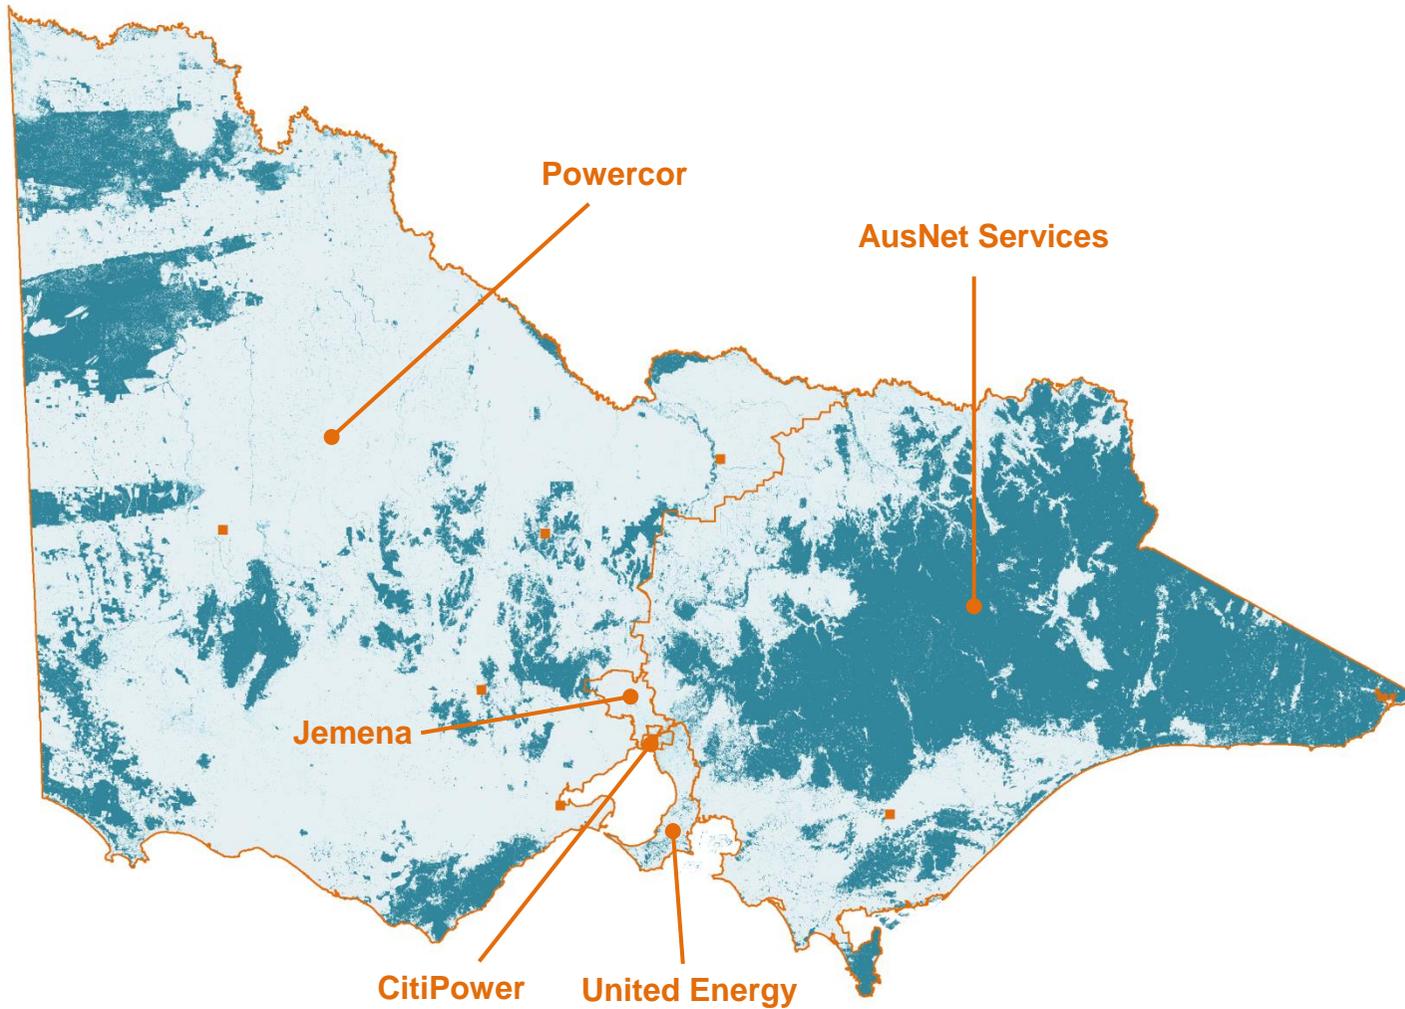
The figure below maps tree density across Victoria with the boundaries of the five distribution businesses in orange. Of the businesses, AusNet Services is most exposed to a high density of tree cover.

Given the high tree density close to assets in the Powercor and AusNet Services regions,<sup>20</sup> there is a higher probability of trees growing into the clearance space or trees failing into or branches being blown in from outside the clearance space. Vegetation management is vital for minimising the bushfire risk from the network. Continued vigilance and implementation of programs under the amended bushfire mitigation regulations is needed to minimise opportunities for contact events to result in fires. Powercor needs to ensure that the recent issues in managing its electric line clearance responsibilities do not recur.
