# Safety performance report on Victorian electricity networks

October 2018

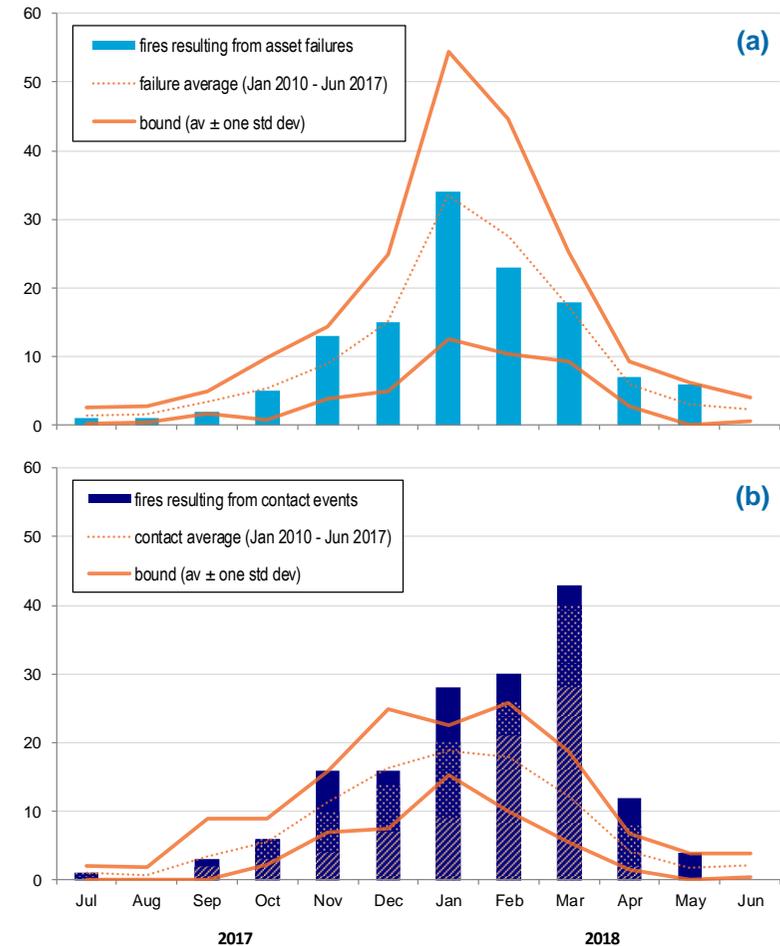
**Figure 2 Ground fire incidents due to (a) asset failures and (b) contact events**

The averages and bounds in Figure 2 show a clear seasonal trend in ground fires due to both asset failures/faults and contact events. Throughout most of the year, there are similar numbers of both types of events; however, the peak in asset-related ground fires is more pronounced historically and has dominated the summer period.

Hatched area in Figure 2b is the contribution from tree contacts; the dotted area is the contribution from animal contacts

This year, the numbers of asset-related ground fires (blue bars in Figure 2a) were close to the 2010-2017 average. In contrast, Figure 2b shows that the numbers of contact-related fires were well in excess of historic numbers from January to April 2018. Tree contacts were a major contributor and dominated the February and March peaks, and drove the March peak well beyond historic levels in their own right.

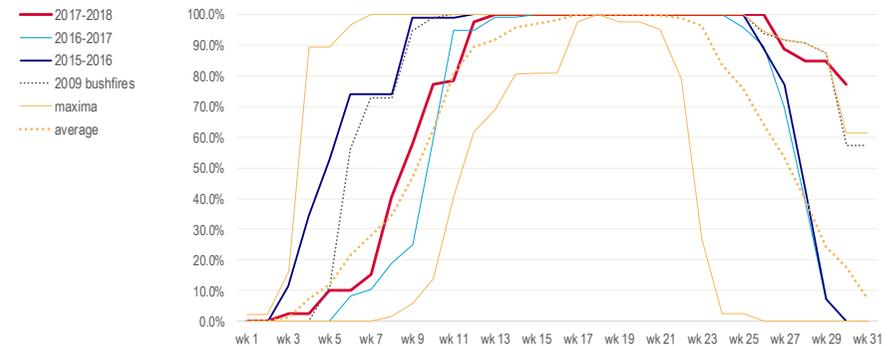
**Figure 3 Summary of CFA fire declarations from 1995 to 2018**

Blue lines indicate the least and most municipalities declared each week

As shown in Figure 3, the start of the 2017-2018 fire season was in line with historical averages. The end of the season, however, was prolonged significantly compared to previous years, with ground conditions continuing to be susceptible to late-season fire events. Of the recent years, it was closer in profile to the 2015-2016 fire season so this is the season ESV has used for comparative purposes.

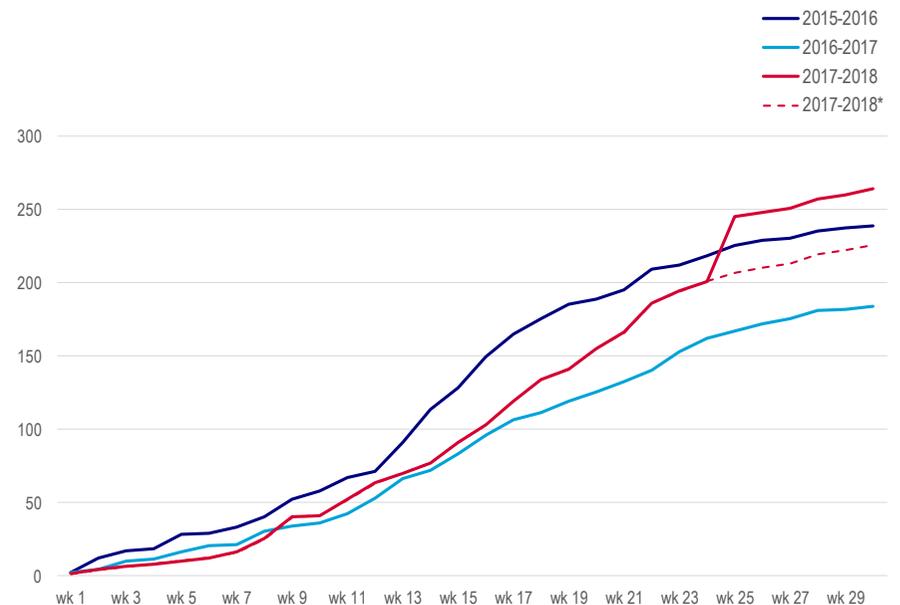
**Figure 4 Cumulative fires across the fire season**

\* dotted line removes the effect of the 17-22 March severe winds

The 2017-2018 fire season was on track to be an improvement on the 2015-2016 season (dashed line in Figure 4). This changed with the fires over the St Patricks Day weekend and in the subsequent week (17-22 March 2018). These fires were primarily associated with severe winds that passed across the state.

These severe winds caused 38 more fires than would have been expected if the winds had not occurred. This, in turn, resulted in fifteen more fires overall than in the 2015-2016 fire season.

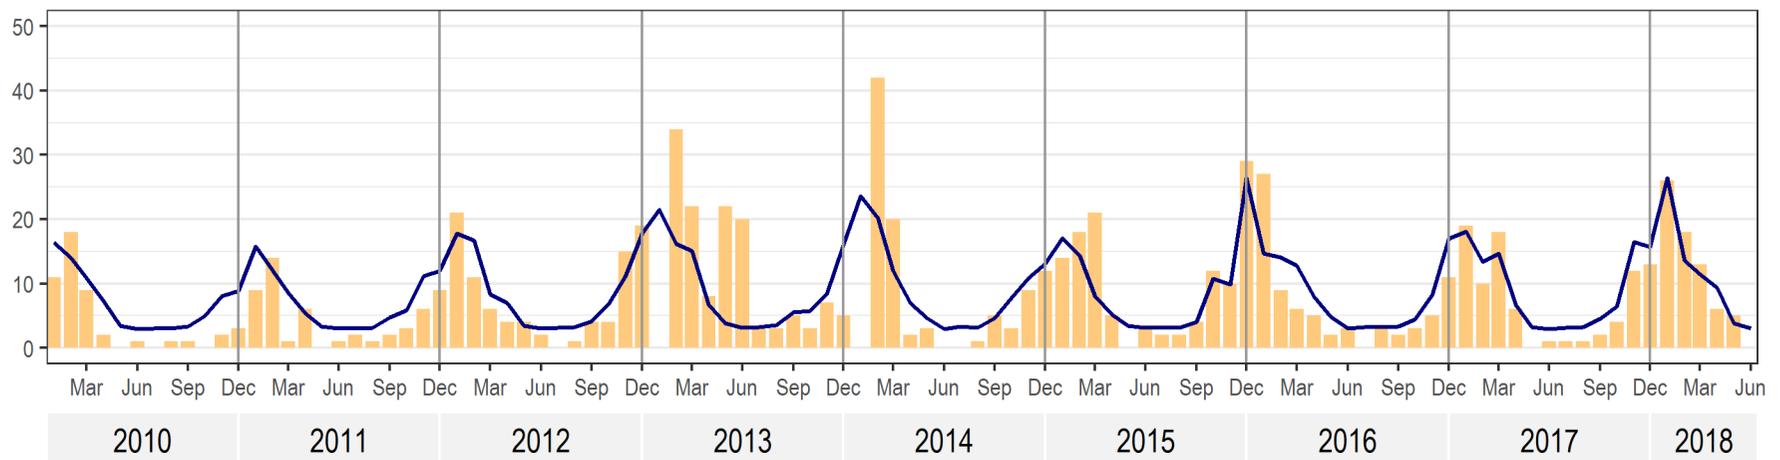
Figure 5 Influence of weather on ground fires due to asset failures

The contributing factors for asset-related fires (Figure 5) are air temperature, wind speed and humidity differential over the preceding three days, with a smaller contribution from maximum temperature. For contact events (Figure 6), the main contributions come from air temperature, maximum wind gust speed, wind speed and, to a lesser degree, humidity.

Both figures show a clear seasonal pattern of ground fires with peaks in summer and troughs in winter.

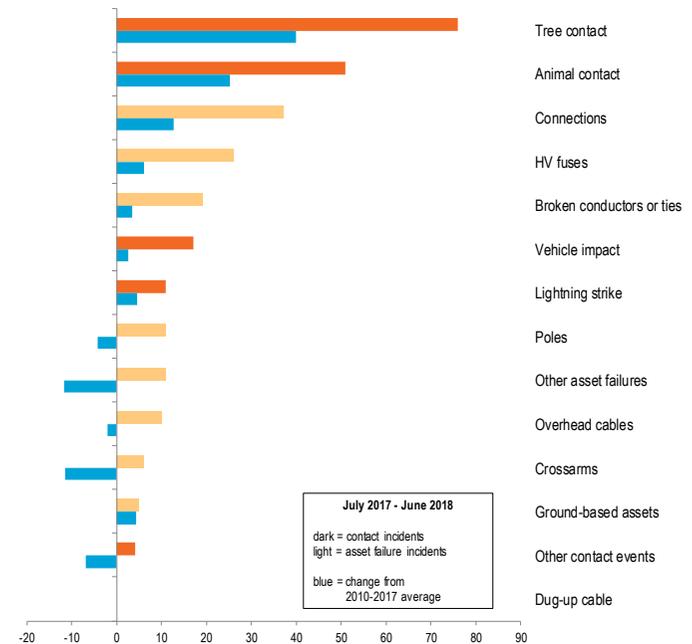
Figure 7 Ground fire-related incidents occurring on Victorian networks

Figure 7 shows the number of ground fire events on the Victorian networks from most common to least common. It also shows, in blue, the difference in incidents between 2017-2018 and the long-term average of the 2010-2017 period.

The top four fire events were due to tree contact, animal contact, connection faults and HV fuse failures. All four events are largely within the control of the networks.

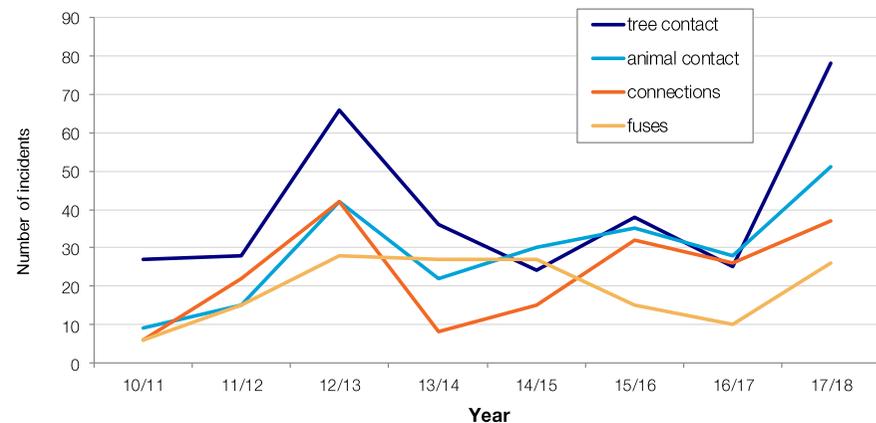
Figure 8 Historic trends for common ground fire events

Figure 8 shows the trend over the last eight years for the top four fire events above. This indicates that:

- fires from tree contact have increased markedly this year and are now well above the historic peak, warranting the continued attention ESV is applying to vegetation clearance
- while animal contact fires fluctuate, there is a general upward trend
- fires from connection faults have been rising steadily for four years
- fires due to HV fuse failures have increased to historic peak levels after a decline in recent years.

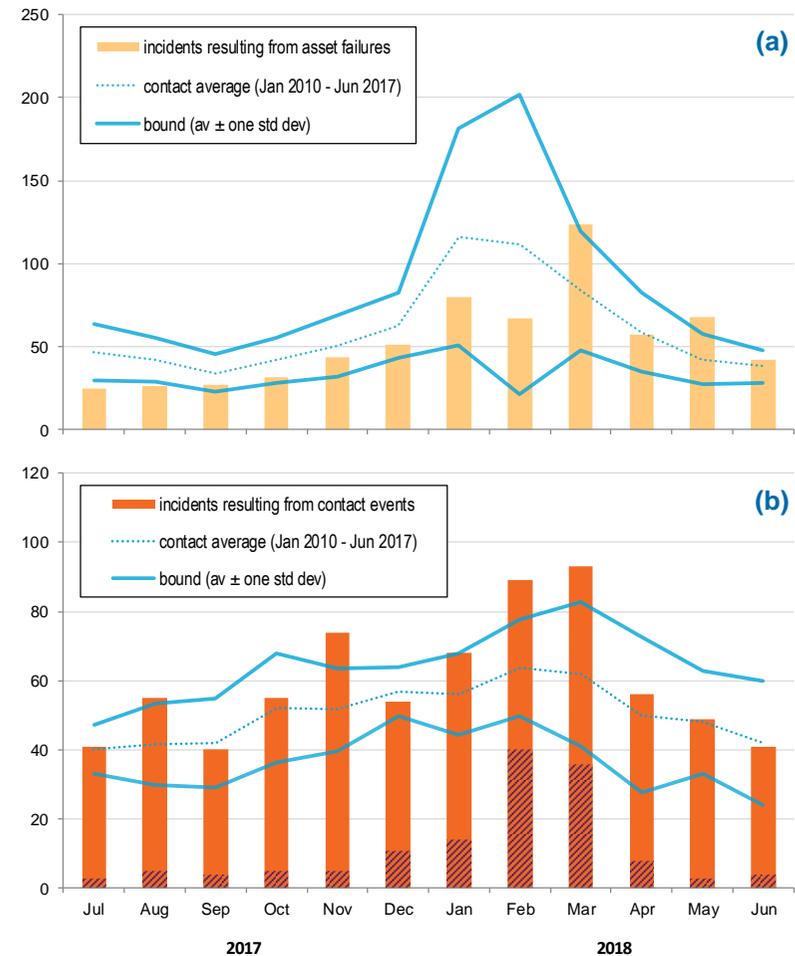
Figure 10 All incidents in the period due to (a) asset failures and (b) contact events

Figure 10 shows the number of network safety incidents on the Victorian networks. The numbers of asset failure incidents and contact events are reported separately.

The historical average for the period January 2010 to June 2017 shows a seasonal trend with increased asset failures over the summer period (Figure 10a). In general, the numbers of asset failures in the last year were well below the average; the annual peak that normally occurs in February was delayed until March. This is possibly due to the extended summer period and/or severe weather events noted previously.

In contrast, the numbers of contact events show less seasonality and more inter-month variability (Figure 10b). Contact events this year showed an even higher degree of variability and were generally in line with the historical average. There were, however, five months where the number of contact events were one standard deviation or higher than the historical average.<sup>7</sup>

Hatched area in Figure 10b is the contribution from tree contacts

While increased tree contacts (the hatched area in Figure 10b) explain the major peaks in February and March, this is not sufficient to explain the August and November peaks. There are four main factors interacting to produce this variability in contact events — tree contact, animal contact, vehicle contact and other contact events (including copper theft, vandalism and intrusions into the No Go Zone around overhead lines).

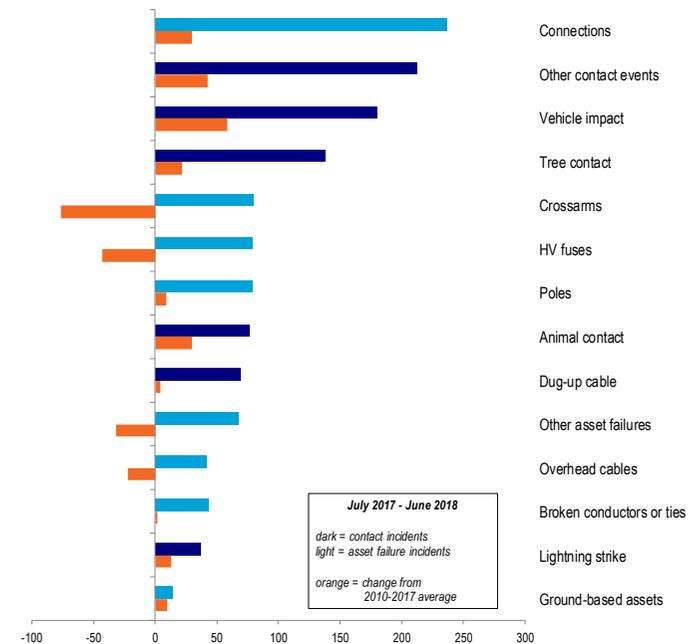
Figure 11 Incidents occurring on Victorian networks

Figure 11 shows the number of incidents on the Victorian networks from most common to least common. It also shows, in orange, the difference in incidents between 2017-2018 and the long-term average of the 2010-2017 period.

While ground fires from HV fuses increased slightly, the total number of HV fuse failures (regardless of whether a fire resulted) has decreased when compared to the seven-year average (see Figure 11). In short, there have been fewer events but more fires resulted from those fewer events.

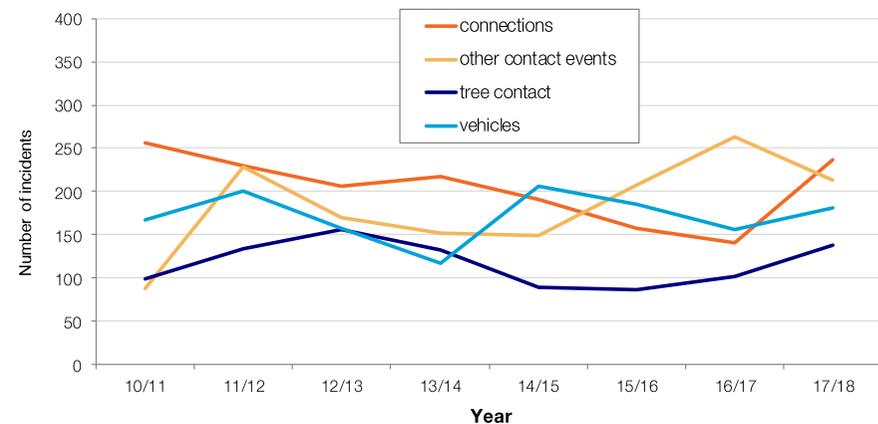
Figure 12 Historic trends for common incident events

Figure 12 shows the trend over the last eight years for the top four events above. This indicates that:

- the downward trend in connections faults has markedly reversed and is almost back at peak levels
- other contact events has dropped this year; however, the decreases on the rural networks are masking increases in the urban networks (see Section 5.3)
- after decreasing and flattening out in 2015-2016, incidences of tree contact have been increasing again over the last two years
- vehicle impacts<sup>8</sup> on overhead lines and poles continue to oscillate and remain an issue for the networks.

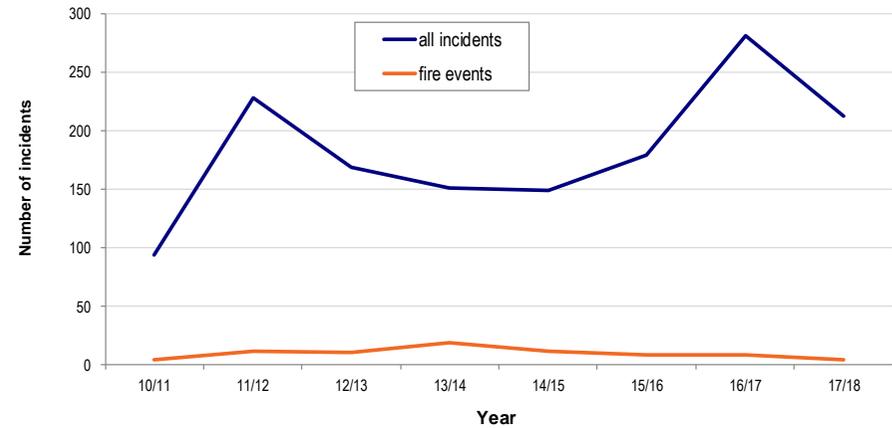
Figure 13 Other encroachment and contact events

These events include copper theft, vandalism, No Go Zone infringements

The last of these categories was the most common event placing members of the public at risk last year. Figure 13 shows that the increase in these events from 2014-2015 reversed this year with a drop of 24% from last year's peak of 282 incidents. Figure 14 shows the locations where these incidents were recorded in 2017-2018.

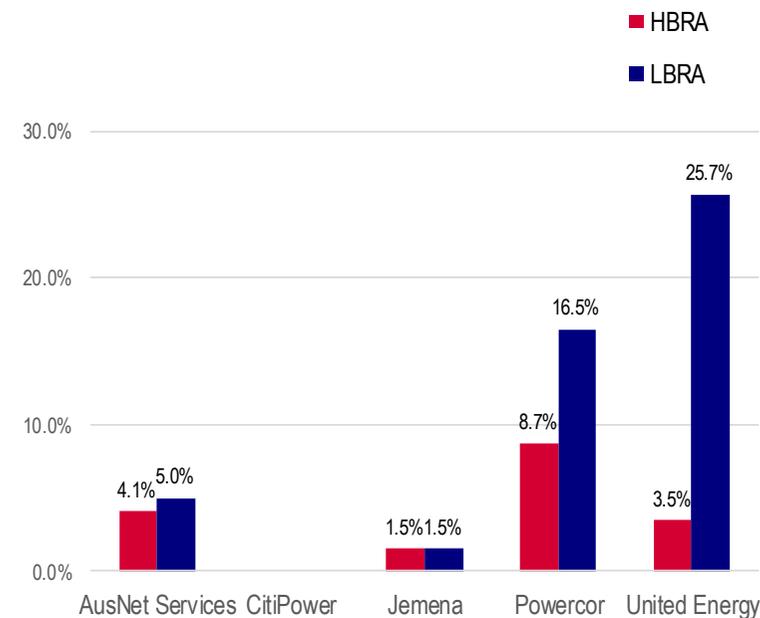
Figure 20 Non-compliance rates by distribution business

Figure 20 depicts the ESV inspection results for the reporting period and the first three months of the 2018-2019 period. This shows that Jemena had the best compliance in HBRA, while Powercor had the worst compliance. AusNet Services had the best compliance in LBRA, while United Energy had the worst.

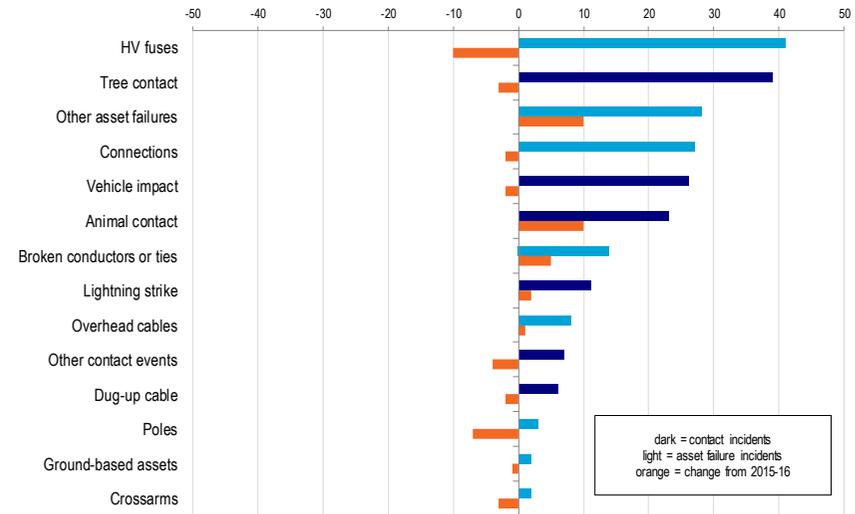
Figure 23 Incidents on the AusNet Services network

Figure 23 shows the annualised number of all serious electrical incidents reported to ESV by AusNet Services, with the data sorted from most frequent to least frequent. Figure 24 shows the same for those incidents that result in a ground or vegetation fire. Both graphs also show the change in incident numbers from 2015-2016, the last year with similar climate to 2017-2018 (see Section 5.1).

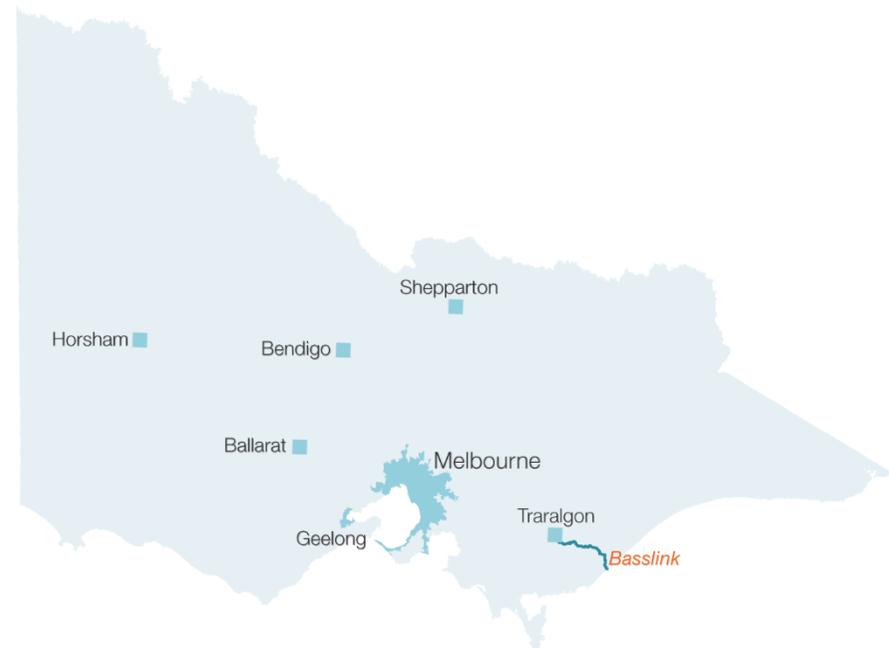
Figure 25 Location of Basslink transmission assets (dark blue line)

Basslink owns and operates the HVDC interconnector between Victoria and Tasmania. In Victoria its assets comprise the Loy Yang converter station connected to the 500kV transmission system via 3.2 km of overhead line. From the converter station, 57 km of overhead line and 6.4 km of underground cable connect to the submarine cables that cross Bass Strait to Tasmania (Figure 25). Only the onshore assets in Victoria are subject to regulation by ESV.

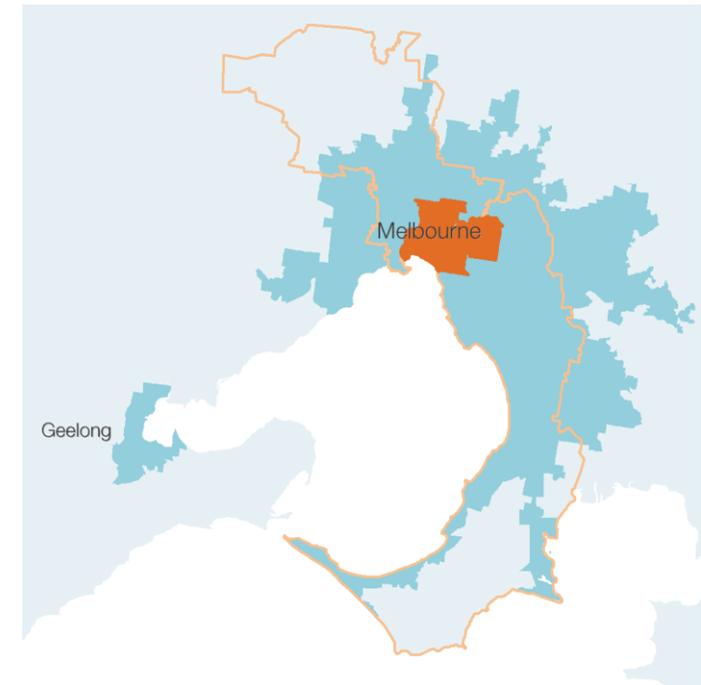
**Figure 26 Service area for the CitiPower distribution network (orange area)**

The CitiPower distribution network covers an area of approximately 157 km<sup>2</sup>, and includes Melbourne's central business district and inner suburbs (Figure 26). It comprises approximately 2,580 km of overhead line, 3,100 km of underground cable, 49,100 power poles and 9,100 public lighting poles. Most of this network (75 per cent) is in the central business district.

Jemena and United Energy service boundaries are shown in orange

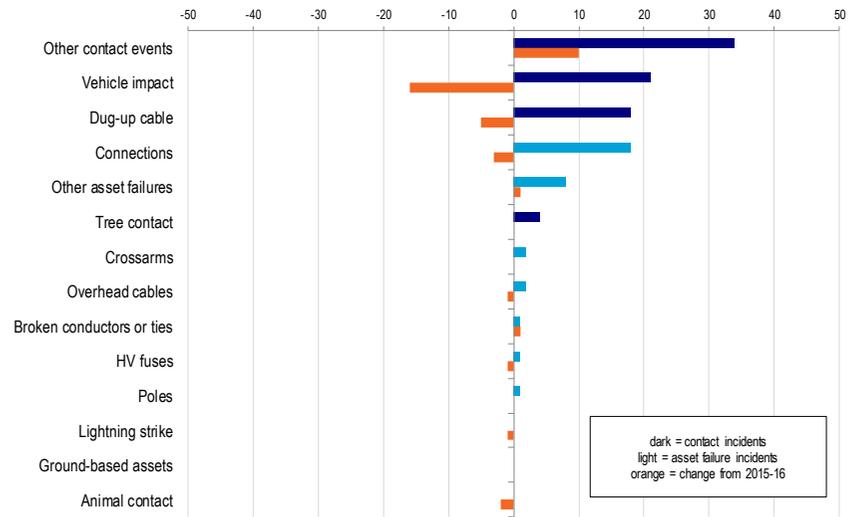
Figure 27 Incidents on the CitiPower network

Figure 27 shows the annualised number of all serious electrical incidents reported to ESV by CitiPower, with the data sorted from most frequent to least frequent. Figure 28 shows the same for those incidents that result in a ground or vegetation fire. Both graphs also show the change in incident numbers from 2015-2016, the last year with similar climate to 2017-2018 (see Section 5.1).

While vehicle incidents have dropped by 43 per cent from 2015-2016, the number this year is double the number reported last year. Dug-up cables are down 22 per cent from 2015-2016, and connection faults are down 14 per cent.

Commendably, the number of fires on the CitiPower network has reduced to zero across all categories except for connection faults, tree contact and dug-up cables. The overall number of ground fires on the CitiPower network is low, with only four fires this year.

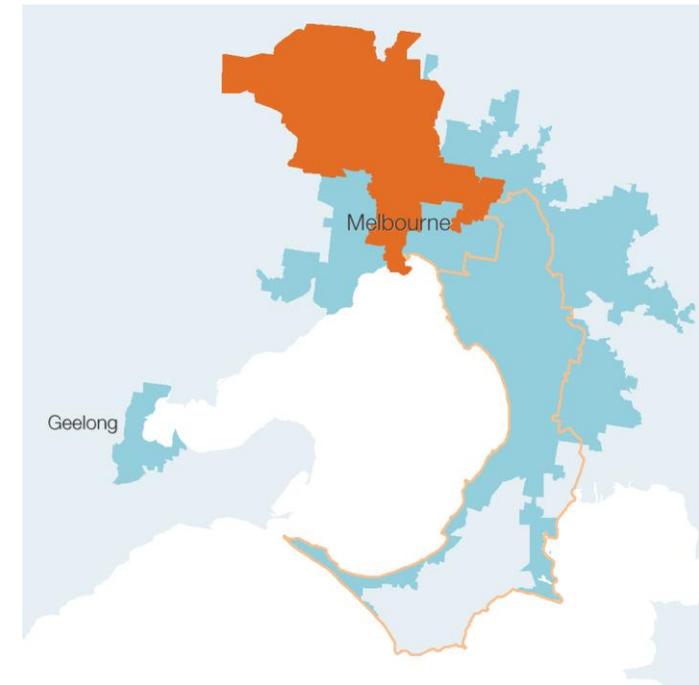
**Figure 29 Service area for the Jemena distribution network (orange area)**

The Jemena AC distribution network covers any area of approximately 950 km<sup>2</sup>, across Melbourne's northern and western suburbs, including Melbourne International Airport (Figure 29). It comprises approximately 4,450 km of overhead line, 1,880 km of underground cable, 81,200 power poles and 26,100 public lighting poles. Most of this network (86 per cent) is in urban areas.

CitiPower and United Energy service boundaries are shown in orange

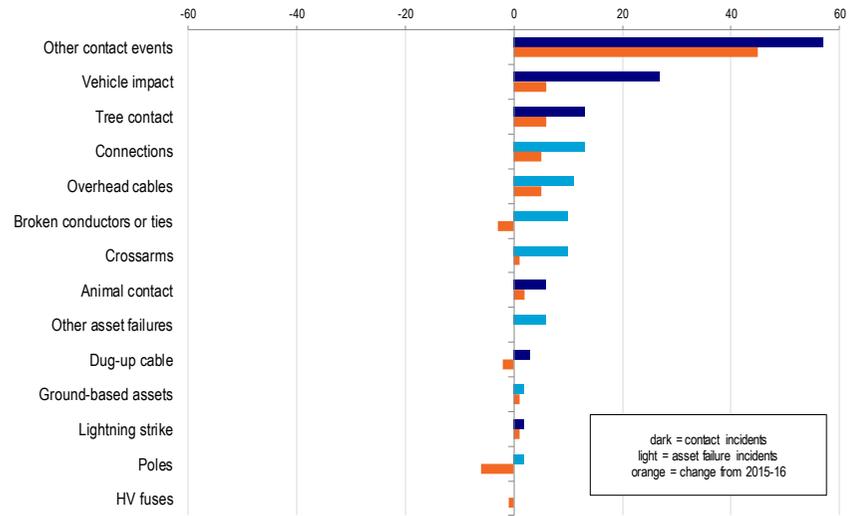
Figure 30 Incidents on the Jemena network

Figure 30 shows the annualised number of all serious electrical incidents reported to ESV by Jemena, with the data sorted from most frequent to least frequent. Figure 31 shows the same for those incidents that result in a ground or vegetation fire. Both graphs also show the change in incident numbers from 2015-2016, the last year with similar climate to 2017-2018 (see Section 5.1).

Other contact events include copper theft, vandalism and intrusions into the No Go Zone around overhead powerlines. These incidents have increased by a factor of five since 2015-2016. Further analysis of these events is warranted to identify whether there is an underlying cause that needs to be addressed with Jemena or Victoria Police.

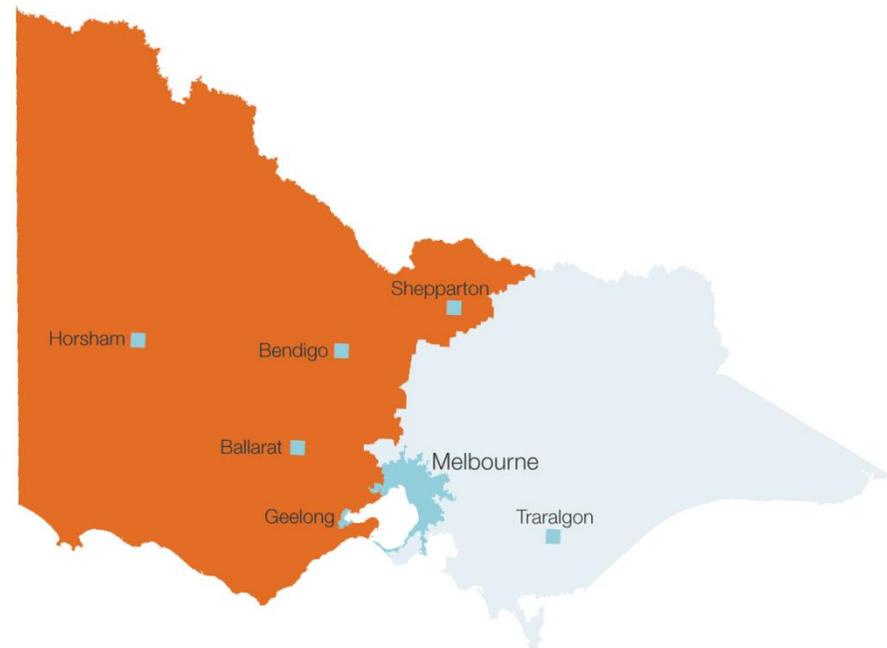
Figure 32 Service area for the Powercor distribution network (orange area)

The Powercor distribution network covers any area of approximately 145,700 km<sup>2</sup>, and includes Melbourne's Docklands Precinct, west from Williamstown to the South Australian border, north to the Murray and south to the coast (Figure 32). It comprises approximately 68,800 km of overhead line, 7,670 km of underground cable, 488,200 poles and 83,600 public lighting poles. Most of this network (92 per cent) is in rural areas.

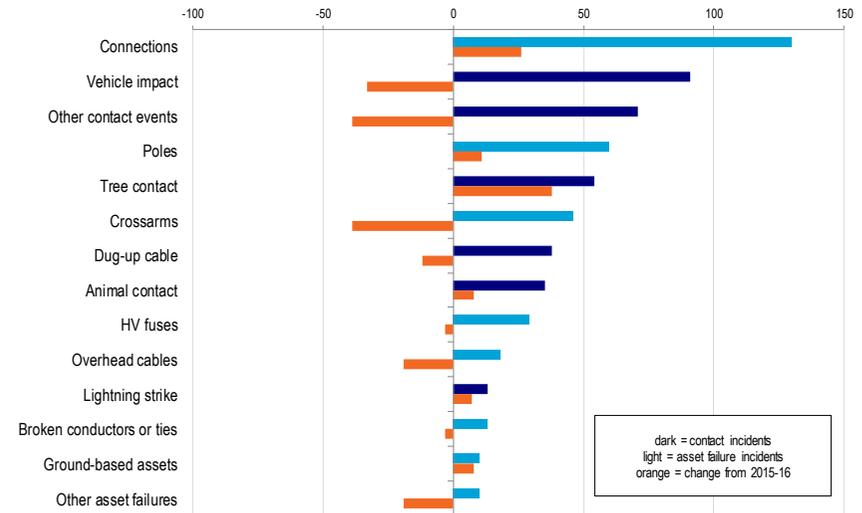
Figure 33 Incidents on the Powercor network

Figure 33 shows the annualised number of all serious electrical incidents reported to ESV by Powercor, with the data sorted from most frequent to least frequent. Figure 34 shows the same for those incidents that result in a ground or vegetation fire. Both graphs also show the change in incident numbers from 2015-2016, the last year with similar climate to 2017-2018 (see Section 5.1).

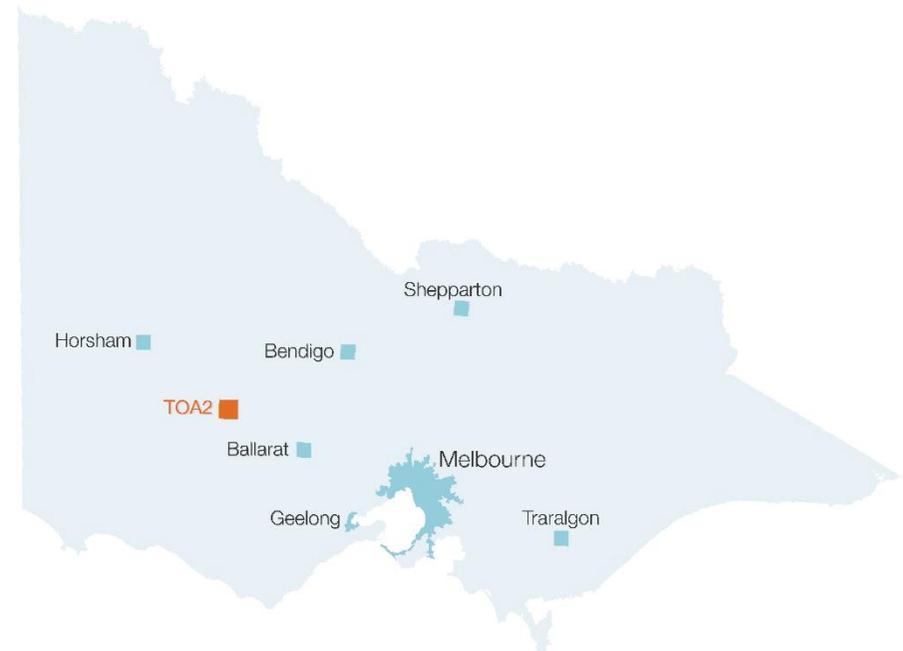
Figure 36 Location of TOA2 transmission assets (orange square)

TOA2 owns and operates the connection from the Ararat Wind Farm to the electrical transmission network (Figure 36). This includes a 21 km 132kV powerline and the Ararat Terminal Station, which steps the voltage up from 132kV to 220kV for injection into the AusNet Services transmission network.

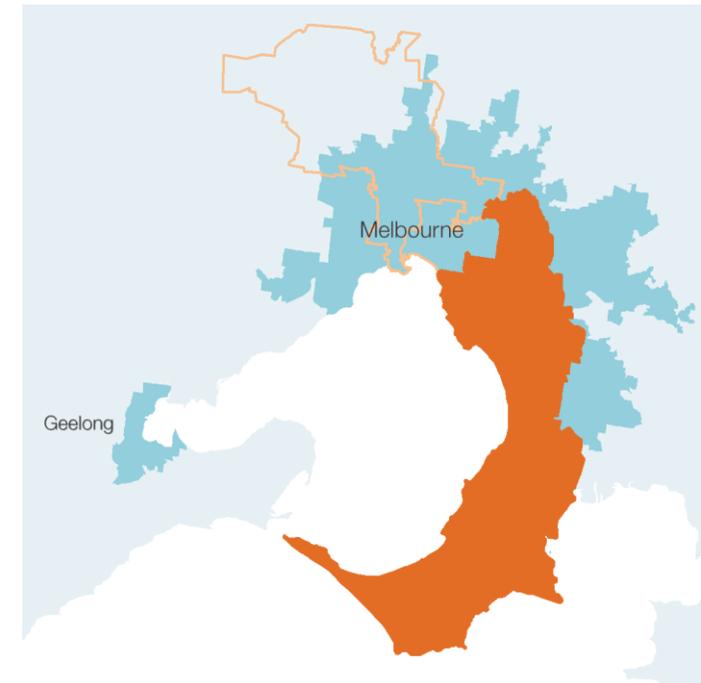
**Figure 37 Service area for the United Energy distribution network (orange area)**

The distribution network covers an area of approximately 1,470 km<sup>2</sup> across Melbourne's eastern and south-eastern suburbs and the Mornington Peninsula (Figure 37). It comprises approximately 9,920 km of overhead line, 3,340 km of underground cable, 168,700 poles and 35,800 public lighting poles. Most of the network is urban and semi-rural.

Jemena and CitiPower service boundaries are shown in orange

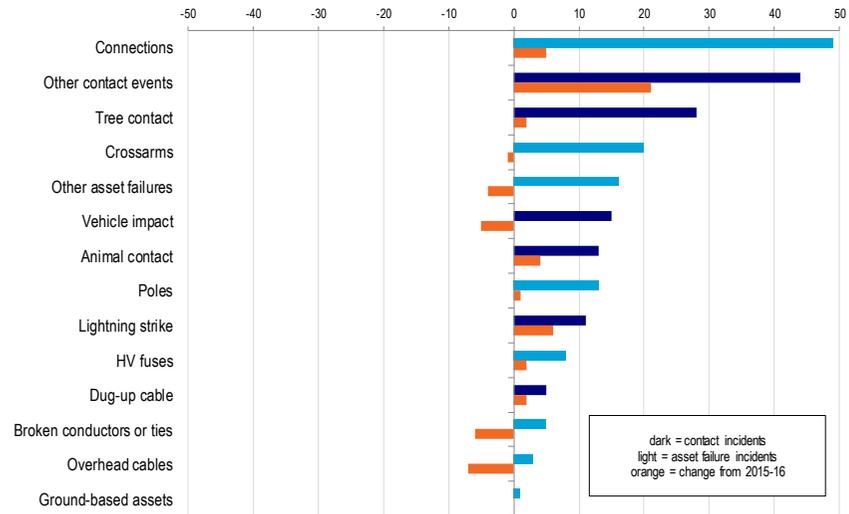
Figure 38 Incidents on the United Energy network

Figure 38 shows the annualised number of all serious electrical incidents reported to ESV by United Energy, with the data sorted from most frequent to least frequent. Figure 39 shows the same for those incidents that resulted in a ground or vegetation fire. Both graphs also show the change in incident numbers from 2015-2016, the last year with similar climate to 2017-2018 (see Section 5.1).

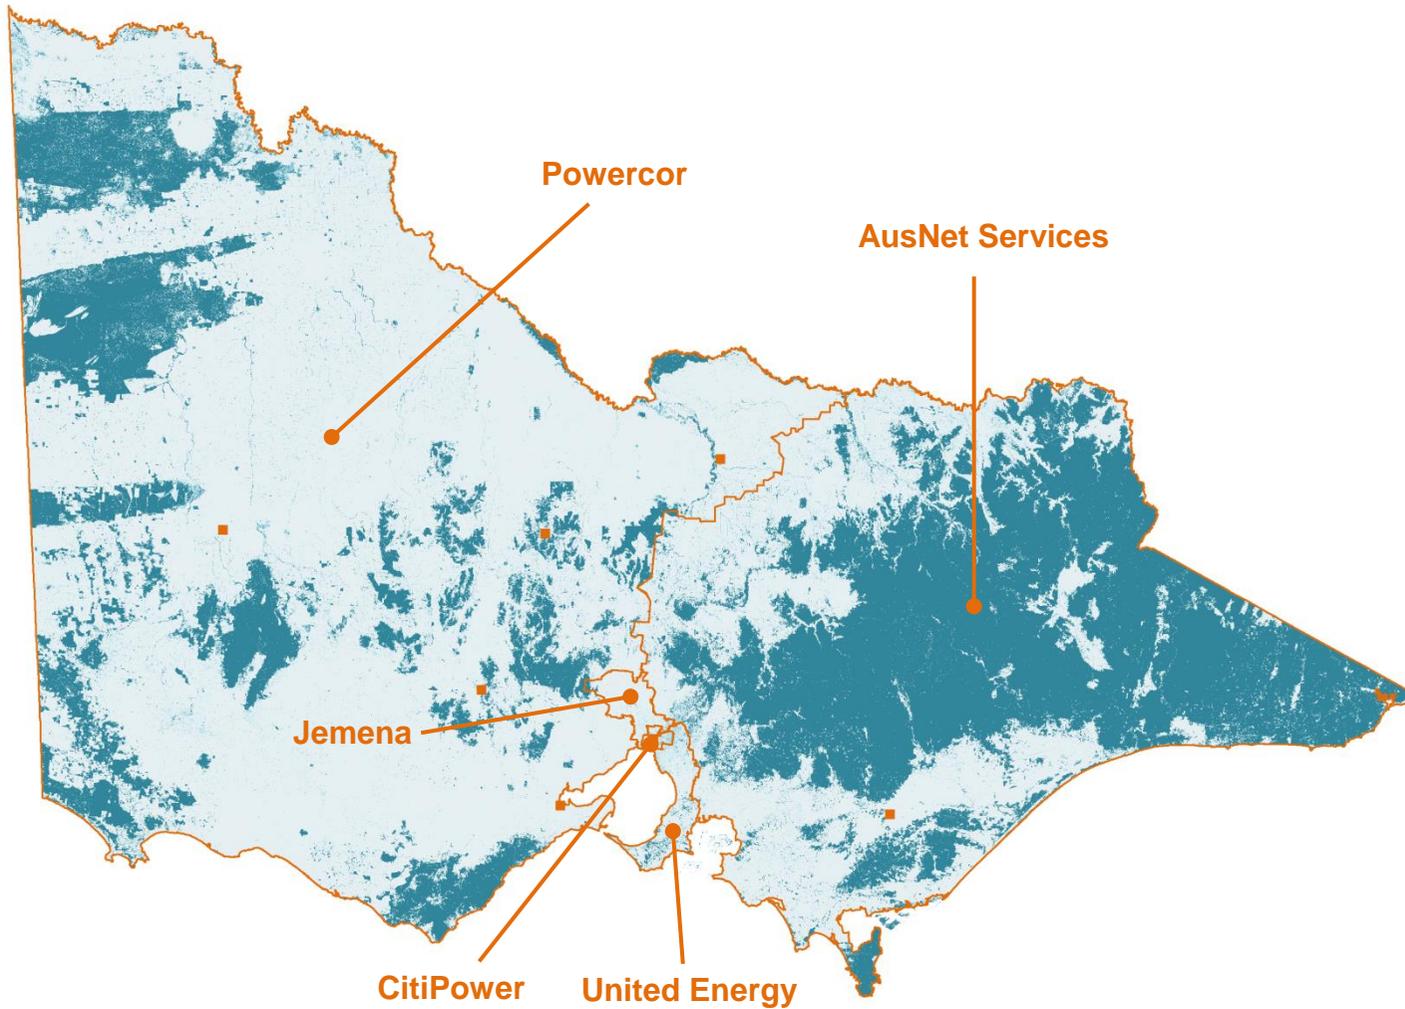
The figure below maps tree density across Victoria with the boundaries of the five distribution businesses in orange. Of the businesses, AusNet Services is most exposed to a high density of tree cover.
