SP Energy Networks 2015–2023 Business Plan

11kV Substation Plant Strategy

SP Energy Networks

March 2014

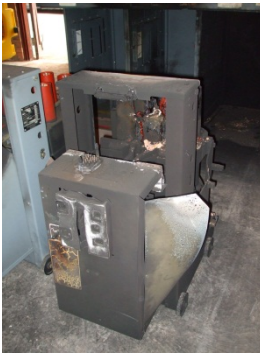
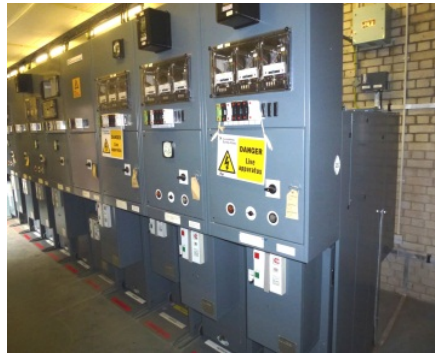
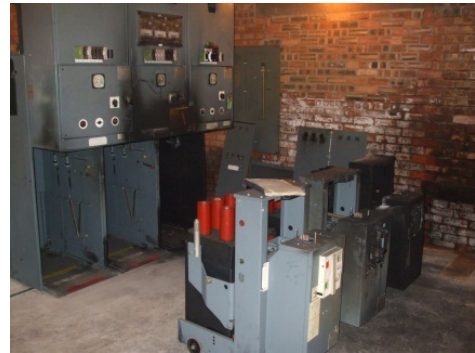
VMX circuit breakers

One recent developing issue has been the early failures of GEC VMX switchgear which are vacuum circuit breakers installed in the 1980's and 1990's, mainly in SPM (population of over 1000). A number of these are on critical primary switchboards that are part of demand groups supplying more than 10,000 customers. These switchboards are very susceptible to the environment they are kept in. Failures of these units have been where the unit is in a damp environment. Our strategy is to replace a percentage of our VMX population that reduces the risk to an acceptable level and also allows us to manage the population going forward. We will start with the worst condition first. These will be VMX in the substation buildings that have, or had, the highest humidity/poorest heating, or a known history of discharging breakers that we have nursed back to serviceability. Most of these will be the early versions which cannot be refurbished so the entire switchboard will need to be replaced. However later versions can be refurbished and these will be sent back to works and will provide spares for others reported as audibly discharging. By the end of ED1 we will have replaced 13% of the VMX population in the ED1 period, and will also have generated enough refurbished spare circuit breakers to keep the remaining VMX switchboard population serviceable. We will deal with the remaining VMX in ED2, by which time we may need to further accelerate the replacement rate.

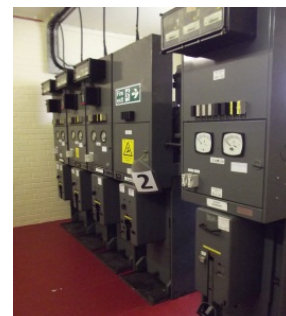
South Wales C4X

South Wales circuit breakers have suffered: performance failure to trip issues failure to trip due to oil within the tripping coil hindering the magnetic tripping bar arrangement, the mechanism failing to operate properly when spring charging, fixed portion busbar and end box failures due to the deterioration of G38 insulating material.

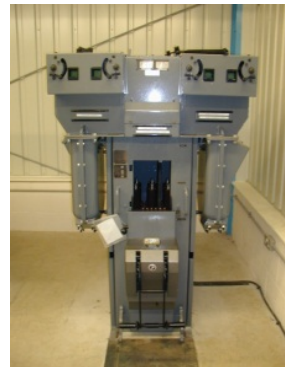
Early 1950's indoor ocb RMU originally fitted with direct manual mechanism un-potted 150MVA type TDB ocb. All ocbs rebuilt to revised 250MVA design by Baldwin and Francis between 1976 and 1985 (hence JPBK). Rebuilt OCB uses original ocb top plate tank, bushings and drive crank. All new mechanism and contact system/turbulators (pots). The internal of the top plate suffers from crystalline rusting due to condensation in an identical manner to the latter manufactured PDB ocbs replaced under DPRC5.

Its onset was delayed by attempted internal re-painting during the rebuild. These ocbs are unique in having ferrous top plates (other makes/types use non-ferrous (and hence nonmagnetic castings). RMU oil switches identical to later NX RMU and are fully rated. Design is very vulnerable to failure if rainwater from roof leak falls on unit – no protection for oil switch tank breather under test access lids. No manufacturer support from either J&P or Baldwin and Francis. No spare parts available other than 'pattern-part' ocb contacts. OCB uses extension earthing kit (new kits purchased from B&F in early 1980's) earth kits beginning to wear out and tested replacements unavailable.

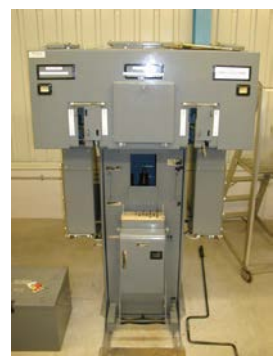
SWS RMN4 RMU

Mid 1950's indoor ocb RMU originally early types fitted with direct manual mechanism un-potted 150MVA type 'C4' ocb with 'H04' mechanism. All C4 ocbs replaced between 1976 and 1985 with SWS D4XDM type adapted to fit the original ocb carriage. Later RMN4 RMUs had original 250MVA C4X ocb with porcelain bushings, many of which have developed bitumen compound leaks into the ocb oil tank and externally due to natural deterioration of rubber/cork gaskets. OCB can be refurbished by Hawker Siddeley but price similar to all new non-oil RMU. No manufacturer support and no parts available for oil switches, RMU housings or ocb mechanisms. Manufacturers and others can supply only pattern-part contacts. OCB uses extension earthing kits supplied in mid to late 1950's. Many now becoming unserviceable and replacements are unavailable.

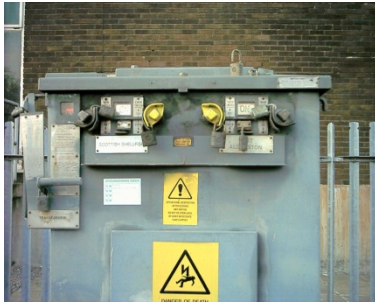
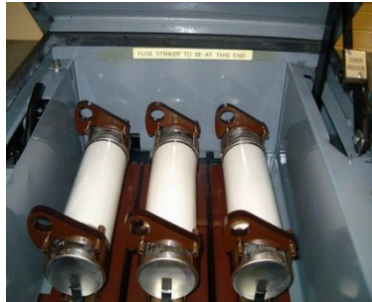
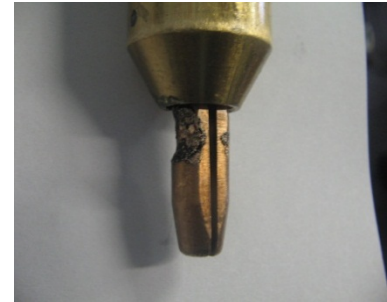
L&C RMU

Oil filled switchfuse RMU purchased by Manweb (and SSEB) from early 1970's to mid 1980's. Generally a reliable RMU although there have been a number of nationally reported type defects, most of which were resolved over a decade ago. Our maintenance strategy evolved into a testing regime 'live tank oil sampling' (LTOS) regime complemented with intrusive maintenance.

During RIIO ED 1 plan to replace RMU based on condition. We will be able to use our testing data and condition information to generate a prioritised plan. Units installed outdoors have suffered some deterioration due to corrosion dependant on location. In addition perishing gaskets, sight glasses, barrier boards, damaged fuses, damaged contacts and internal corrosion have informed our investment assumptions for such assets.

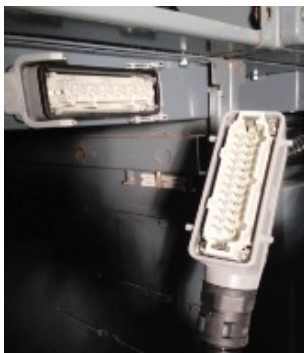
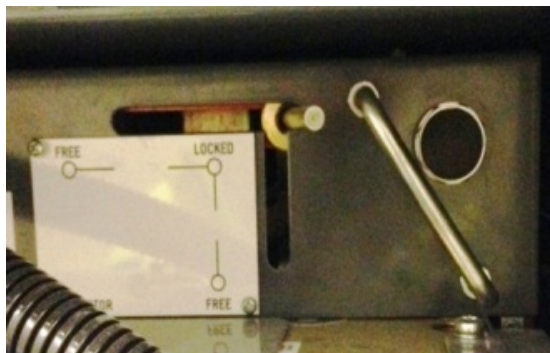
- *The selector lever can only be moved when the black solenoid release push button is pressed. This action releases a solenoid connected to the lever mechanism. Should supplies be 'lost' the solenoid interlock can be defeated by inserting a small screwdriver into a hole which is located underneath the 'locked/free' label.*

- *The CB trip function is only operative when the racking switch plunger is engaged when the circuit breaker is in the raised service position. The functionality must be proven following disconnection/reconnection. For example: Following works and when the Harting plug/sock is reconnected - Rack in, close, trip test and tele close. The CB cannot be tripped electrically when the CB is in the circuit earth position or bus-bar earth position.*

We have already started to install 11kV CB moving portion retrofit solutions during DPCR5, and we plan to further develop this technology during ED1. All solutions will be ENA assessed. One type is the Siemens LMT retrofit which utilises a Sion vacuum device. This requires minimal maintenance, increasing switching durability and has no oil or SF6 gas. A successful condition assessment was carried out at Abronhill Primary SS, Lanarkshire, which included an inspection of the fixed portion, civils and heating. Six moving portions have now been installed. It should be noted that one Reyrolle Pacific CB moving portion retrofit (earlier model) remains in place within this switchboard. The Reyrolle LMT Retrofit brochure and Inspection, Operating and Maintenance manual contains more detailed information and can be found on the SPEN Intranet under Manufacturers Manuals.
