Directlink Joint Venture

Directlink
Revenue Proposal

Attachment 8.1

Capital expenditure
business cases

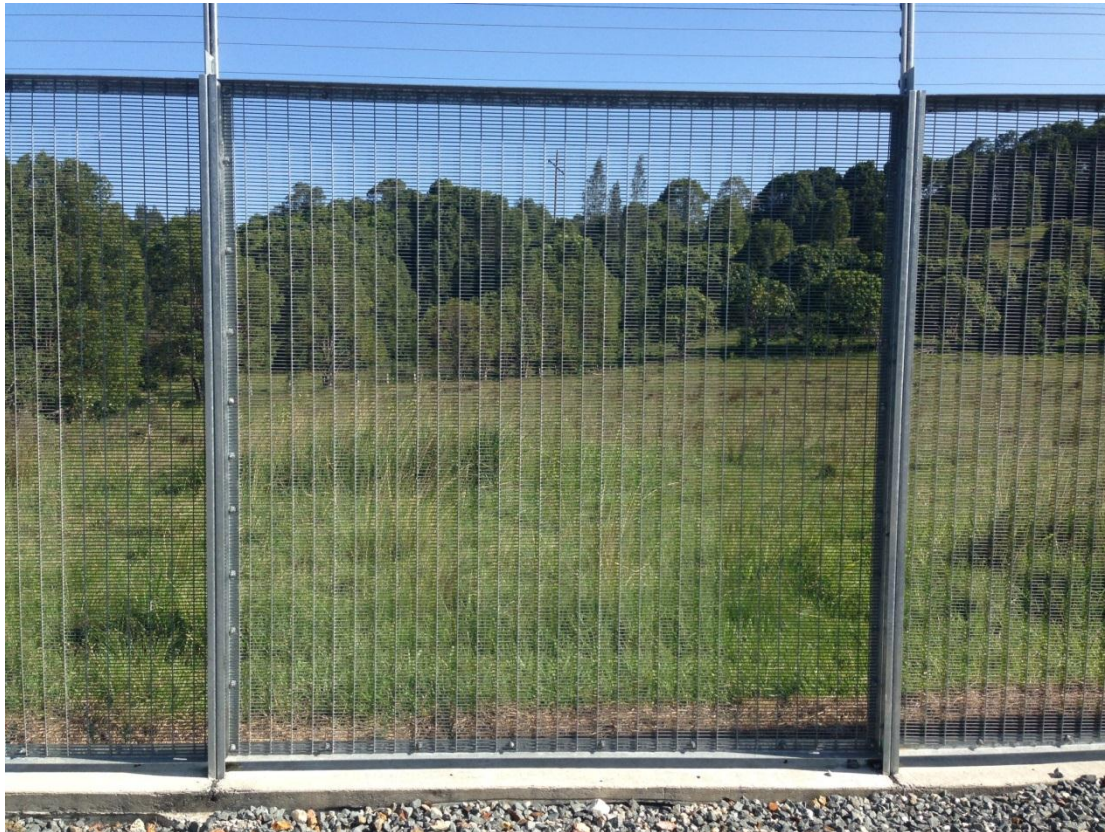
The above photo from our Bungalora site is an example of the type of “Secure Max” installation proposed, including electrification of the top wires.

Advice has been sought from a number of fencing providers who provide similar solutions to other utilities to prepare the scope and budget for this project. All have recommended similar solutions using “Securemax”, to meet the specific requirements for a high voltage site. This project will be undertaken via competitive tender when rolled out and will ensure the most effective solution will be offered to deliver a compliant system.

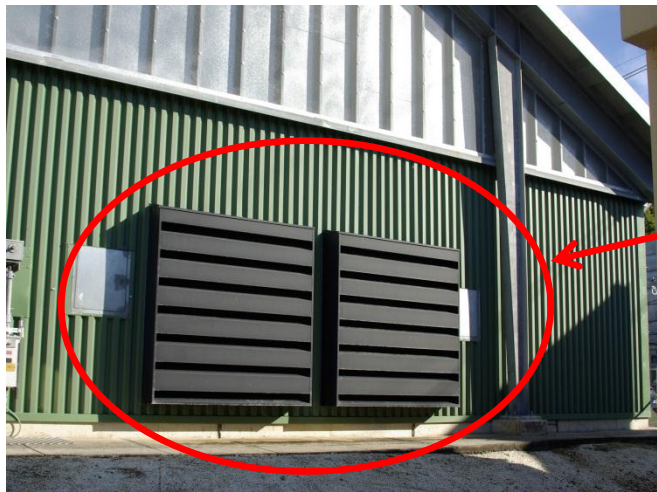
The illustrations below highlight the current state of the corrosion in the sound dampers.

External View of building sound dampers

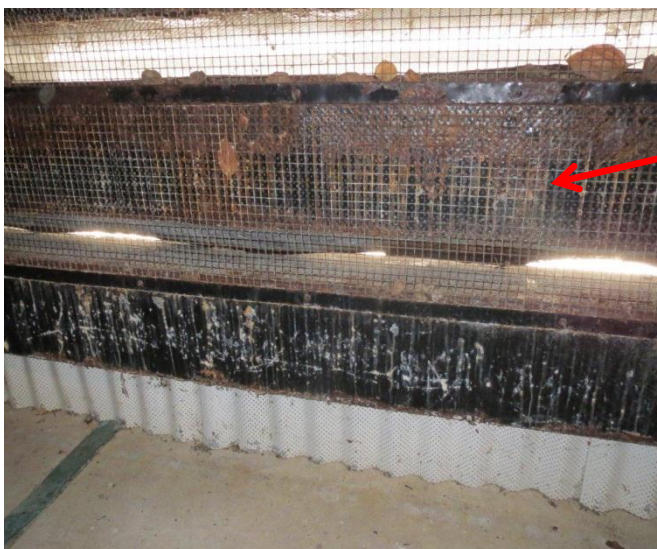
Internal View of corrosion in building

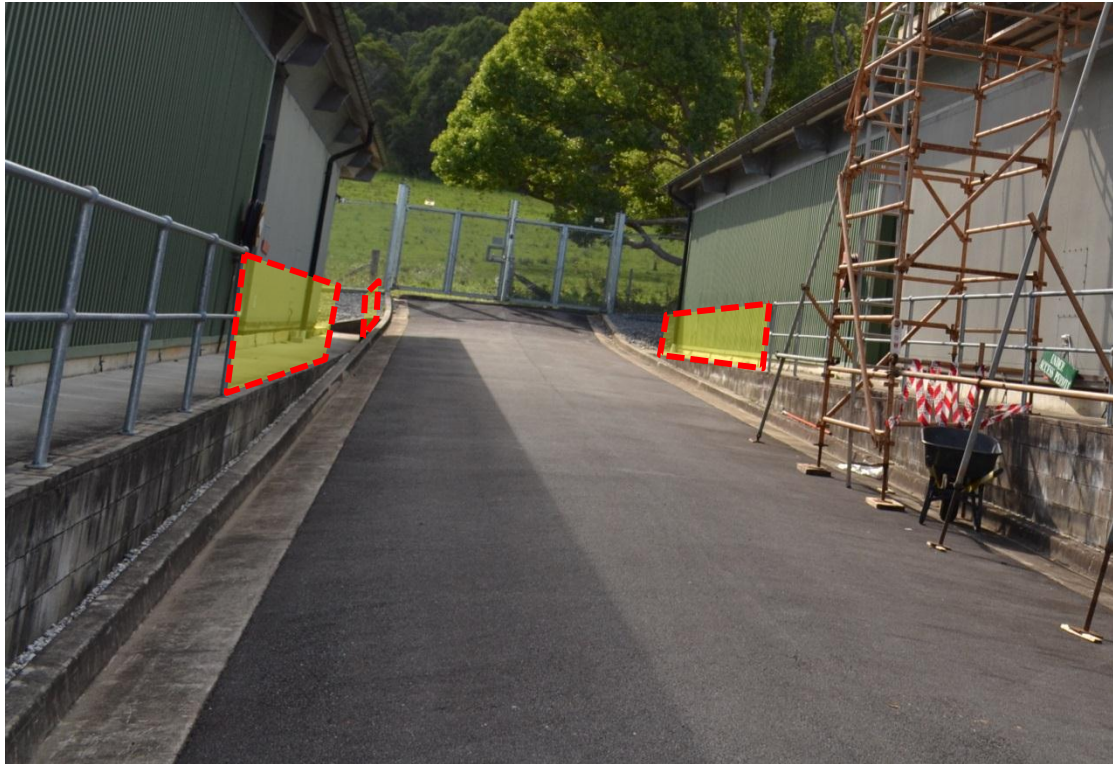
Proposed railings at buildings 2 & 3, Bungalora

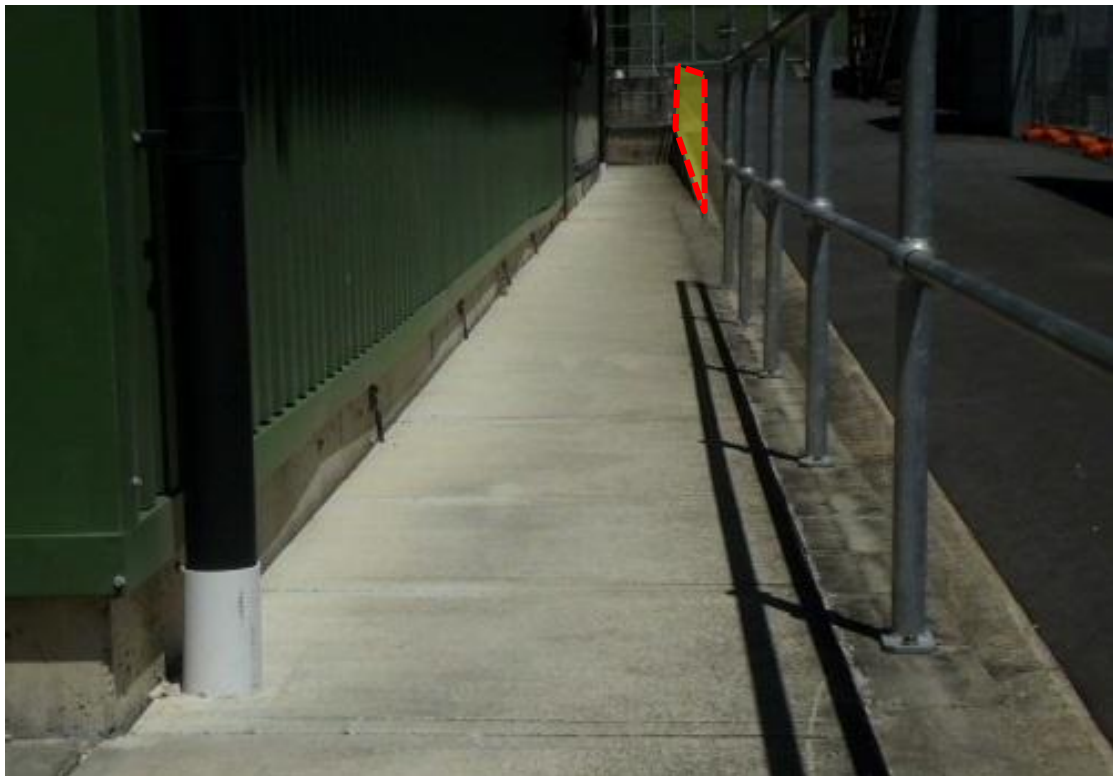
Proposed Railing at building 1, Bungalora

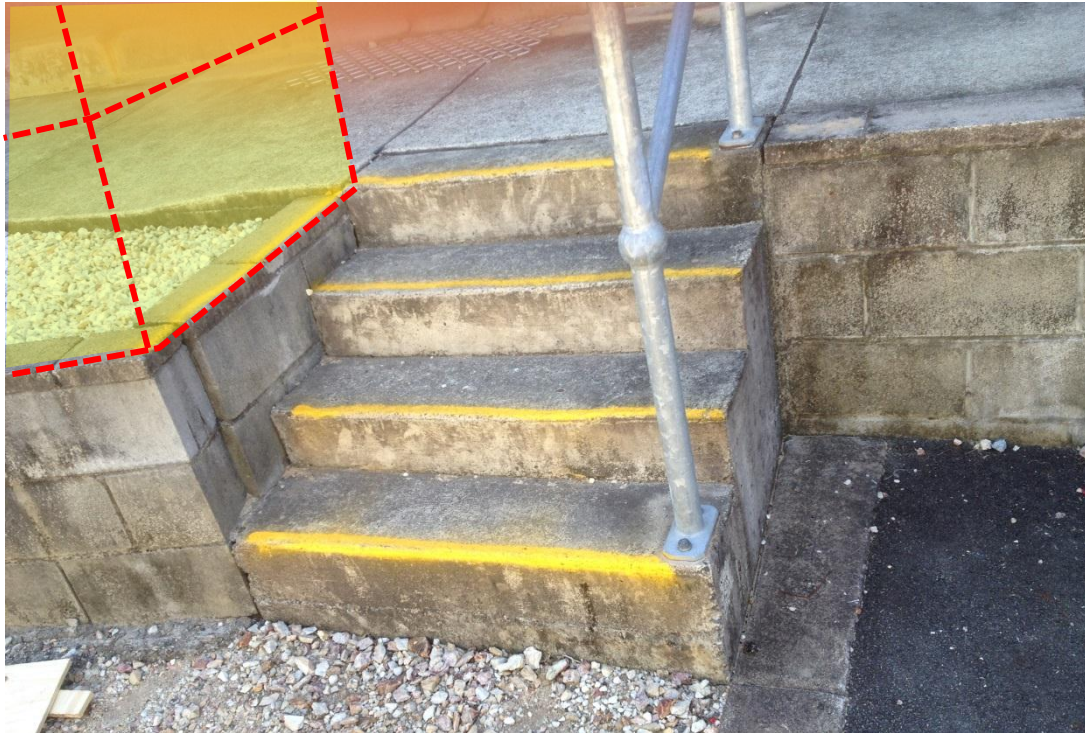
Proposed railings for stairs and terrace, off building 1, Bungalora

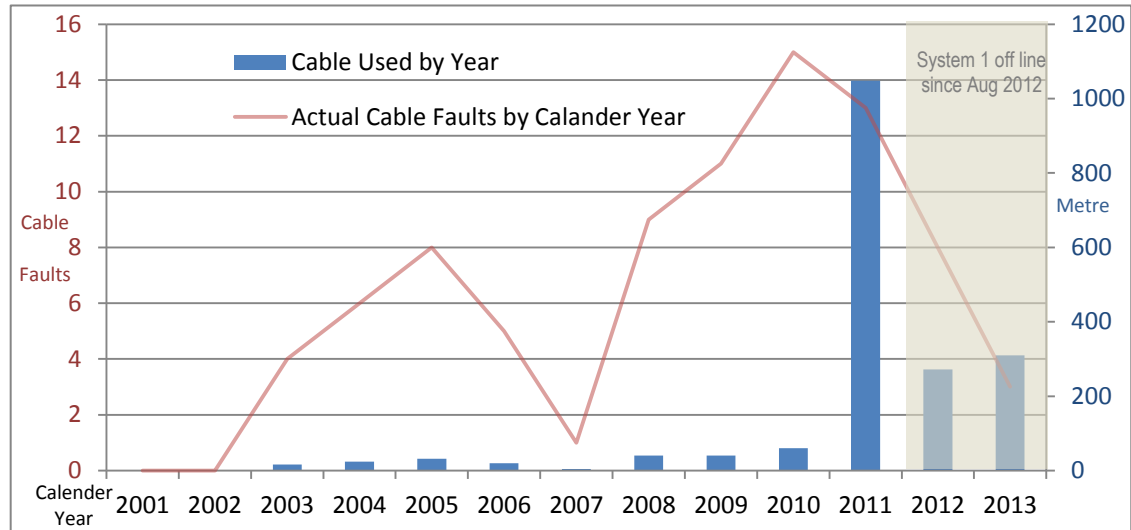
The graph below demonstrates historic usage (replacement) of cable in maintaining the Directlink assets. Since 2011, longer sections of cable have been replaced due to the high number of faults which were occurring in close proximity. The expanded repair strategy has delivered positive results and has thus formed the basis of the program to manage this asset during the next regulatory period.

- It is envisaged that an average of 12 faults (empirical evidence, see chart below) per year will require ~250 m cable per event (3 km per annum). This program will therefore see less than 1% of Directlink's cable being replaced per year.
- Recent use of this above repair strategy has seen a distinct improvement in the reoccurrence of faults in close proximity (refer to the chart below for supporting historical data).

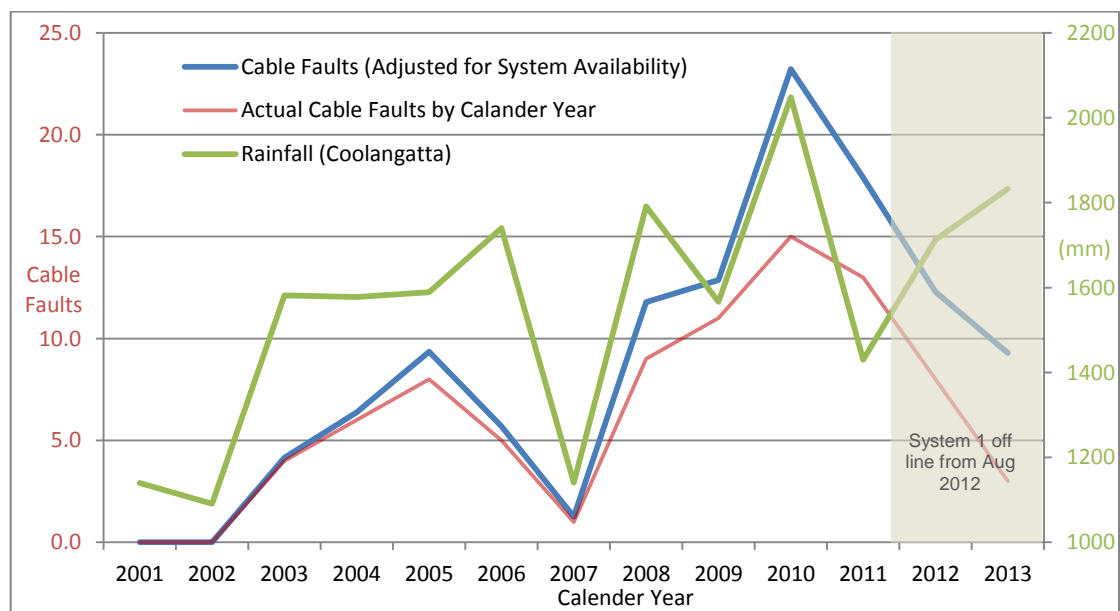
The graph below demonstrates historic cable repair activity as an increasing trend. A potential correlation to yearly rainfall levels has been identified to possibly explain the fluctuating cable fault occurrences over time:
