Directlink Revenue Proposal

Bottom Up Cost Study

Operational Expenditure Forecast

Directlink (High Voltage DC Link)

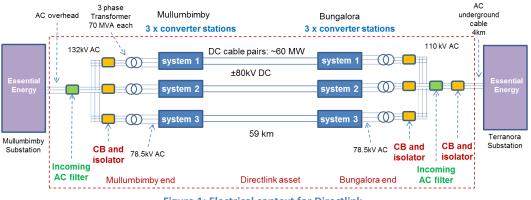
The starting point for the examination of the Directlink technology was the Single Line Diagram (schematic of the converter stations). The Single Line Diagram shows the equipment used in the Directlink HVDC link (Appendix B lists identified components). Before examining the Single Line Diagram, an understanding of the electrical context of Directlink had to be formed. This context is shown in the high level schematic diagram in Figure 1:

At the highest level, Directlink consists of three separate connections between Essential Energy's Mullumbimby and Terranora substations. Each DC connection requires a pair of converter stations (a total of six converter stations). Directlink uses three DC cable pairs to connect the AC substations. The key point in this figure is the large number of components used in the conversion from AC to DC and back to AC in the Directlink asset.

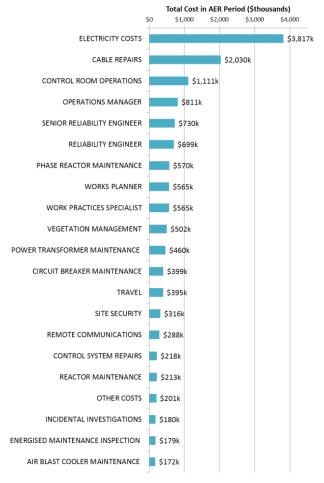
Figure 3: Plotting the O&M Direct Cost categories shown in Table 2

The first item in Figure 2 is Electricity Costs. Electricity Costs at the two sites contributes 23% of total O&M Direct Cost. The top twenty categories account for 87% of the total O&M Direct Cost. The following figure shows the categories with the most significant contribution to the O&M Direct Cost (figures are in \$thousands).

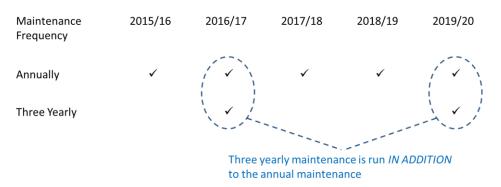
For example a component with 1 year and 3 year maintenance requirements is shown in the following figure:

Figure 7 provides an example of a component for which both annual (1 yearly) and 3 yearly maintenance is required. The figure shows that every 3rd year both the 1 year and 3 year maintenance schedules are undertaken. The O&M Model includes both maintenance requirements to be undertaken in the specified year, as this is specified in the OEM maintenance instructions.

Many components specify multiple maintenance periods, for example annual maintenance and 3 yearly maintenance. When both the more frequent and less frequent maintenance tasks fall in the same year it is important to note that Directlink maintenance procedures are written so that the less frequent maintenance procedure is required to be undertaken *in addition* to the more frequent maintenance. This maintenance strategy follows the system designer's maintenance instructions.

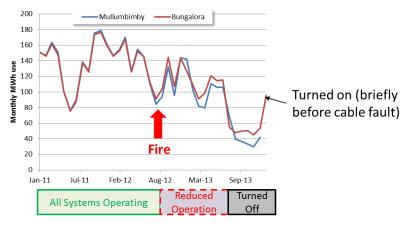
Figure 8: Monthly Electricity Use at each site (MWh)

To obtain typical electricity costs for Directlink it is necessary to examine historical electricity use. This analysis is restricted to the period before the Mullumbimby converter fire when Directlink was fully operational. Figure 8 shows electricity use at both sites.

Three areas are highlighted in Figure 8. Before the Mullumbimby fire the figure notes "All Systems Operating". After the fire energy use decreases, this is labelled "Reduced Operations". In August 2013 Directlink was "Turned Off" with a significant drop in electricity use at both sites.

Even when the HVDC link is not being operated electricity use at the two sites remains relatively high (in the order of 15% to 20%) due to continuous operation of numerous dehumidifiers (air conditioners), fans and pumps (used to keep components cool), heaters (to heat components), control systems and associated air-conditioners.

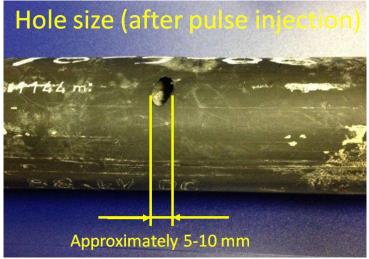
Figure 11: Hole that must be located in the cable to find the fault location

Once the test equipment is disconnected a visual inspection of the cable is required to find the actual location of the fault in the cable. The following figure shows the small size of the hole in the cable. This hole is created by the test equipment to pinpoint the location of the cable fault. The location of the cable fault is only confirmed once this hole has been located (for underground faults this will require excavation when the cable will be covered in mud).

The test equipment also provides an indication of the distance to the fault. A field crew is therefore sent to the approximate location but must then walk along the cable route trying to hear the precise location of the fault. Sometimes the fault is found quite quickly and other times the search is more involved and may even require digging pilot holes to validate the position. Throughout the manual search the test equipment must continue to inject pulses regularly into the cable.

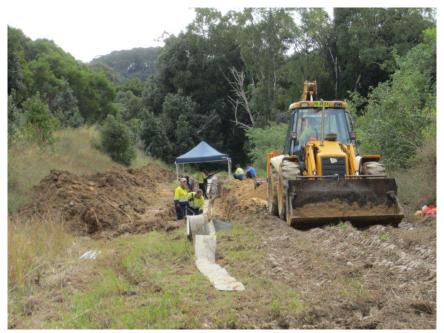
Figure 13: Photograph taken during an underground cable repair

Roughly 50% of the cable is underground with slightly more faults occurring in underground sections.

NKT are the specialist contractors who install the cable joints. Their services are in high demand and the checklist requires the responsible person to "lock down a date". For faults located in the underground sections of cable this provides time for heavy earth moving equipment to be brought to the site and careful excavation to expose the cable.

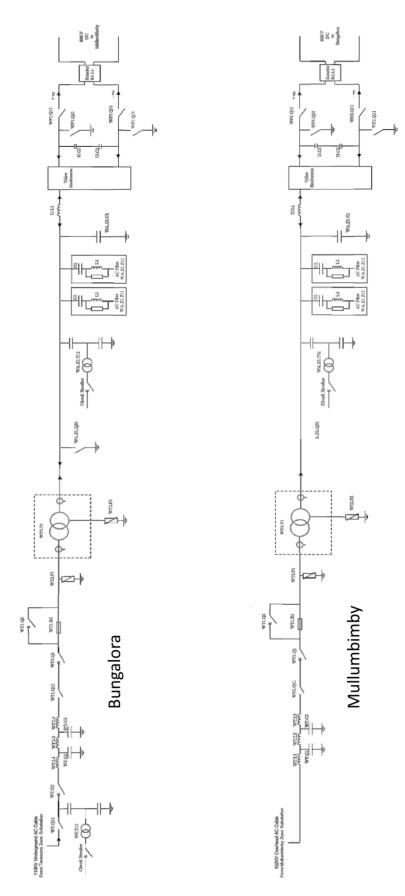
Figure 17: The Single Line Diagram of the two Directlink converter stations (showing only one system)

Note that approach still underestimates the actual number of components requiring maintenance. For example while this analysis shows that there are 36 "IGBT Valves", each Valve comprises 8 stacks each containing 148 individual IGBTs. In the Directlink system there are 5328 IGBTs each of which must be individually checked and tested.

Single Line Diagram provided by the OEM

In the bottom up study it was important to start with the individual components that had to be serviced under each category. Appendix B of this report analyses the Single Line Diagram of the Directlink HVDC link to reveal the number of components of each type. It is noted that the line diagram includes 750 individual components. Further several of these components actually comprise banks of individual devices, for example the oil filled capacitors, air blast coolers and IGBT valves. The number of individual devices in the Directlink HVDC system numbers well over 5000.

A Single Line Diagram for both sites is shown in Figure 17. This diagram is included to show the one difference between the two sites.

The following sections of this Appendix use the Single Line Diagram to count the number of each component.

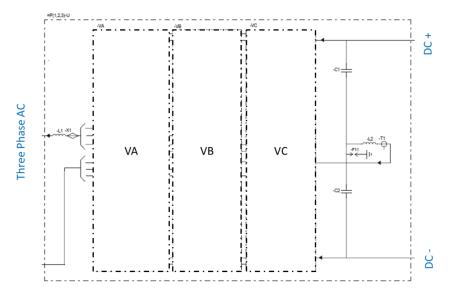
U (Converter section)

Multiplier (for three phase AC components):

$$\begin{bmatrix} S1\\S2 \end{bmatrix} \cdot \begin{bmatrix} P1\\P2\\P3 \end{bmatrix} \cdot U \cdot XX \cdot \begin{bmatrix} LA\\LB\\LC \end{bmatrix} = 18$$

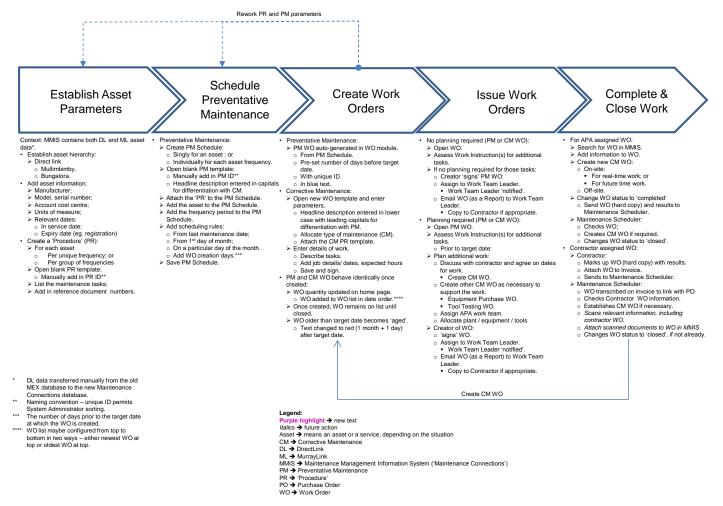
Diagram E1 – MMIS process map

Maintenance Management Information System

- The Directlink maintenance cycle² (Appendix D);
- The Maintenance Management Information System and how it was used (Appendix E).
- The Condition Monitoring process and how it was deployed (Appendix F).

- increased numbers of corrective maintenance work orders were being generated compared to preventative maintenance work orders due to the excessive fault conditions;
- maintenance results associated with completed work orders were not being electronically archived.
- photographic information to provide future evidence of the condition of an asset were not being collected.
