ElectraNet Transmission Network Revised Revenue Proposal

Appendix Q - Asset Refurbishment Plan for the
Period 2013-2018

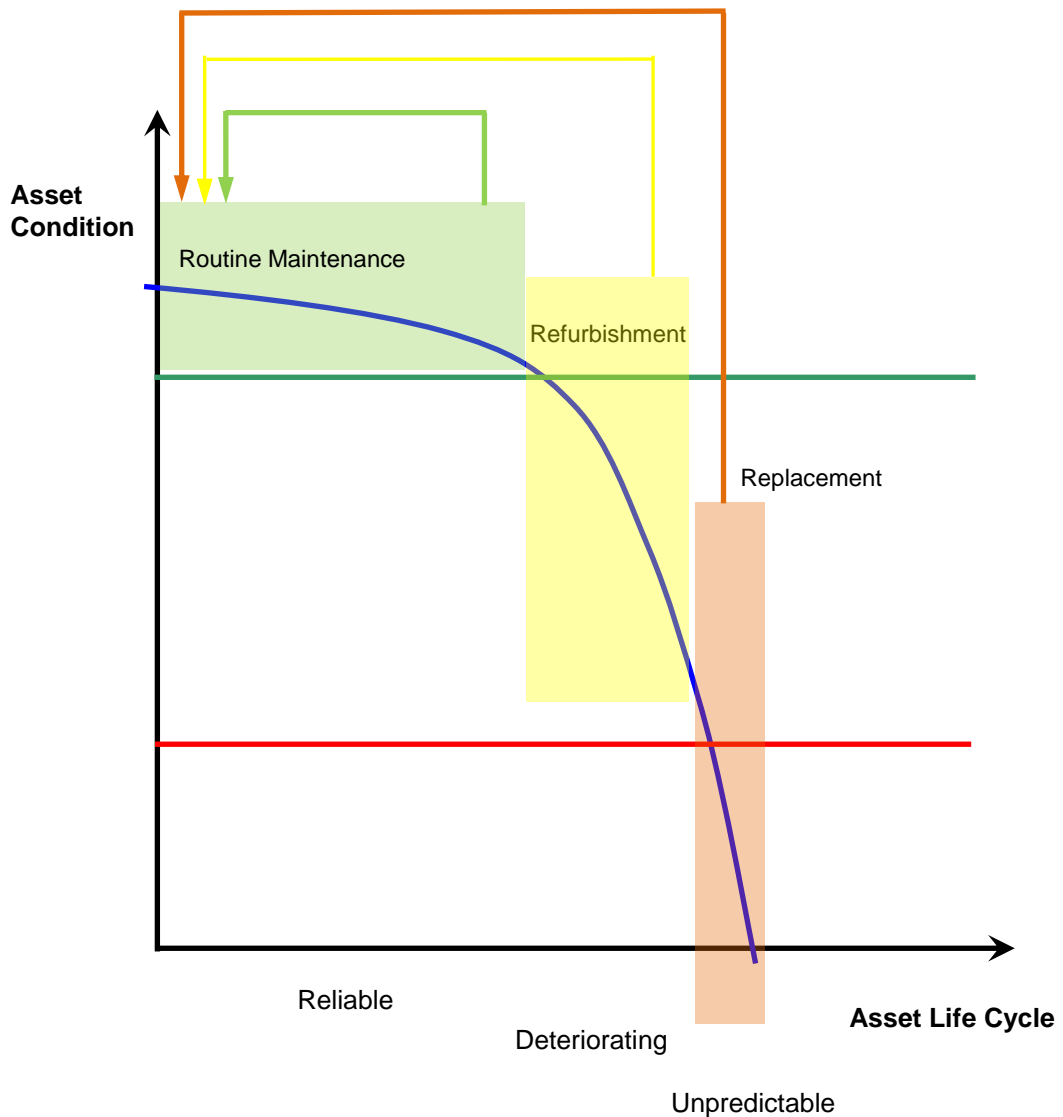
Figure 4-1 Asset Lifecycle Maintenance and Replacement

As an asset moves through its lifecycle the relative effectiveness of maintenance on the asset changes. Therefore, maintenance decisions change in response to asset condition changes as represented in Figure 4-1 Asset Lifecycle Maintenance and Replacement below.

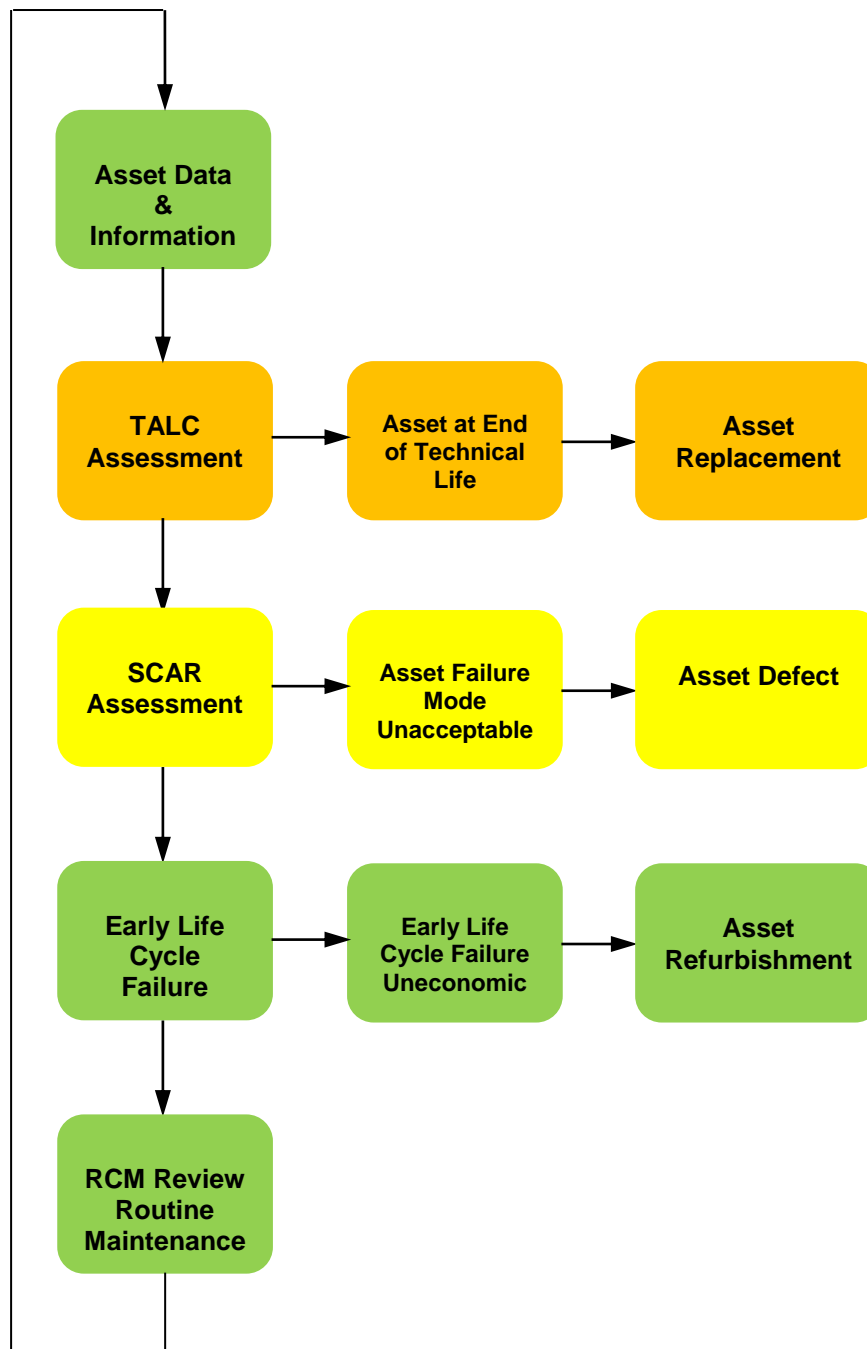
Figure 4-2 Asset Refurbishment - Decision Steps

Development of the Asset Refurbishment Plan is based on identifying those assets that have not yet reached the end of technical and economic life but exhibit active failure modes that if allowed to continue to functional failure will result in unacceptable safety, environmental, operational or asset management consequences. The decision steps are set out below.

Features of the decision framework are:

- Assets at end of technical life are not considered for refurbishment (as end of technical life indicates refurbishment is no longer economic)
- Only assets that have active failure modes with unacceptable consequences of failure are managed as defects
- Where an asset has an active failure mode that will result in early life cycle failure, it is refurbished when economic to do so

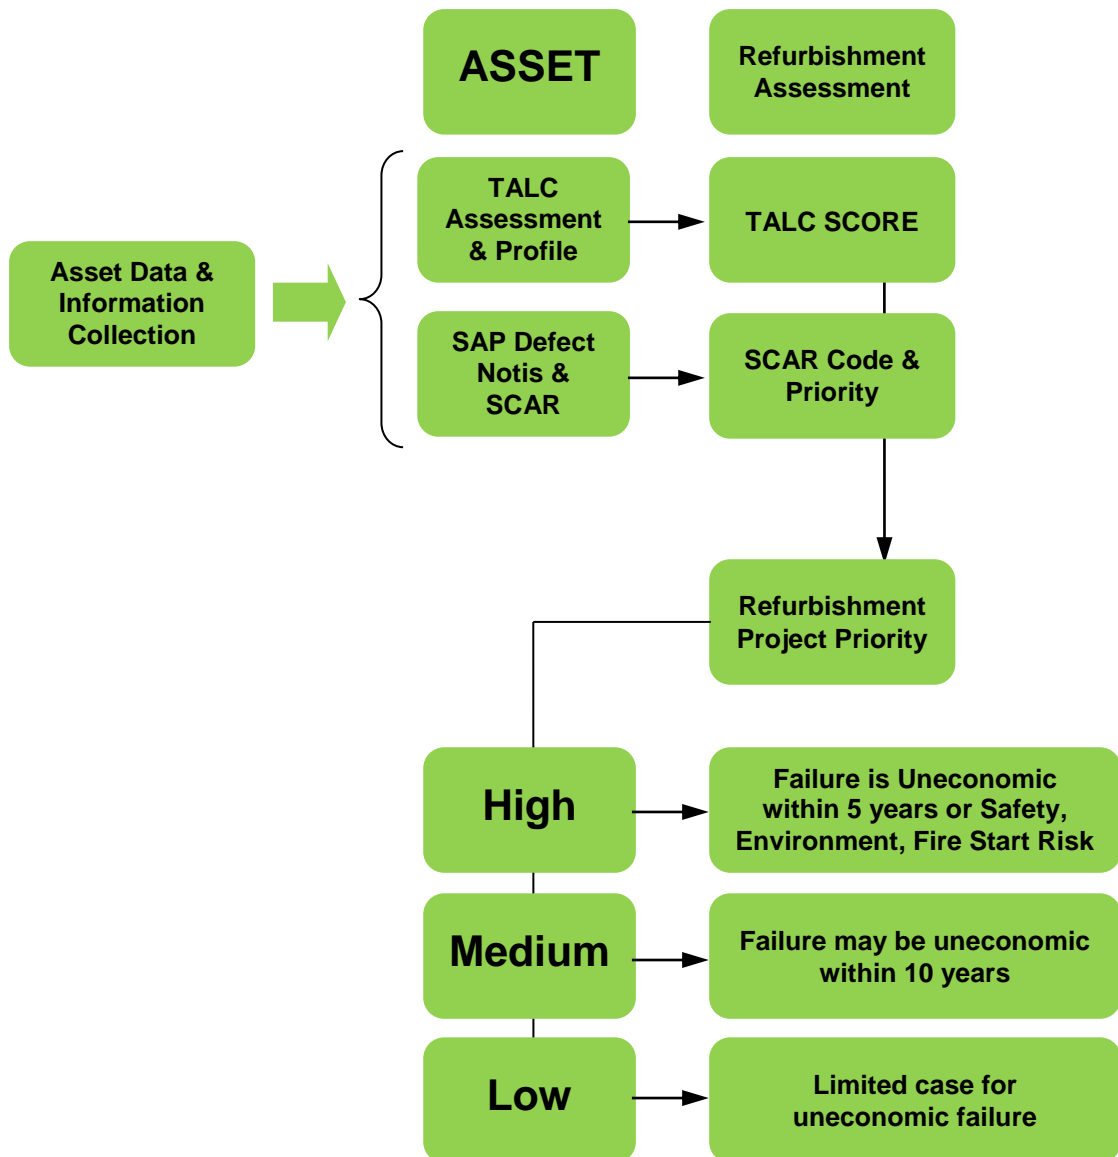
Figure 4-3 Rating Process Refurbishment Priority

Only projects that are likely to result in an uneconomic outcome (or may relate to the need to address safety, environmental or fire start risk) during the next 5 years, if not refurbished, are rated as High Risk. These projects form the basis of the Asset Refurbishment Plan. All projects listed in the plan are subjected to a more detailed assessment in order to confirm final inclusion.

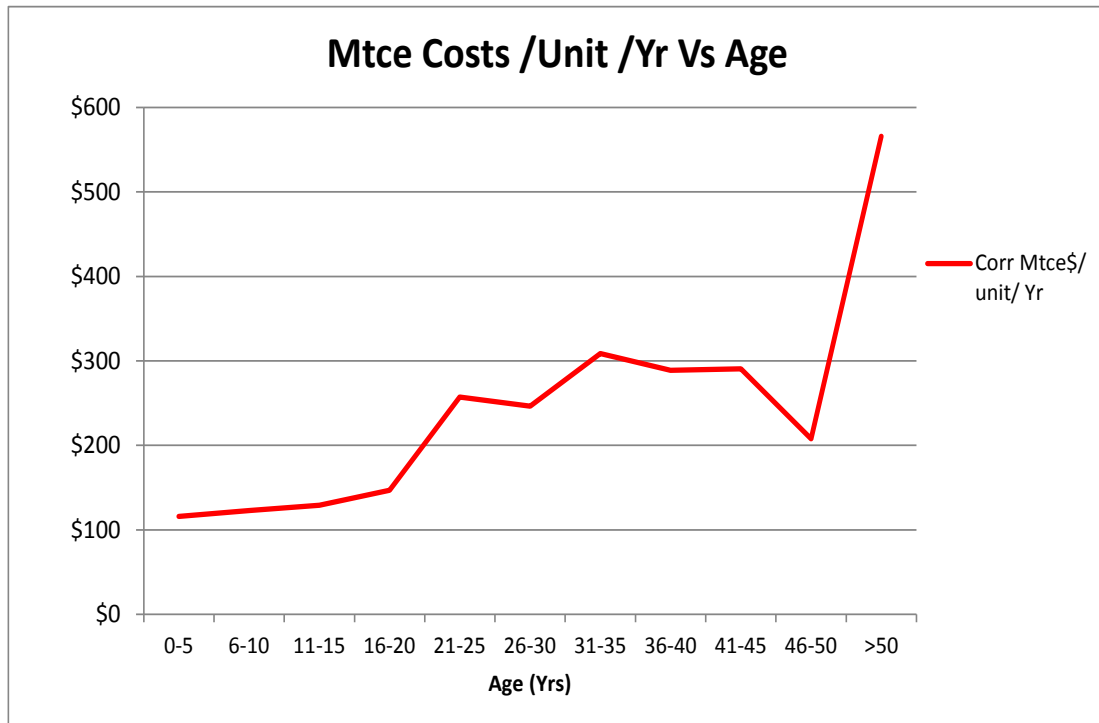
Figure 6-1 Isolator Corrective Maintenance Cost as a function of Age

Item	Risk	Value
Isolator Condition	During the next five years isolator condition deteriorates (operational safety and network reliability) – 60% of defected isolators (220 units) require change out in each of the next two regulatory periods.	Change-out cost is based on \$70k per unit
Isolator corrective maintenance cost	On average the additional corrective maintenance cost per unit is \$200/year/unit (see isolator age/cost profile below) – over a five year period this equals an additional \$1k/unit/period	Additional corrective maintenance cost of \$1k/unit/period
Isolator Operability	Due to additional time taken to operate network, incremental increases in outage times increase lost load	VOLL = \$44,300 MWh, load lost = 5MW for 5 events/year of 1 hour each
Risk (NPV 20 Years)	Replace Later	\$16,540k
	Refurbish	\$10,452k
