# SUBSTATION PROTECTION RELAY REFURBISHMENT

Program PS008 Business Case 2017/18 – 2018/19

Prepared by Strategy and Network Planning

April 2017

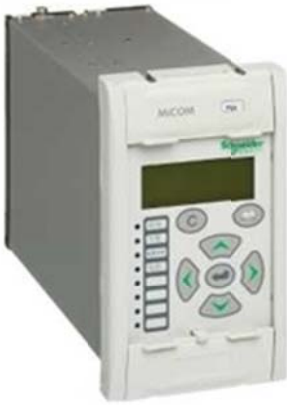
ALSTOM P121

Known issues			
Failure mode	Failure rate	Comments	
Non-operation (Alarmed)	Extreme	8.3%	
Non-operation (Non-alarmed)	High	3.3%	
Applications			
Application	Risk level	Qty	Comments
Single Aux Transformer OC	Medium-Low	2	Like for like replacement with P123
Duplicate 22kV OC/EF	Medium-Low	8	All at Parklea ZS – six P121 relays have failed at Parklea ZS over the last three years. Like for like replacement with P123 at next maintenance (bring maintenance forward by 18 months if required)
Single 33/11kV TX LV OC/EF	Medium-Low	1	Like for like replacement with P123
33/11kV TX HV OC/EF with SR745	Medium-Low	1	Replace in this program with a P123, align with the replacement of the SR745
Total		12

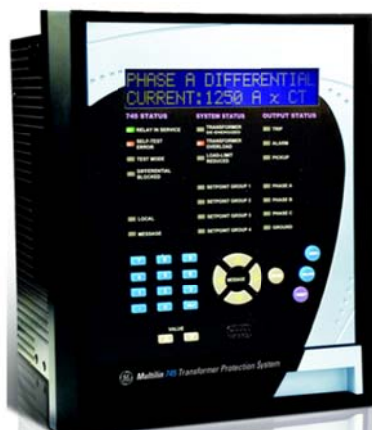
### GE SR745

Failure mode	Failure rate	Comments
Non-operation (Alarmed)	Medium	1.98% - Relay found failed at maintenance. One example of transformer fault failed to clear with differential.
Non-operation (Non-alarmed)	Low	0.4% - Inner Harbour, internal transformer fault, differential failed to operate leading to delayed trip of transformer.
Mal-operation	Medium	1.58% - Phantom current issues, input sensitivity issues, Inrush restraint, initial application included all instantaneous devices trip through the relay. Lithgow loss of load. Springhill malop (triggered CB fail).

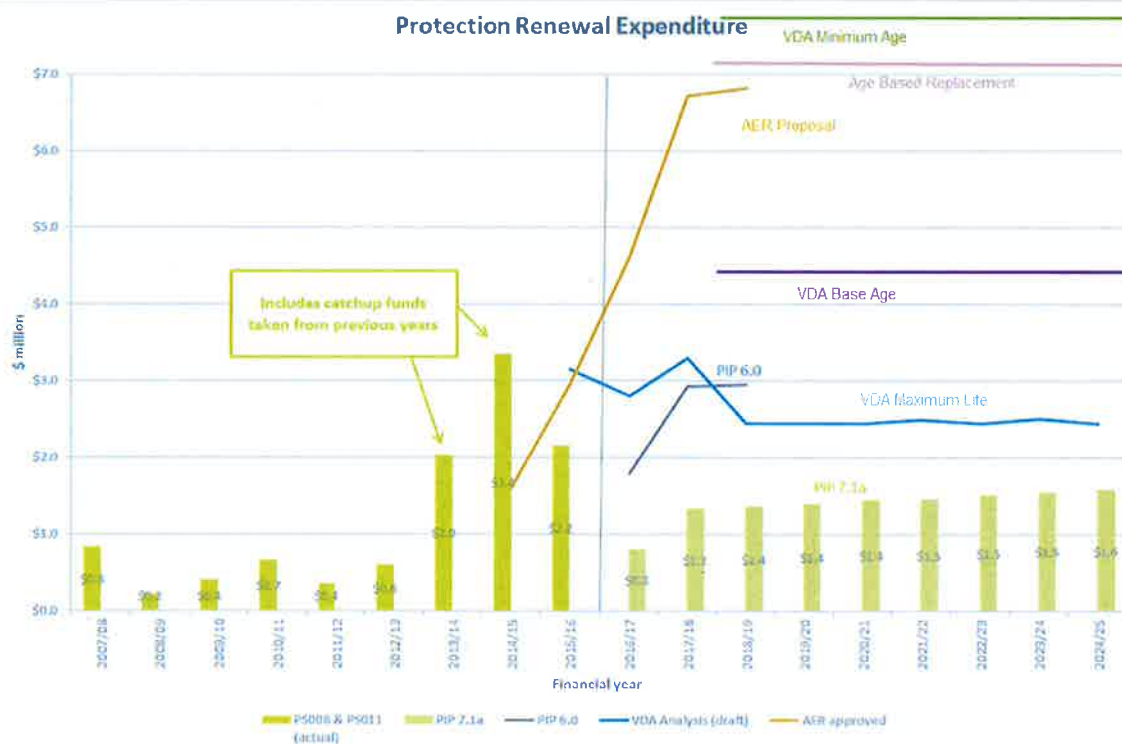
Asset Strategy & Planning conducted a projection for protection relay replacement. This analysis estimated the following average planned replacement levels per annum over a 10 year period, which is dependent on relay replacement age by type (Electromechanical/Electronic /Microprocessor). The cost per relay replaced was estimated to be \$25k. This VDA Base Age is the age base profiling tool for forecasting program expenditure.

Replacement Criteria	Replacement Scenarios (10 year average per annum)		
	Scenario 1 (Minimum Age) 30/20/10 years	Scenario 2 (Base Age) 45/25/20 years	Scenario 3 (Maximum Age) 50/30/25 years
Relays replaced (p.a.)	621	179	101
Cost (p.a.)	\$15.5 million	\$4.5 million	\$2.5 million
Total Cost	\$155 million	\$45 million	\$25 million

The additional risk based analysis requires an additional \$14.3m investment over a 10-year period, over the current PIP v7.1a investment levels, taking the total funding requirement to \$28.3m over the 10-year period. This falls between the VDA Base and maximum age investment profiles.
