# APPENDIX 4.4

## Unmodelled repex: Business cases for “SCADA” repex

## Protection Relay Replacement Program

## Protection Relay Replacement Program 2015/16 - 2019/20

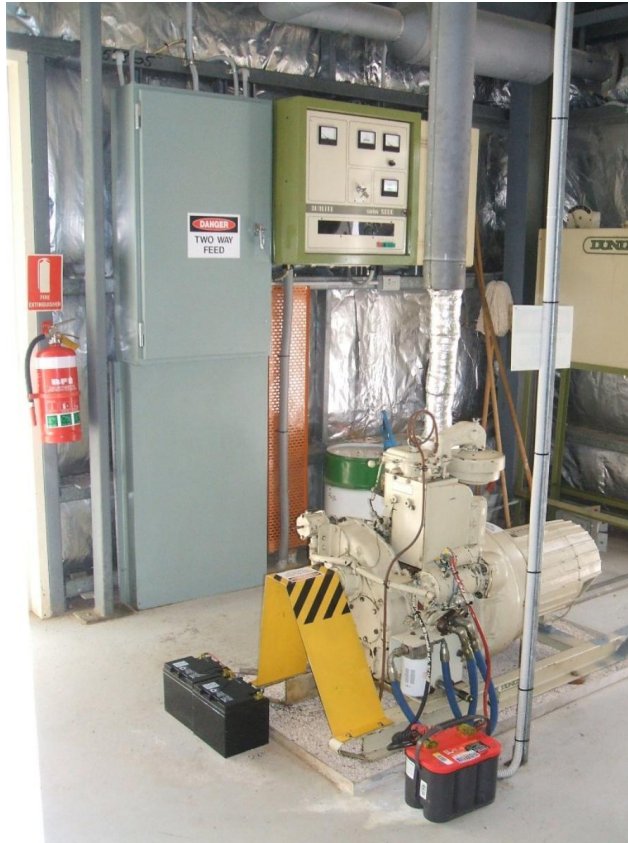
The diesel generators installed at the Energex radio sites provide backup power in the event of a power failure. In the case of RRDAG a solar site, the diesel generator is supplemental to the solar power supply. In the event of a generator failure and assuming an average amount of cloudy days, the site batteries will eventually discharge, causing a total loss of all services through the site.

The generator at RRDAG currently has the highest runtime of all radio site generators. This generator was installed in 1997, and has had a number of reliability issues in recent years. The generator at Mt Boulder was installed in 2001. It is proposed to replace both of these units in the coming regulatory period.

**Figure 1: Typical remote site diesel generator**

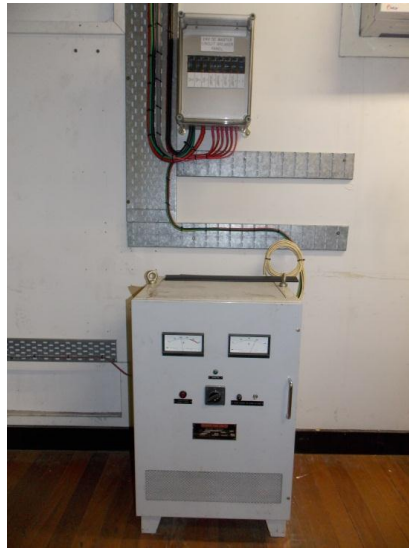
Two depots have been identified as having battery chargers at end of life (Southport Depot and Raceview Depot). Both sites have non-redundant power supply units and have multiple protection and other services operating through them that depend on the reliable performance of the site power supply. Both of the chargers were manufactured in the 1980's. There are no replaceable parts available for this charger in the event of a failure, and Energex does not hold any spares. Southport charger will be removed as part of a project to relocate the communications equipment from this depot, thus only a single battery charger (Raceview Depot) replacement is necessary for the period.

**Figure 2: Raceview Depot battery charger  
– estimated manufacture date 1989**

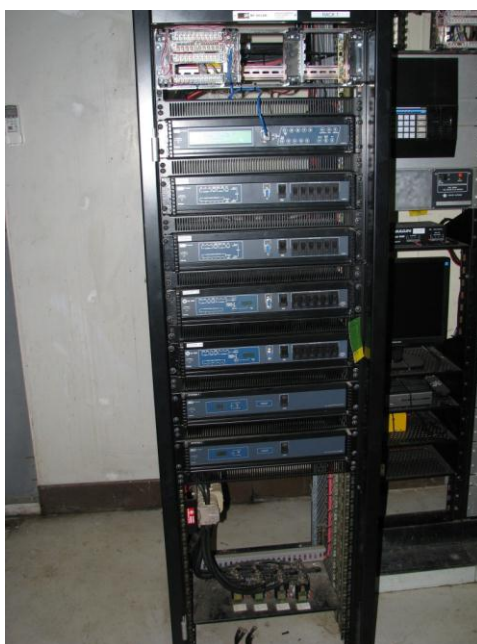
The solar regulators at D'Aguilar Range repeater were installed in April 1998 and have had a number of faults in recent years. These regulators will require replacement during the 2015/20 regulatory period.

**Figure 3: Solar Regulators – D'Aguilar Range Repeater**

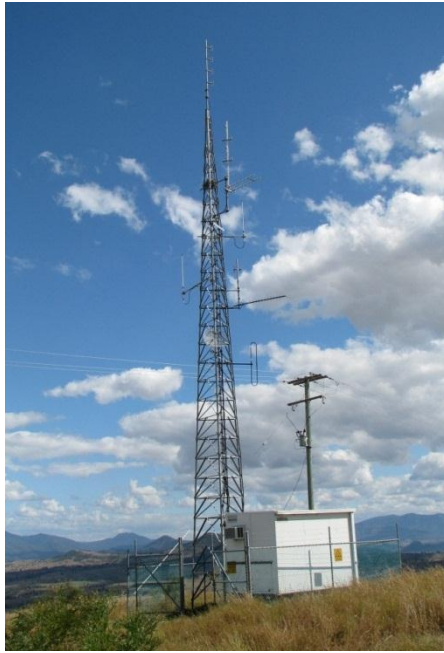
All Energex radio communications towers are inspected at 6 monthly intervals as part of the radio site maintenance schedule. Any minor defects are rectified before they become a major issue. A structural analysis on the tower has however highlighted an issue where the existing equipment has resulted in overloading of the tower. Remedial work such as upgrading footings and reinforcing is required to rectify the problem.

**Figure 4: Typical Telecommunications Radio Tower**

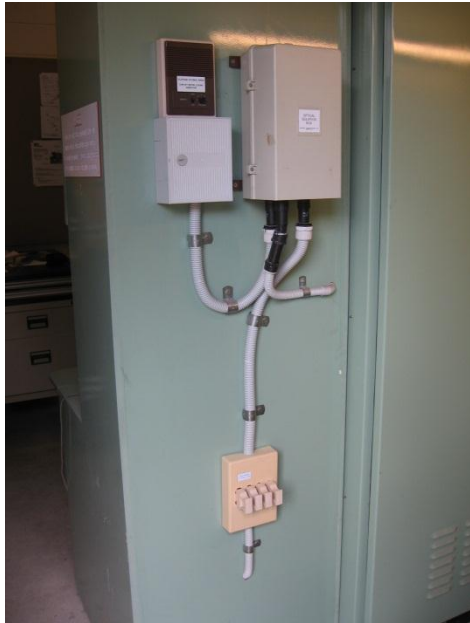
**Figure 5: Non- Compliant isolation – Close Proximity to earthed metalwork (adjacent cabinet)**

Figure 5 and Figure 6 show examples of telephone line isolation issues.

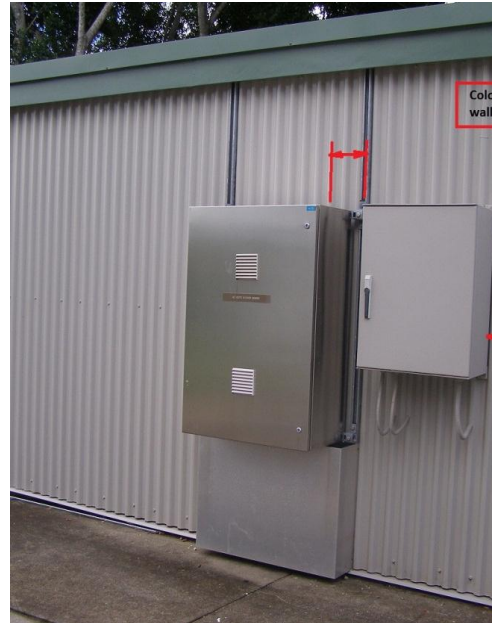
**Figure 6: Isolation cabinet mounted on metal sheeting, and close to GPO and other equipment**

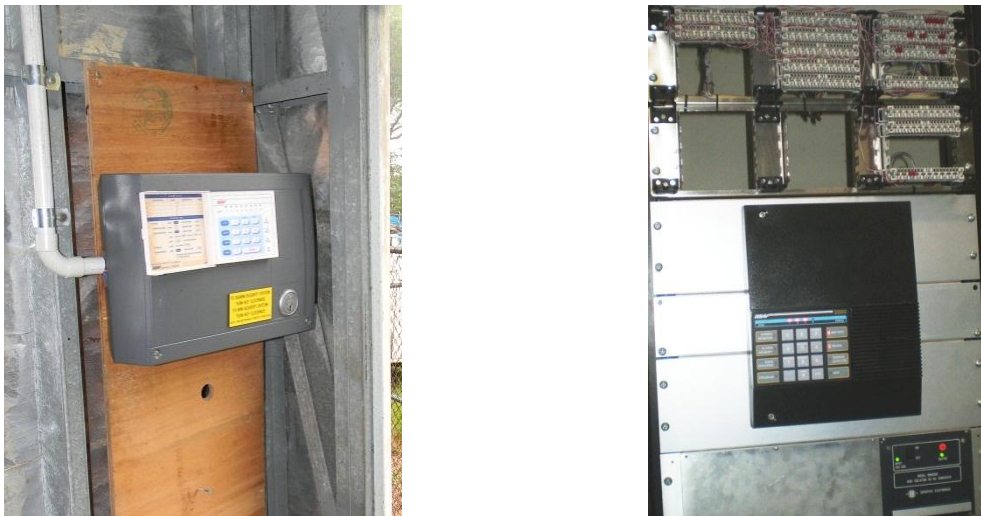
The security alarms installed on these sites were installed in the mid 1980's and are based on electronic components and key based systems. The lack of availability of replacement locks utilised at the sites has prompted a review of current security arrangements.

**Figure 7: Typical remote site security panels**

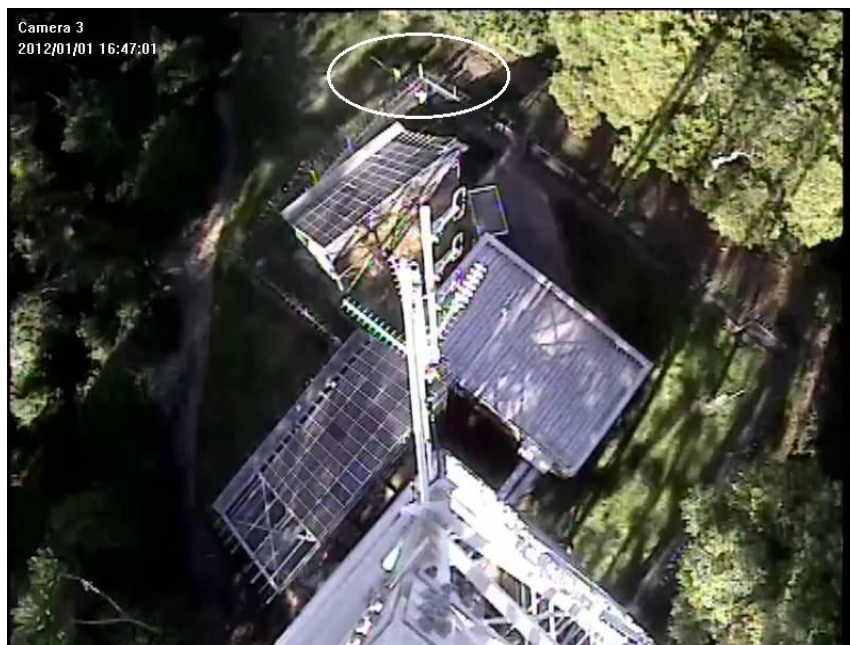
**Figure 8: Footage from RR DAG tower with offenders circled**

An example of a site security breach occurred at the D'Aguilar Range Repeater on 1 January 2012. The radio site RRDAG is located in a remote area within the D'Aguilar Range National Park. The site is off the main track, approximately 100m, and is not easily visible to passers-by. There is significant infrastructure that is attractive to would-be thieves. This site has had a number of security breaches over its operational lifetime. Approximately 6 years ago, a secondary gate was installed to prevent unauthorised access to the compound perimeter by vehicles. This has reduced the number of incidents; however incidents continue to occur, as described below

In this case, no significant damage was done, except to the fence. The offenders were climbing on structures at greater than a safe height, with no fall arrest or safety equipment. The offenders could have been injured or worse. No critical infrastructure was damaged, however the offenders had ample opportunity to do this. No alerts were raised from the existing security system, and our staff only became aware of the incident 5 days later. The existing system had no integration with the cameras, and therefore no proximity sensing capability was available to generate alarms. The alarming capabilities from the existing system were not performing reliably enough to generate accurate alerts in a reasonable timeframe.
