Preliminary Business Case Rocklea Training Facility

Executive Summary

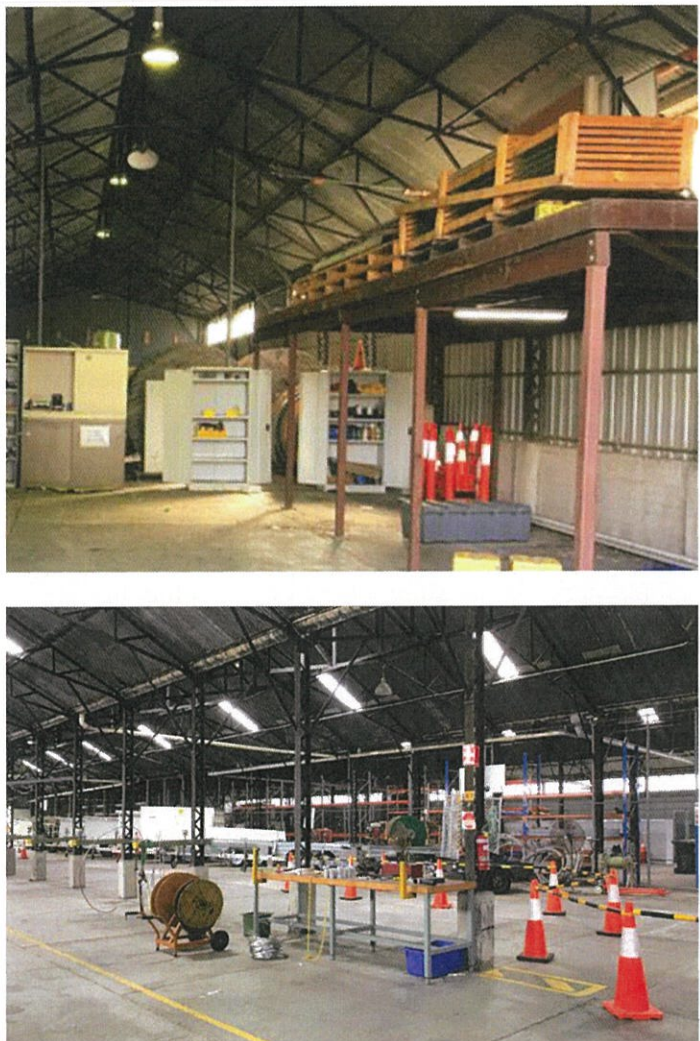
Figure 1: Aged workshop structures

The two large warehouse buildings (B2 and B3) were originally constructed by City Electric Light Company in 1952 for depot purposes and as such have poor lighting and a lack of natural lighting, as well as poor ventilation which is not suitable for a practical training environment.

Most of the buildings at the Rocklea Training Facility are heavily aged (Appendix C), in a poor state of repair and at or nearing end-of-life. This particularly includes the two large warehouses (B2, B3), which in 2020, will be 68 years old and the classroom building block B7, which will be 49 years old. Buildings B4 and B6 will be 56 and 42 years old respectively.

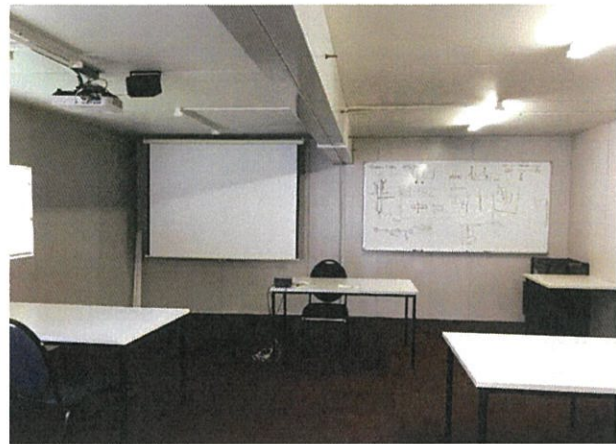
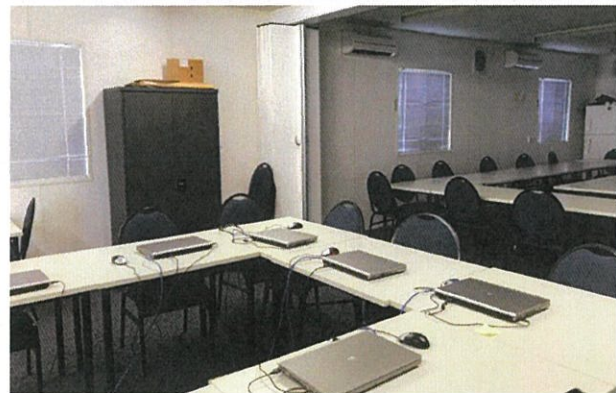
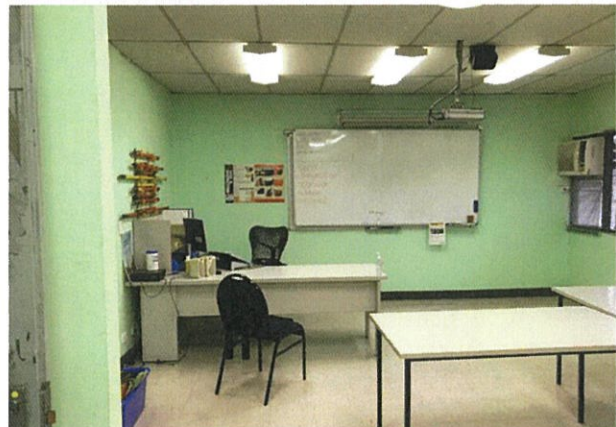
Figure 2: Classroom layout

Numerous demountable buildings have been added to the site in a piecemeal manner to provide necessary classroom facilities to meet the requirements at that point in time. The classrooms and training workshops are functionally ineffective for training purposes, due to their configuration, layout, age and structural design. For example, most buildings are of a demountable style and do not allow for flexible classroom training or optimal participant numbers (i.e. 16 participants).

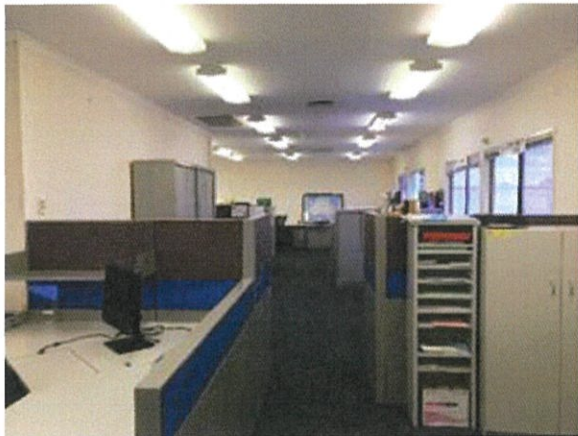
<p>Refer Toowoomba plan over page.</p>
<p>Current fit-for-purpose limitations include:</p> <ul style="list-style-type: none"> Not open plan Narrow walkways with crammed in workstations to fit 1984 building size and shape Multifunctional devices in inappropriate locations Underutilised due to ground floor not meeting Building Code Australia (Volume 2 part 3.8.2) requirements and is thus uninhabitable. For the requirement to be satisfied, the ceiling height must not be less than: in a habitable room excluding a kitchen - 2.4 m' 	<p>Characteristics of a fit-for-purpose facility includes:</p> <ul style="list-style-type: none"> Open floor plan with appropriately sized walkways Ergonomic design with separate utility room Consistent workstation size and spacing.

The administration building (B1) was constructed as a two-storey structure in 1984 designed to meet the 1980's workforce requirements. In 2020, the building will be more than 35 years old with specific limitations including:

- Configured with narrow walkways and crammed workstations to fit the 1984 building size and shape;
- Multifunctional devices are necessarily placed in locations with poor accessibility; and
- The ground floor does not meet Building Code Australia requirements (Volume 2 part 3.8.2), rendering this space uninhabitable.

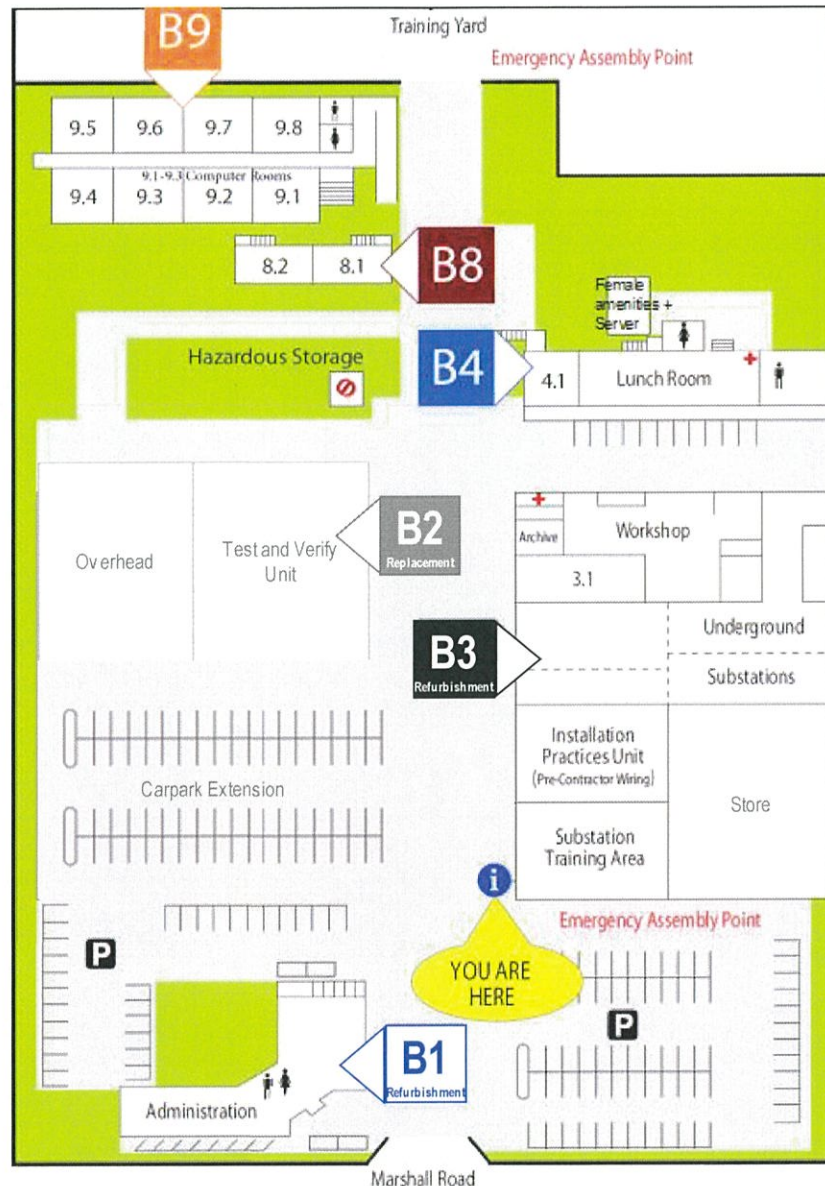
Appendix J. Site Layout – Option C

Depicted below is the indicative layout of Option C. Workshop B3 and Building B1 are refurbished. Workshop B2 is demolished and replaced with a smaller facility to house Overhead Training and the Test & Verify Unit.
