MANAGEMENT PLAN 2011 UNDERGROUND SYSTEM

DOCUMENT NUMBER: NW-#30160588-V5

DATE: 8 MAY 2011

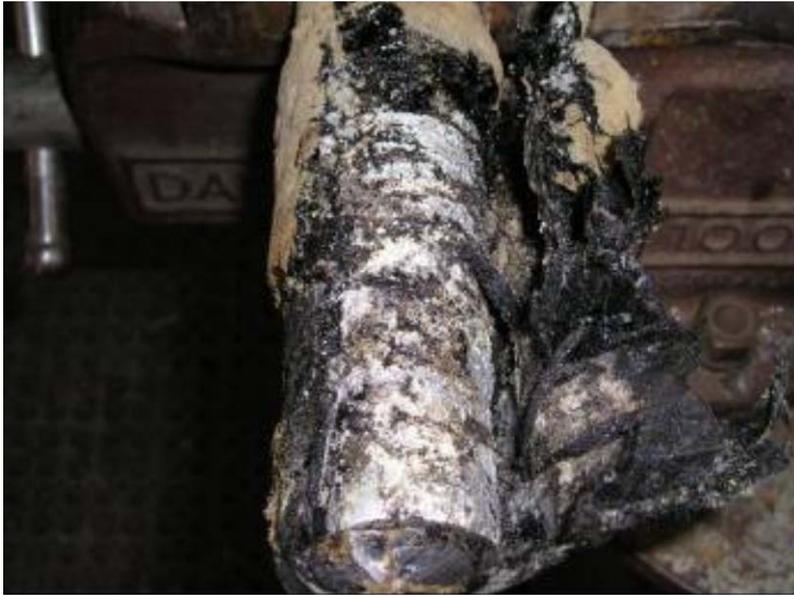
Appendix E Failed CONSAC Cable Pictures

Figure 4: Cable sheath near failed joint

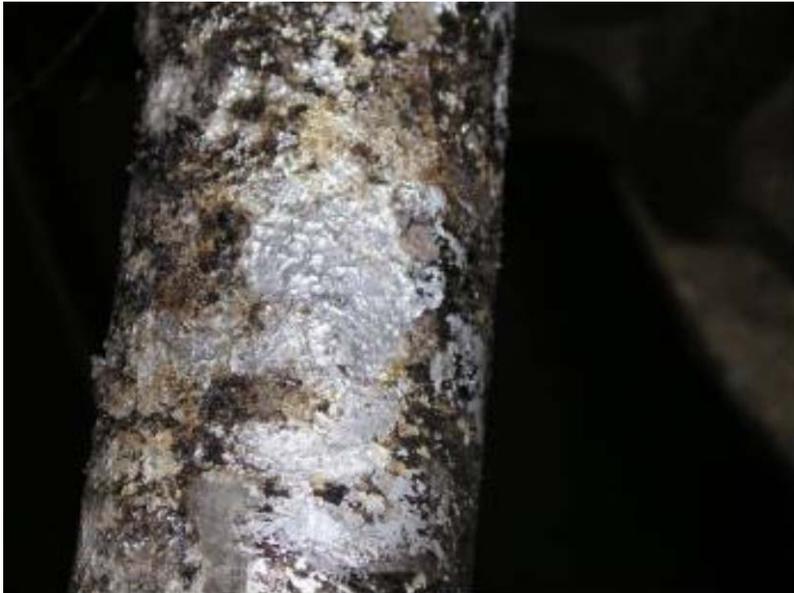
Figure 5: Corrosion under 'Ozokerite' sealing tape
