POWERCOR DETERMINATION
AUSTRALIAN ENERGY REGULATOR
SUBMISSION ON POLE REPLACEMENT NUMBERS
8/01/2021

POWERCOR DETERMINATION 2021 - 2026 SUBMISSION ON POLE REPLACEMENT NUMBERS

DOCUMENT ID	DOCUMENT1
GROUNDLINE ENGINEERING PROJECT NUMBER	GR6266 / PCA SUB / 002
CLIENT	
CLIENT REFERENCE	
CLIENT CONTACT

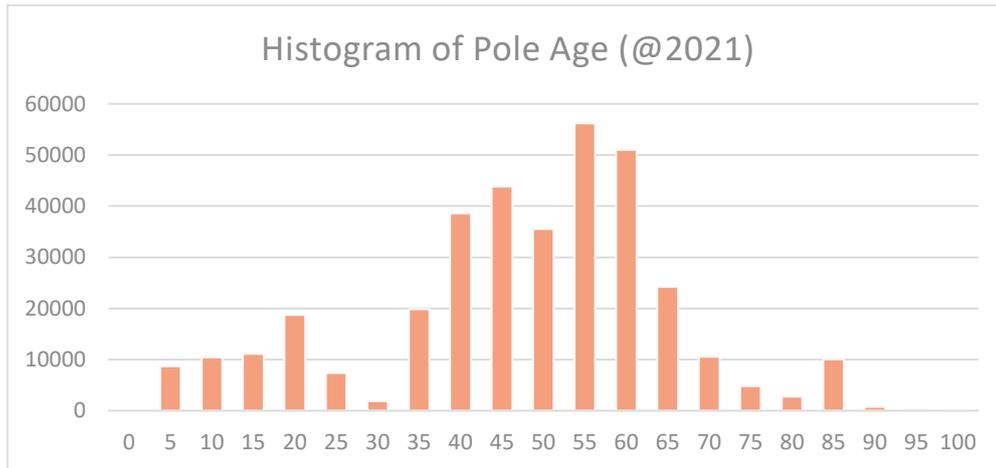
Figure 2 Histogram of Pole Age as at 2021

At the proposed projected pole replacement rates of approx. 3,400 PA (revised determination), a further 30,000 poles will be 50 years or older by the end of the next reset period and if pole replacement rates are maintained until 2031, it is likely over 75% of the pole population will be over 50 years old.

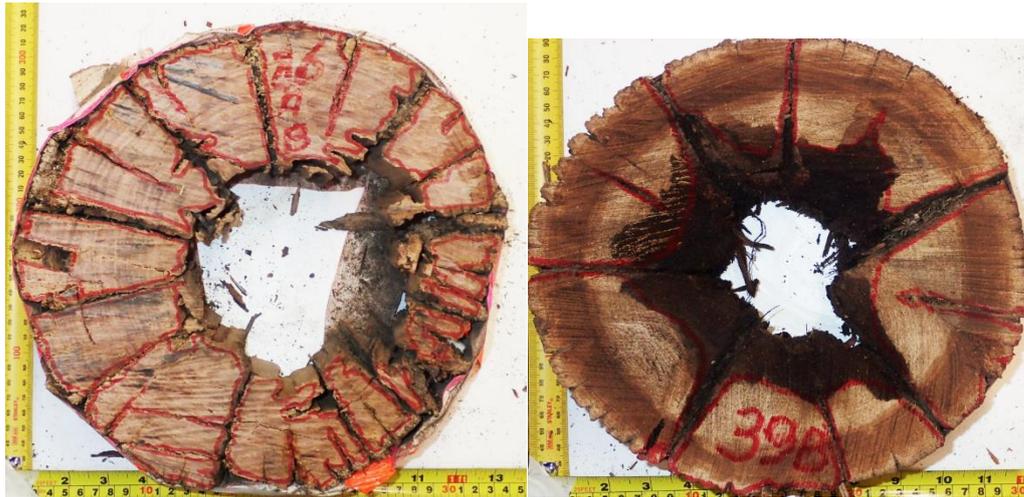
Figure 3 Decayed Pole Cross Section

As can be seen in figure 3, obtaining a “sound wood” measurement on the above poles depends solely on where the drill is applied and could easily vary between 25 – 150mm.

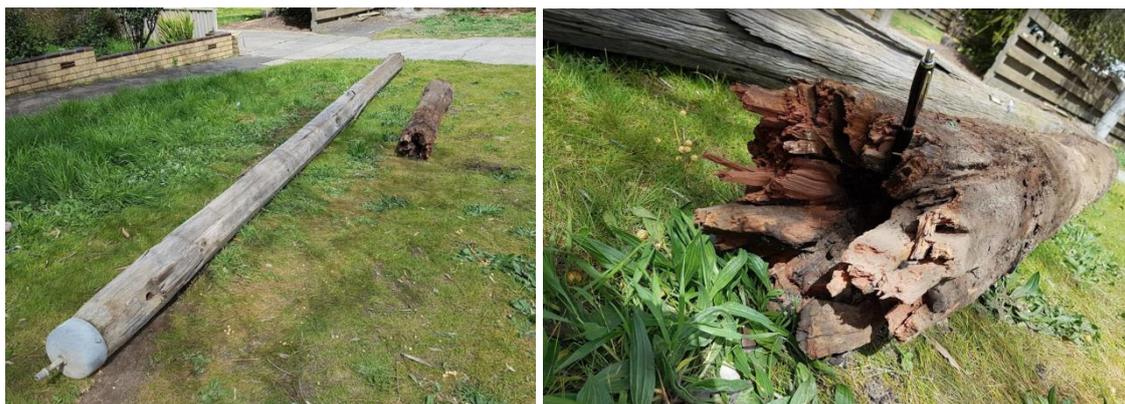
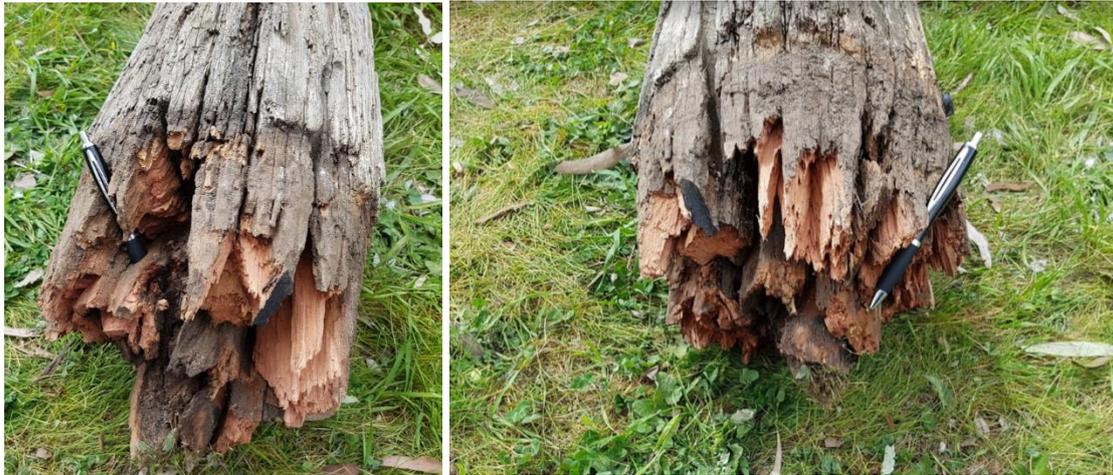
Figure 4 Failed Pole, Otherwise solid, but for drill holes and advanced decay

It's likely that the pole failure shown in Figure 4 was not drilled every few years, the pole would still be standing.

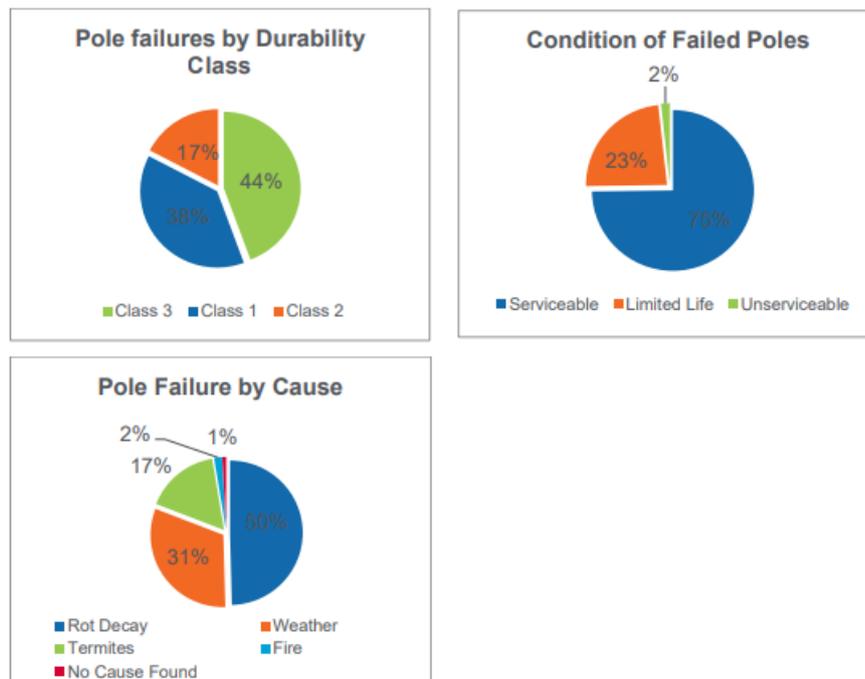
Figure 6 Pole failure performance by durability, condition of pole and cause

Note: 98% of failures occurred in poles identified as serviceable provides for little confidence in the traditional assessment technique.

- 50 per cent of the failures were caused by wood rot/decay - this is a well understood failure mode for timber poles and is difficult to accurately detect
- 31 per cent of the failures were due to weather – ESV assumes this refers to high wind pressure, but within the limit state design wind pressure on poles specified in AS/NZS 7000
- 17 per cent of failures were due to undetected termite infestation.

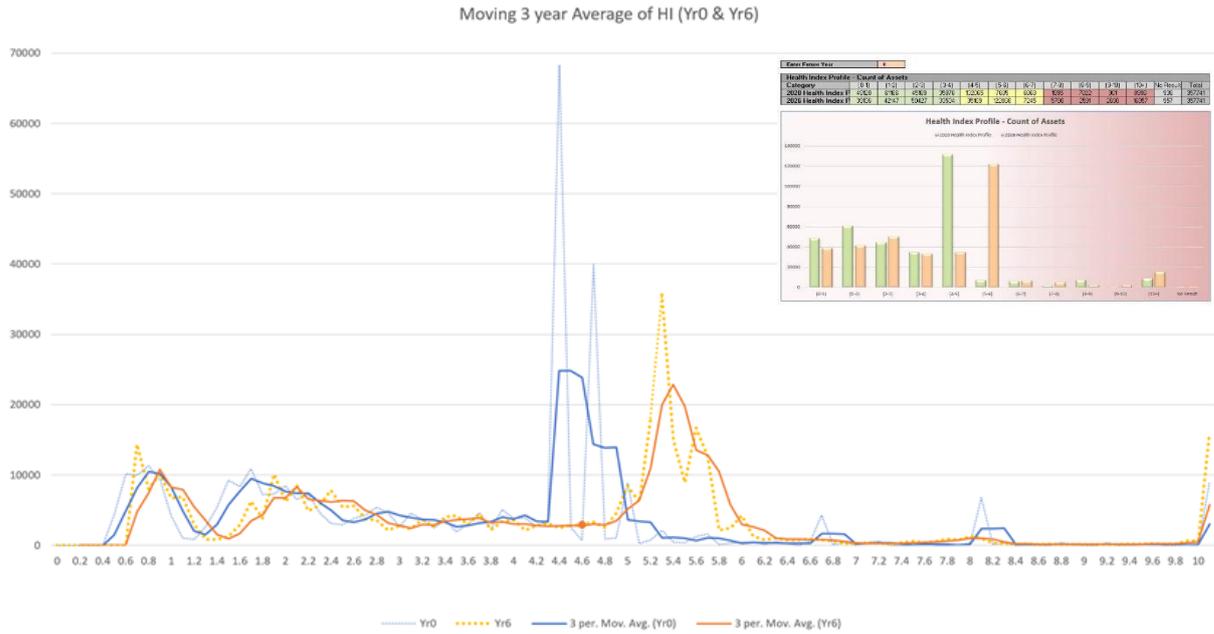
Figure 7 Granular HI Assessment from available data showing distribution of HI

Using public data from *Powercor - Revised Regulatory Proposal - 2021-26 - MOD 4.16 - CBRM - condition model - December 2020.xlsx*⁸ to produce a more granular histogram than what was provided (inset).

Notes on above histogram and further review of the publicly available data:

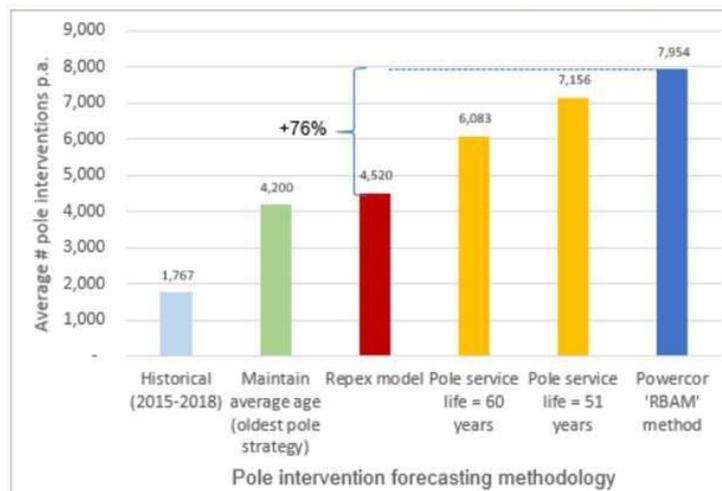
Figure 8 Comparison of pole replacement forecasting approaches

This number is close to the RBAM model in page 139 of last years ESV technical report⁹ – using Powercor’s own data:

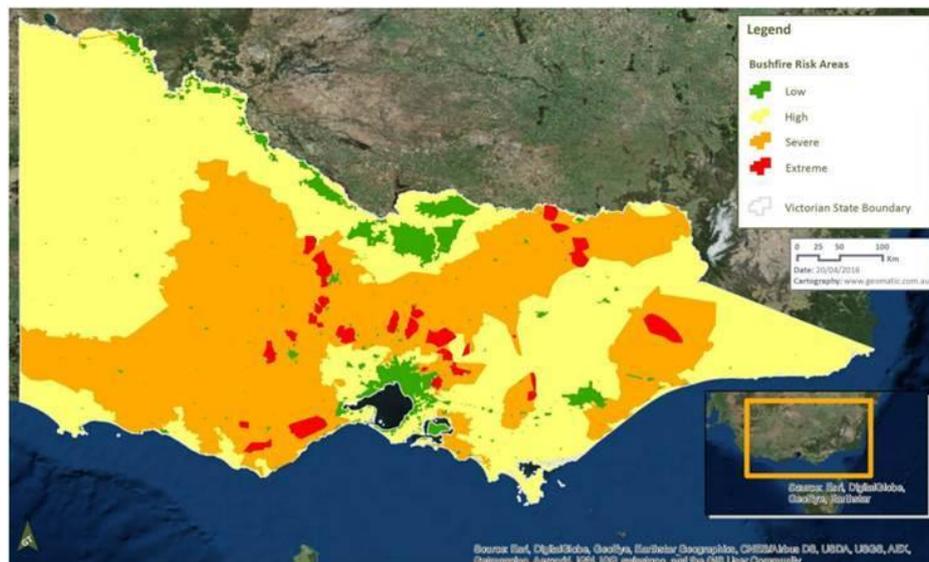
Figure 9 DELWP Phoenix Rapidfire Mapping - with BFRA

The fire risk mapping above was built on limited information and was constructed for the purpose of prioritising powerline replacement works and funding, not a for a comprehensive asset management function.

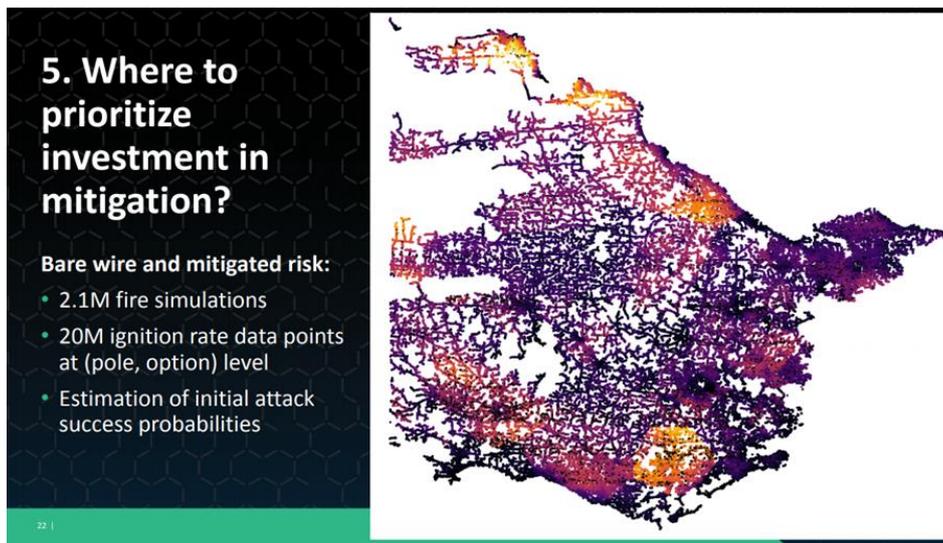
Figure 10 CSIRO Spark Consequence Mapping

Overlaying the two maps (between the legislated DELWP Phoenix and CSIROs Spark), we can clearly see the difference in the Powercor Network area.

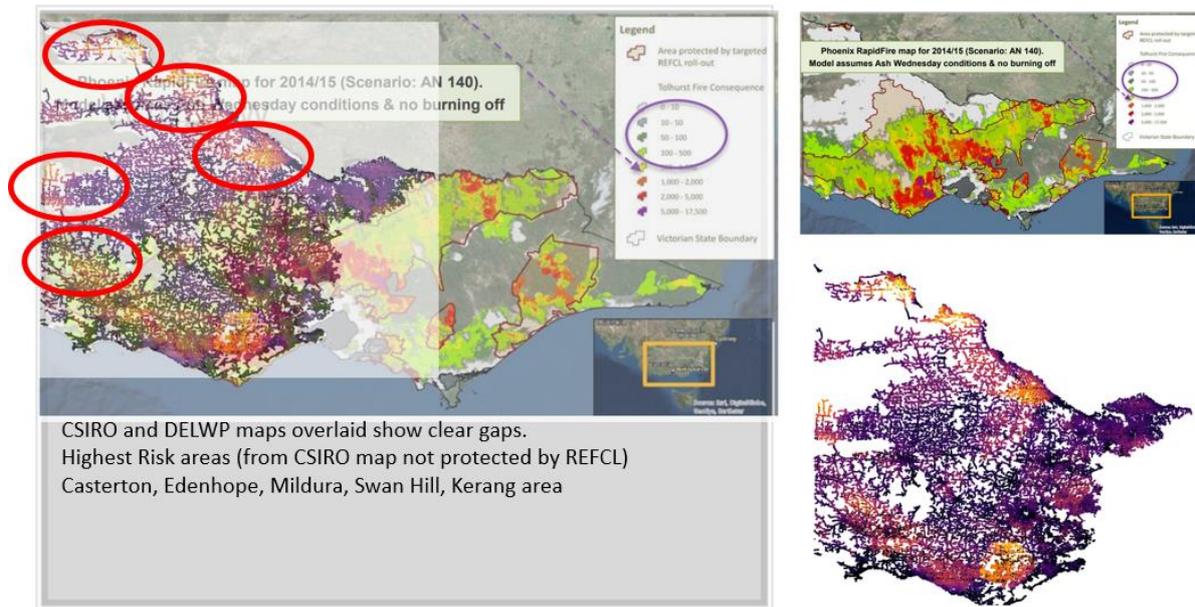
Figure 11 Comparison between Legislated (HBRA) and Consequence Mapping
