# STRATEGY

## ELECTRICITY PRIMARY PLANT ASSET CLASS STRATEGY

ELE AM PL 0061

Revision Number: 2

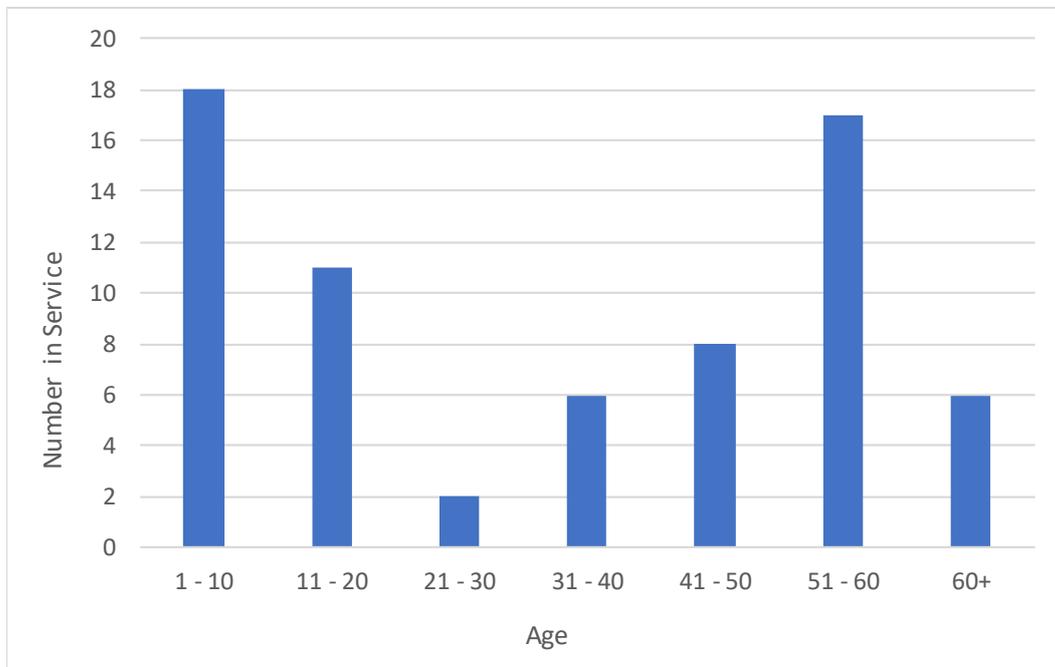
**Figure 4–1: Power Transformers Age Profile**

Figure 4–1 shows the power transformer age profile and Figure 4–3 shows the percentage of population in nominated age groups.

Of the various transformer age groups:

- Twenty one are over 50 years old, representing 31% of the total population (which will be prioritised for replacement using a condition and risk-based approach); and
- Ten are between 40 and 50 years old, representing 15% of the total population (the ageing condition of which will be closely monitored as they approach and exceed 50 years).

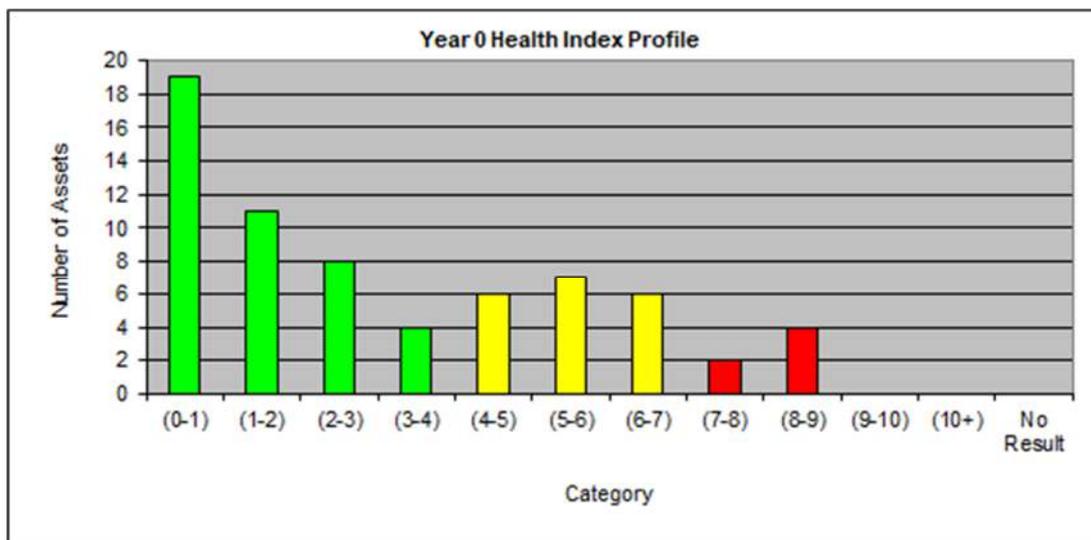
**Figure 4–3: Transformer Health Indices at Year 0**

The graphs below show the CBRM Health Indices for JEN’s population of transformers at the present time as well as in 5 years and 10 years if no replacements are made.

Figure 4–3 shows there are 7 transformer in the red zone with Health Indices of 7 or above, indicating a high probability of failure. These transformer are: FF 1, 2 & 3; ES 1 & 2; and HB 1.

Total risk for all failure scenarios at Year 0 is calculated to be \$1.70M.

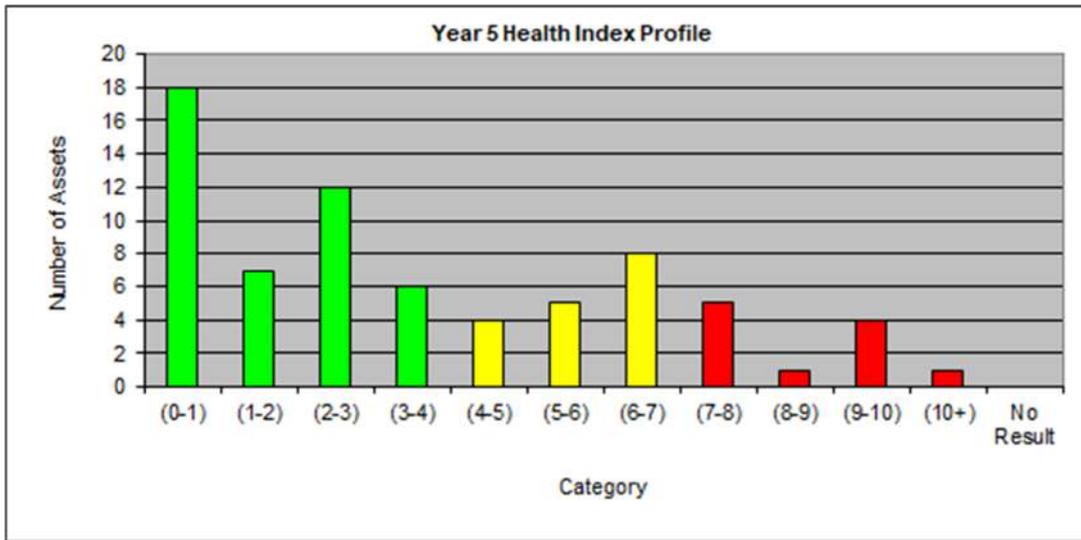
**Figure 4–4: Transformer Health Indices at year 5**

Figure 4–4 shows there will be 11 transformer in the red zone, (HI>7) in 5 years if no replacements are made. The one unit (FF No.1 Transformer) in the 10+ category would be in danger of immediate failure if still in service. These transformers are: FF 1, 2 & 3; ES 1 & 2; HB 1; EP-A 3; NT 1 & 3; and BD 2 & 3.

Total risk for all failure scenarios at Year 5 is calculated to be \$2.03M.

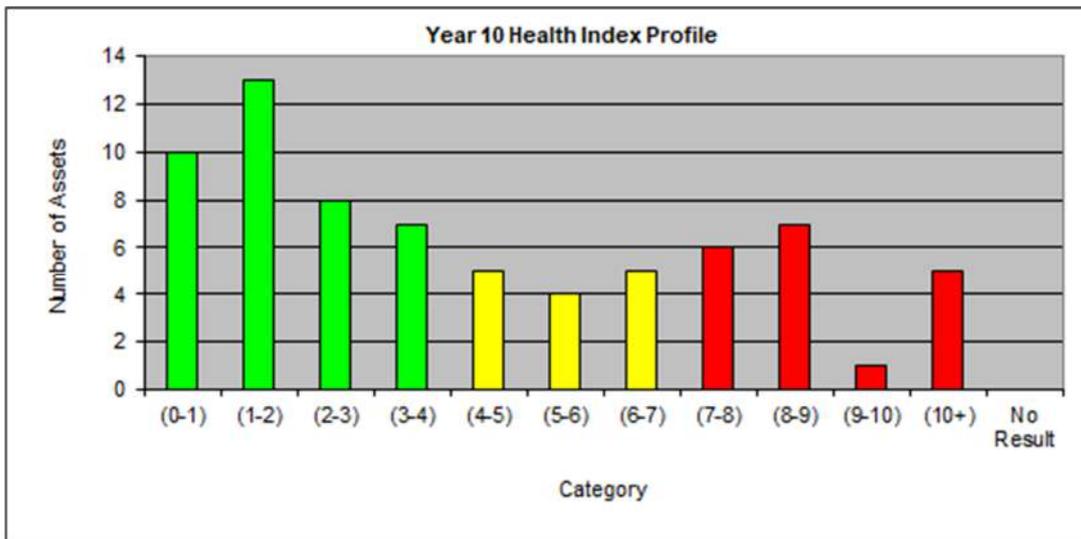
**Figure 4–5: Transformer Health Indices at year 10**

Figure 4–5 shows there will be 19 transformers in the red zone (HI>7) in 10 years if no replacements are made. The five units (FF 1, 2 & 3 and ES 1 & 2) in the 10+ category would be in danger of immediate failure if still in service. These transformer are: AW 3; BD 1, 2 & 3; BY 1; CN 1 & 2; EPA 1 & 3; EPB 4; ES 1 & 2; FF 1, 2 & 3; HB 1; NT 1 & 3.

Total risk for all failure scenarios at Year 10 is calculated to be \$2.56M.

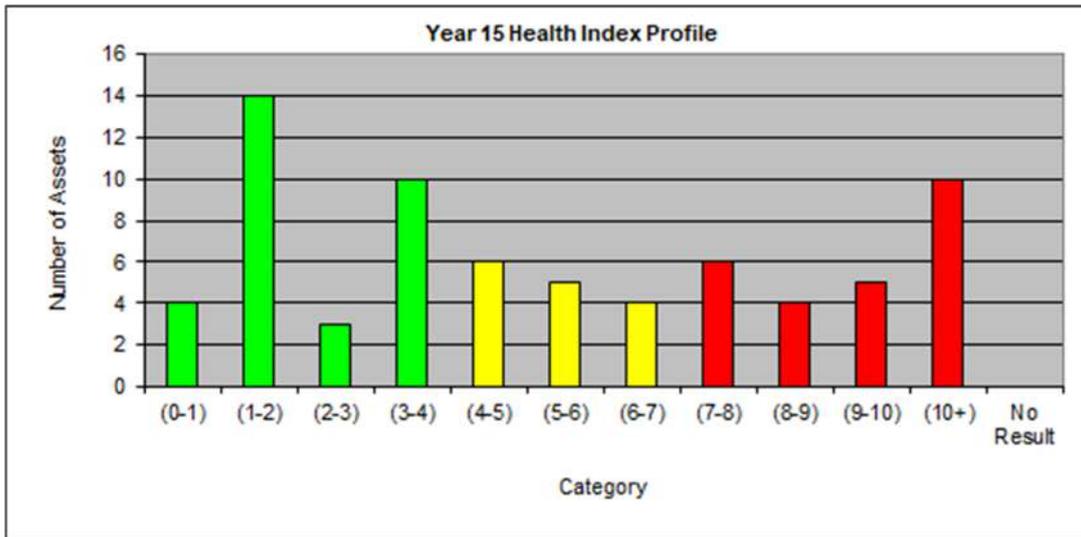
**Figure 4–6: Transformer Health Indices at year 15**

Figure 4–6 shows there will be 25 transformer in the red zone, (HI>7) in 15 years if no replacements are made.

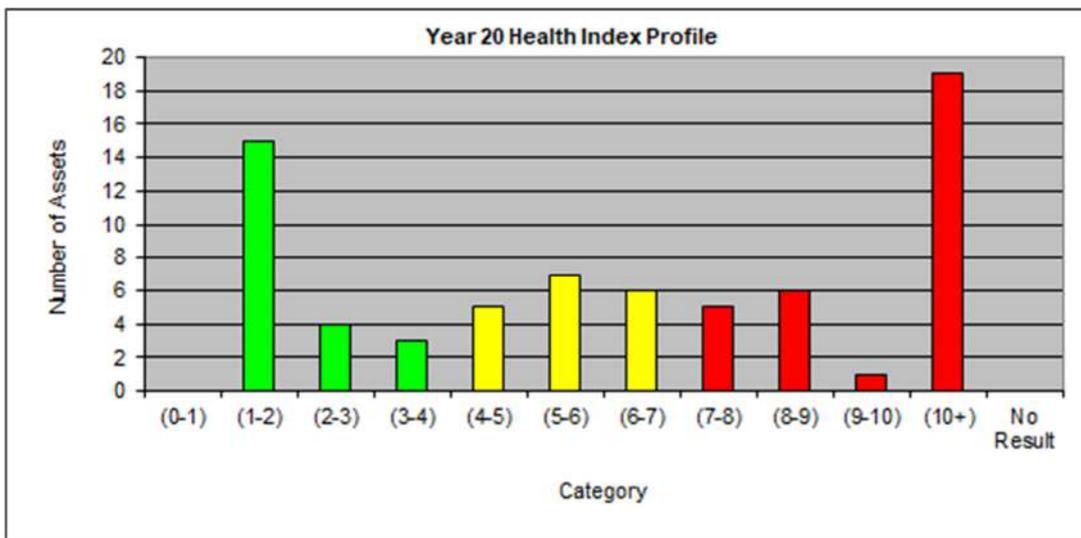
**Figure 4–7: Transformer Health Indices at year 20**

Figure 4–7 shows there will be 31 transformer in the red zone, (HI>7) in 20 years if no replacements are made.

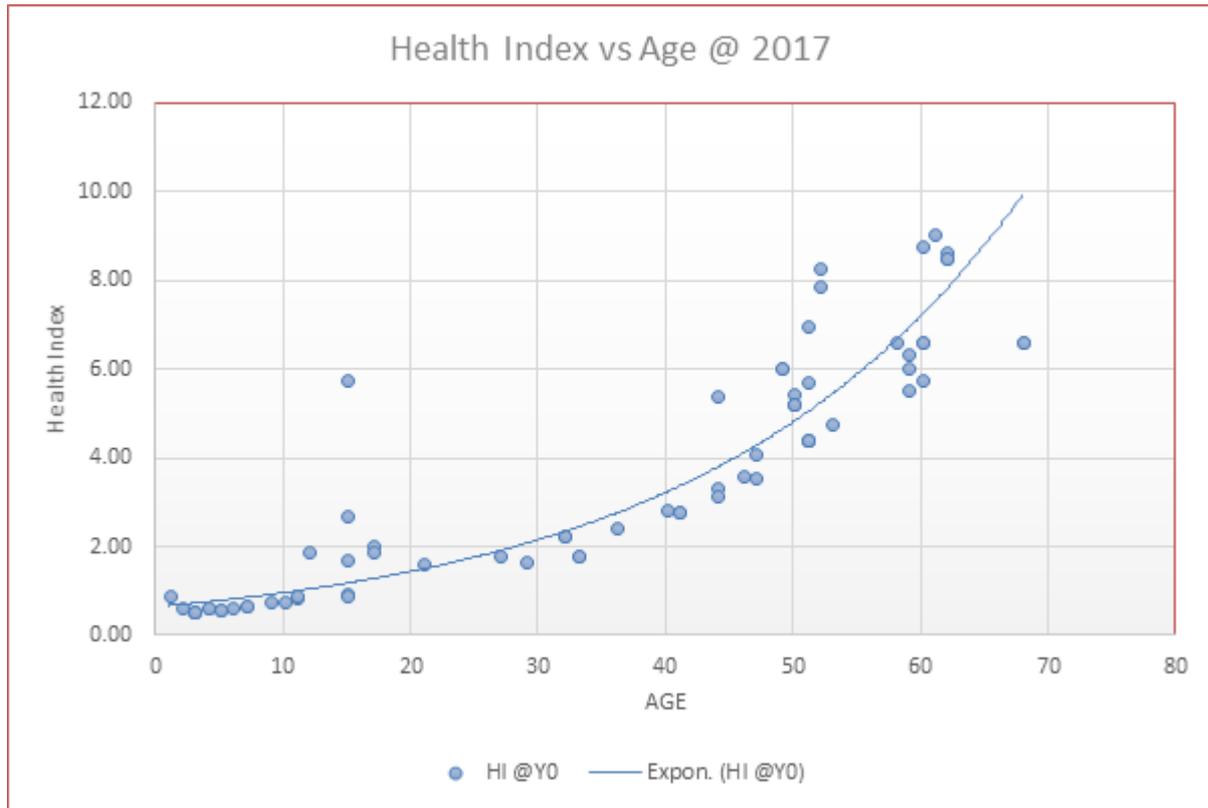
**Figure 4–8: Correlation between Transformer Age and Health Index**

Multiple condition monitoring checks and tests are conducted to derive an overall condition assessment for each transformer. It is expected that the transformers in the poorest condition will also be among the oldest units. Figure 4–8 below illustrates the relationship between the CBRM Health Index and transformer age. There is a reasonable correlation between transformer age and high HI.

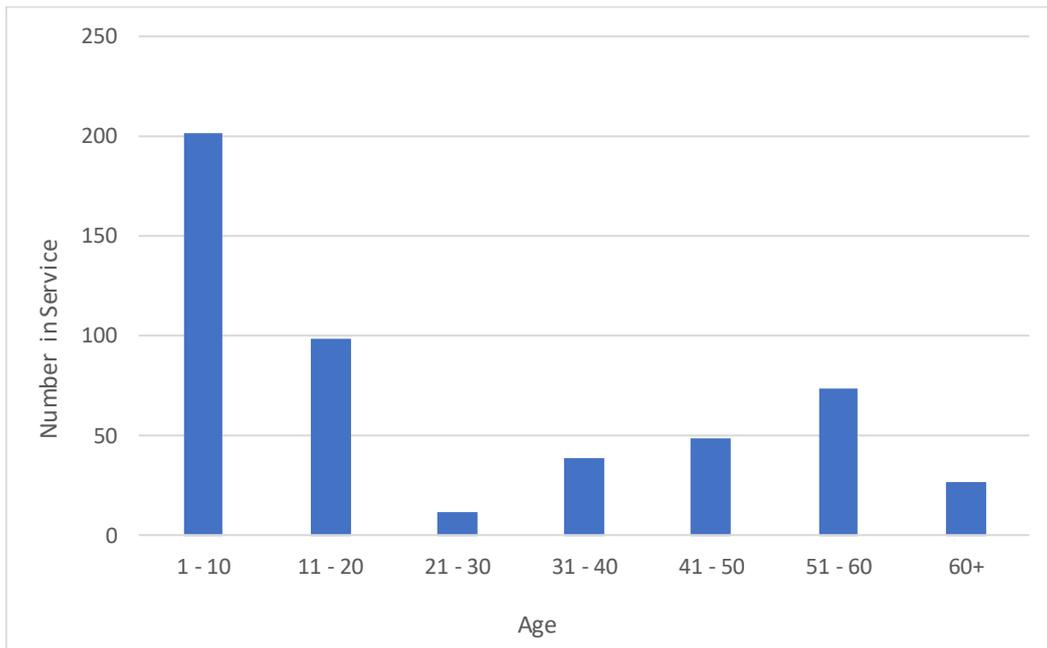
**Figure 4–9: Circuit Breaker Age Profile**

Of the various circuit breaker age groups:

- 101 are over 50 years old, representing 20% of the total population (which will be prioritised for replacement using a condition and risk-based approach);
- 49 are between 40 and 50 years old, representing 10% of the total population (the ageing condition of which will be closely monitored as they approach and exceed 50 years).

Figure 4-10 and 4-11 **Error! Reference source not found.** **Error! Reference source not found.** shows the circuit breaker age profile and the percentage of population in nominated age groups.

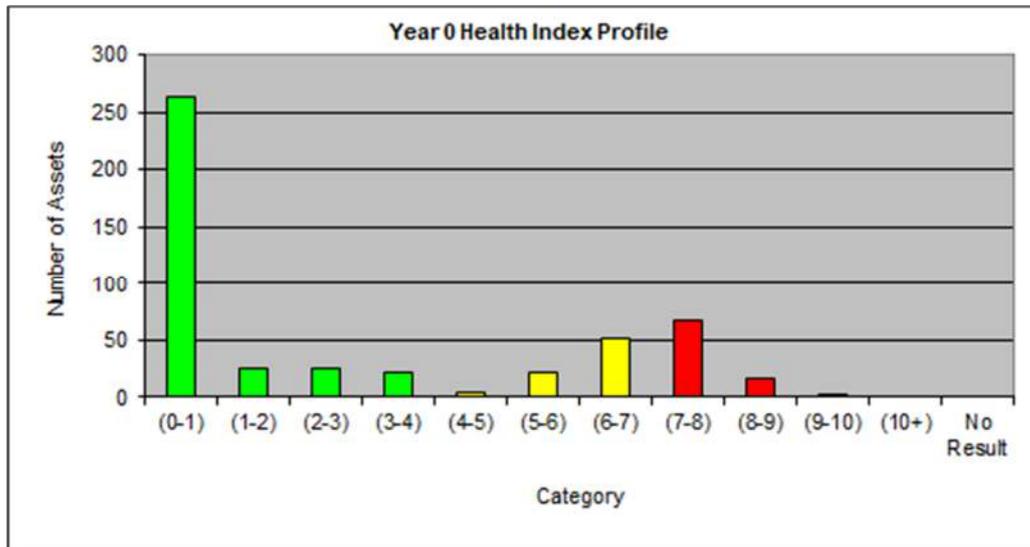
Figure 4–11: Year 0 Health Indices

Total risk for all failure scenarios at Year 0 is calculated to be \$6.65M.

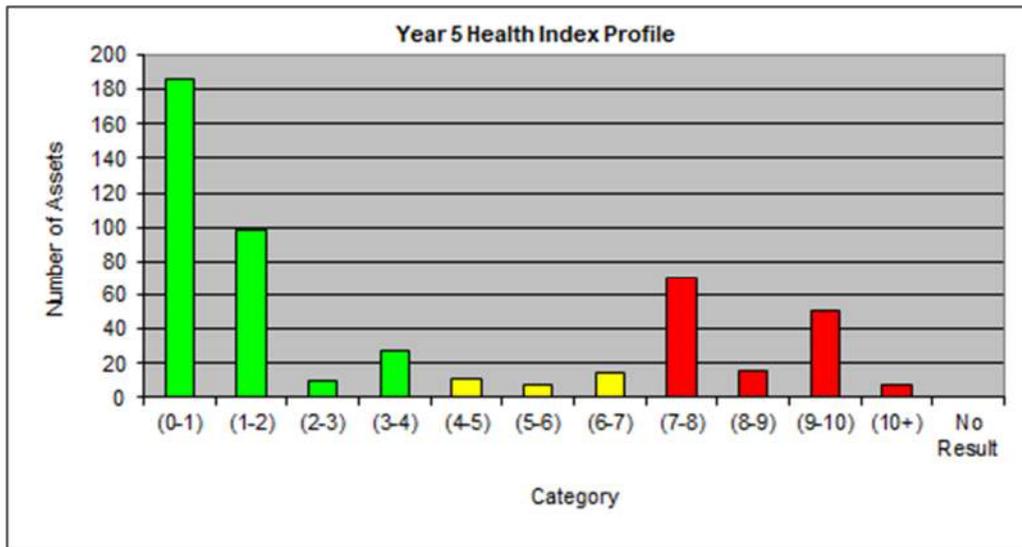
Figure 4–12: Year 5 Health Indices

If asset replacement is deferred until 2023 (Year 5) the health index changes as shown in Figure 4–12. A total of 144 circuit breakers will be in poor condition (HI > 7) with the associated higher probability of failure.

Total risk for all failure scenarios at Year 5 is calculated to be \$9.60M.

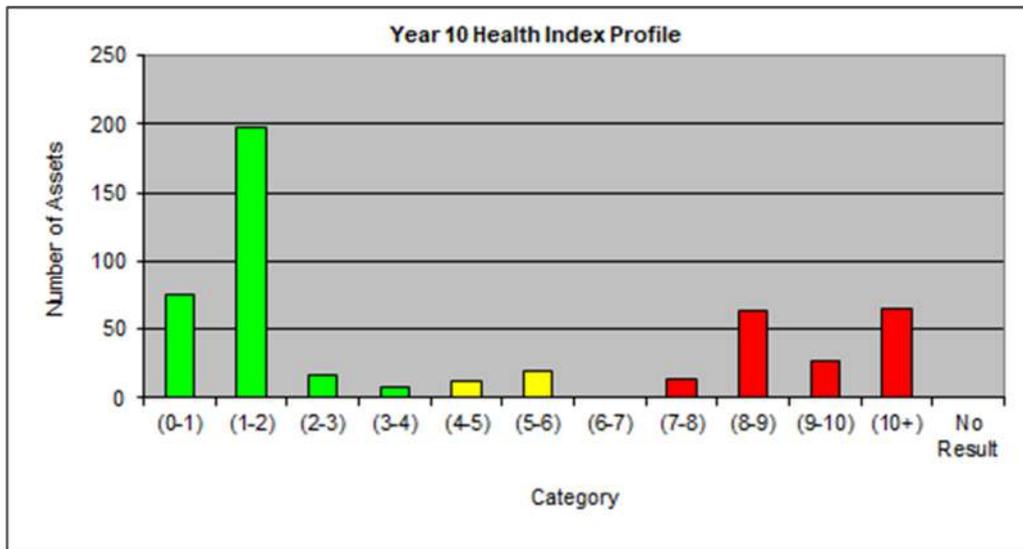
Figure 4–13: Year 10 Health Indices

If circuit breaker replacement is deferred until 2027 (Year 10) the health index changes as shown in Figure 4–13. A total of 169 circuit breakers will be in poor condition (HI > 7) with the associated higher probability of failure.

Total risk for all failure scenarios at Year 10 is calculated to be \$14.90M.

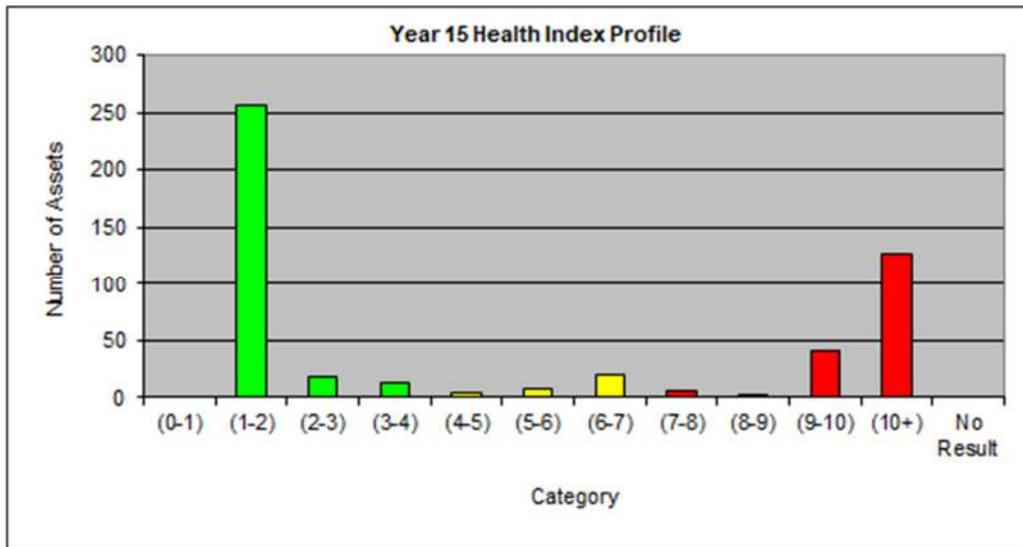
**Figure 4–14: Year 15 Health Indices**

Total risk for all failure scenarios at Year 15 is calculated to be \$24.76M.

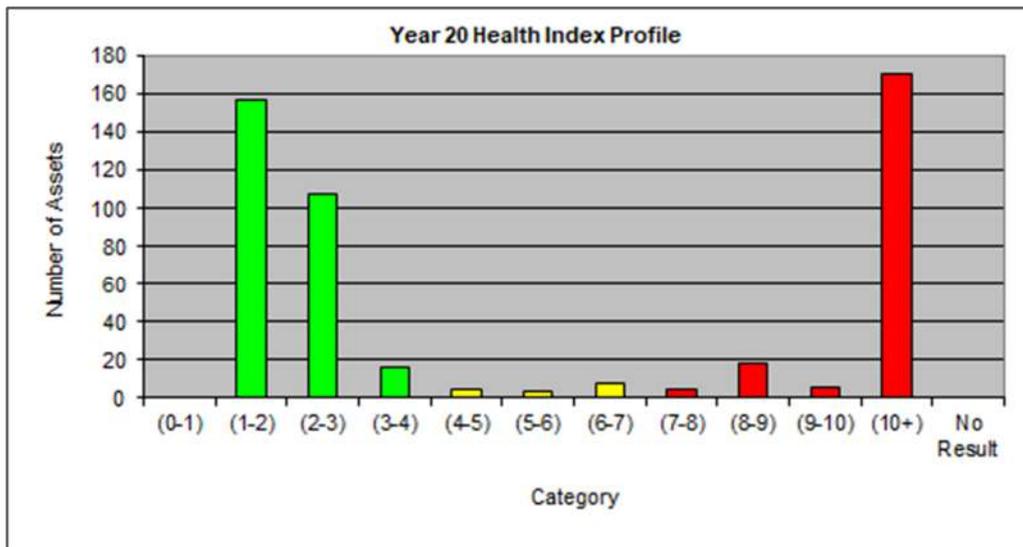
**Figure 4–15: Year 20 Health Indices**

Total risk for all failure scenarios at Year 20 is calculated to be \$35.58M.

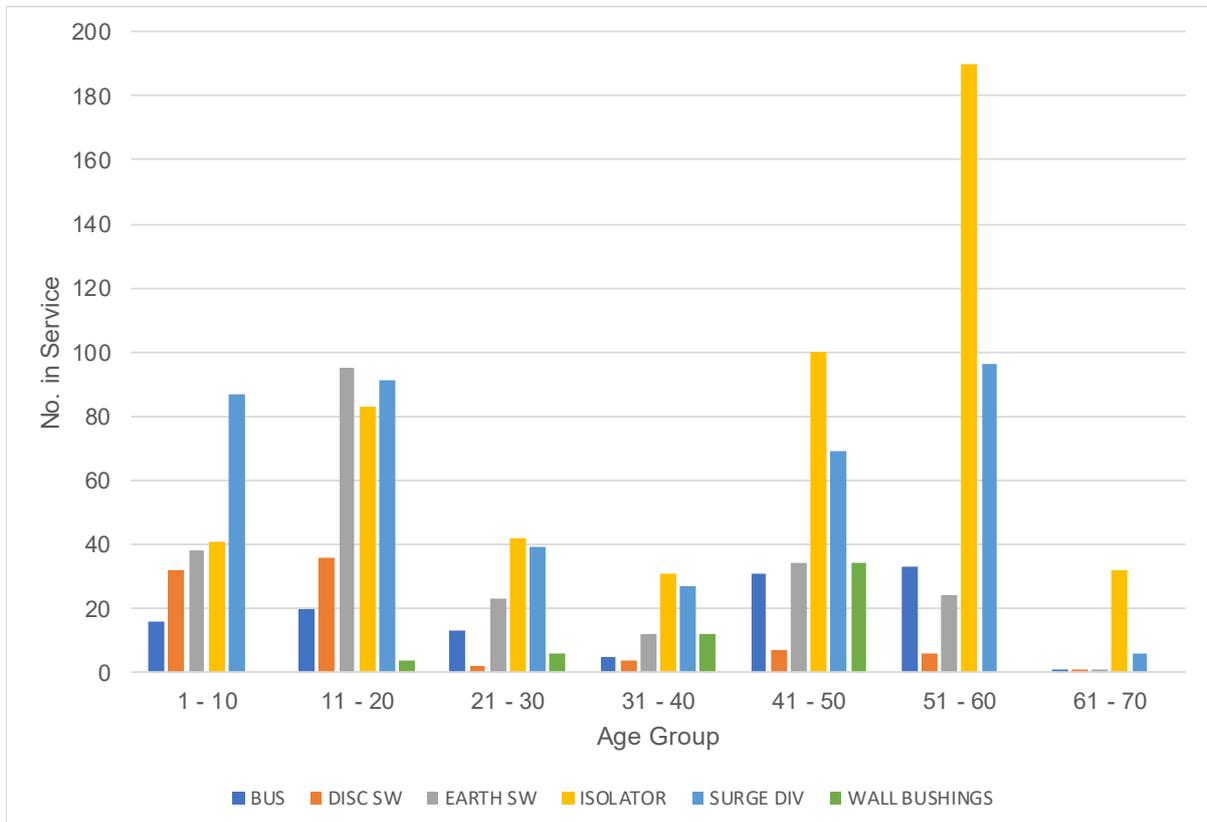
**Figure 4–17: Average Age of Specific Assets**

The average age of disconnectors/isolators, earth switches, buses, surge arresters and wall bushings installed on the JEN network is shown in Figure 4–17. Notably disconnectors/isolators and buses have an average age >35 years and may require more age related maintenance in the coming years.

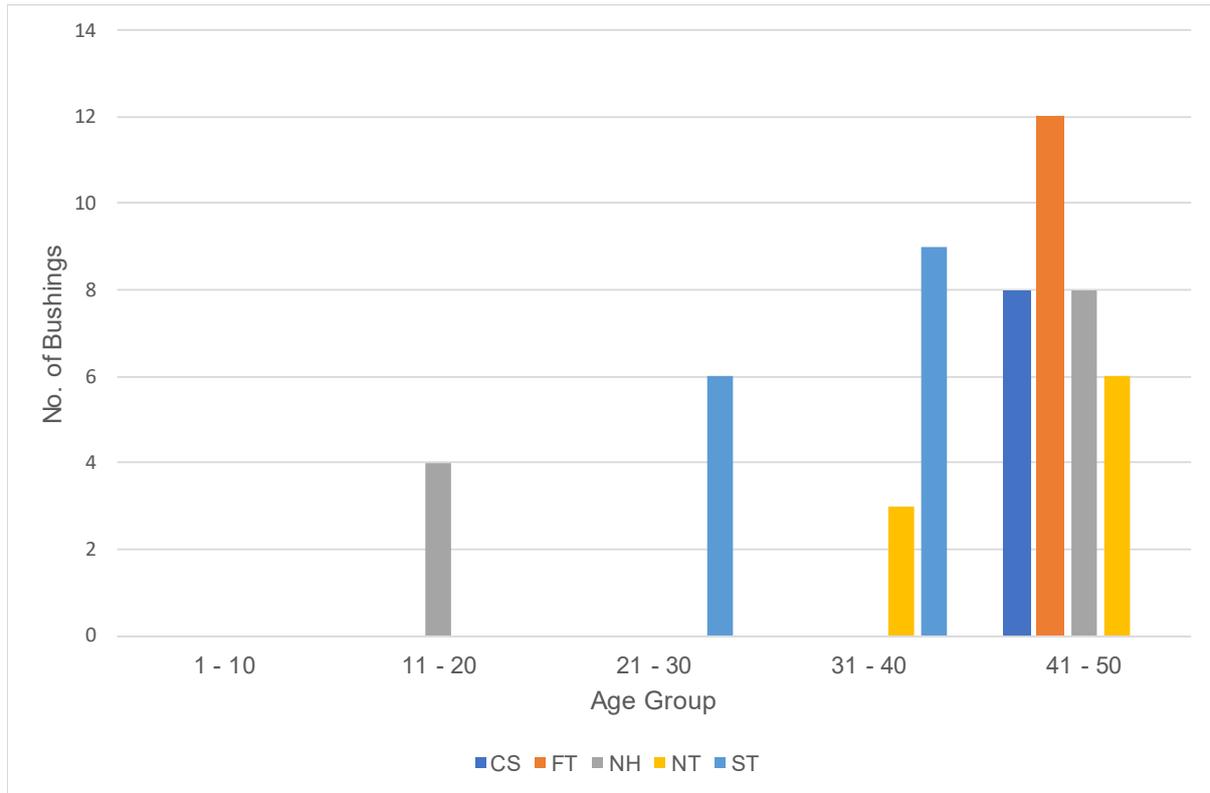
Figure 4–18: Wall Bushing Age Profile

Figure 4–18 shows the age profile of wall bushings in service across the Jemena Electricity Network.

The oldest wall bushings date back to 1970 and are located at FT. The bushings located at CS are a 1976 specification and are therefore 37 years old. 50% of the wall bushings on the JEN network are >30 years old.

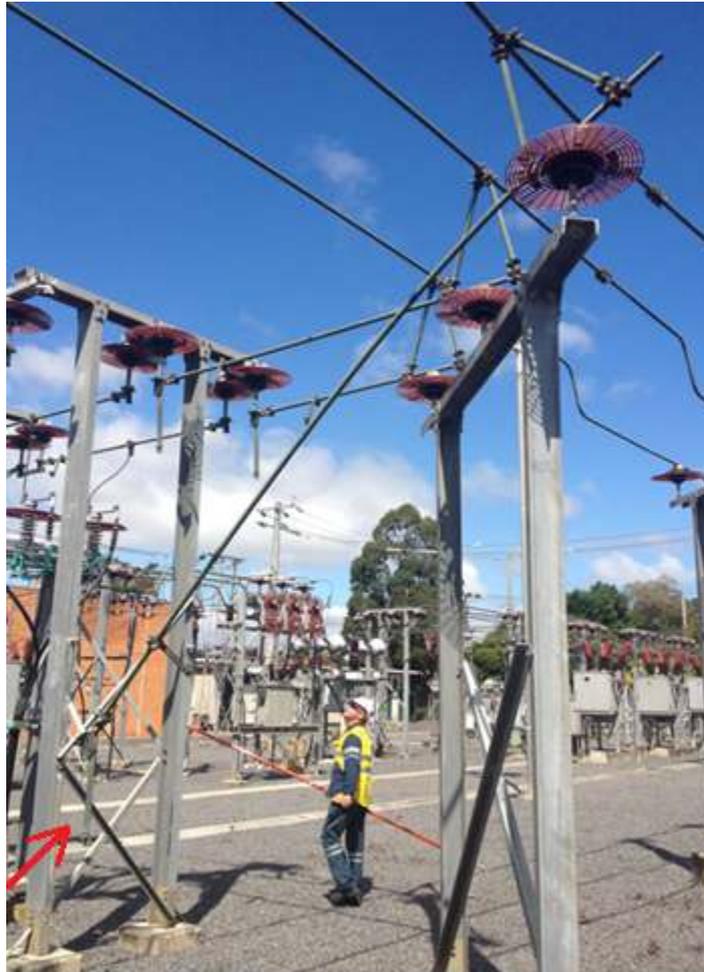
**Figure 4–19: Failed Pin and Cap Insulator**

- In 2011 a pin and cap insulator failed in a Victorian electricity network. The failure caused the insulator to separate from its support structure, resulting in the transfer bus isolator together with the pin of the insulator and the tubular bus to be left unsupported. As a result, the tubular bus has bent due to cantilever forces, leaving the pin, isolator and tube hovering approximately 1 metre from the ground. It remained live and was discovered by personnel carrying out ground maintenance. The hovering isolator is identified by the red arrow in Figure 4–19.

Porcelain has very high compressive strength (80,000 psi), sixteen times greater than its tensile strength (5,000psi). Cap and pin insulators have a generic design deficiencies when subjected to tensile forces which can lead to the porcelain cracking and eventual failure of the cement joint due to moisture ingress and increased pressure due to corrosion and thermal expansion.

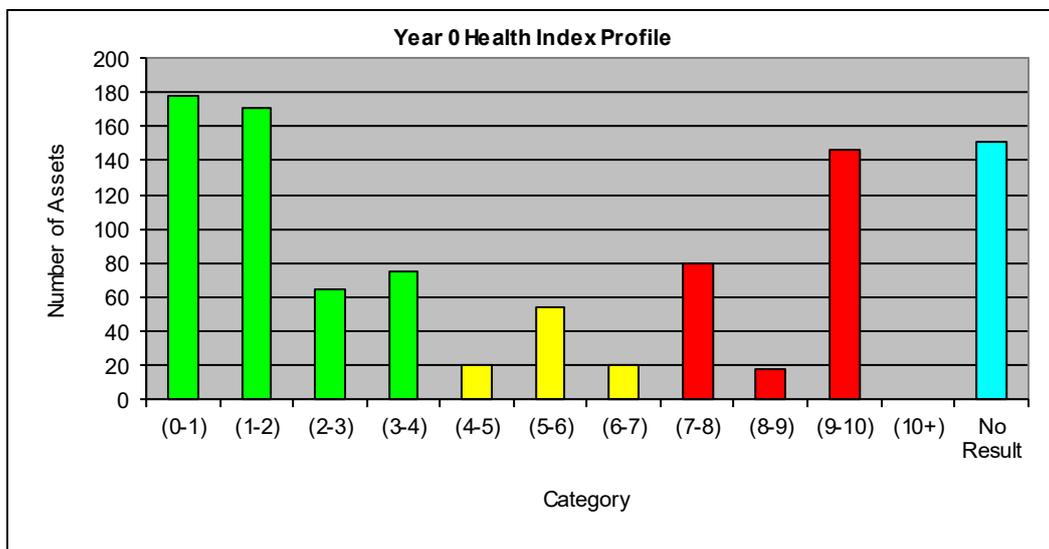
Figure 4–20: Year 0 Health Indices

Total risk for all failure scenarios at Year 0 is calculated to be \$66,589.

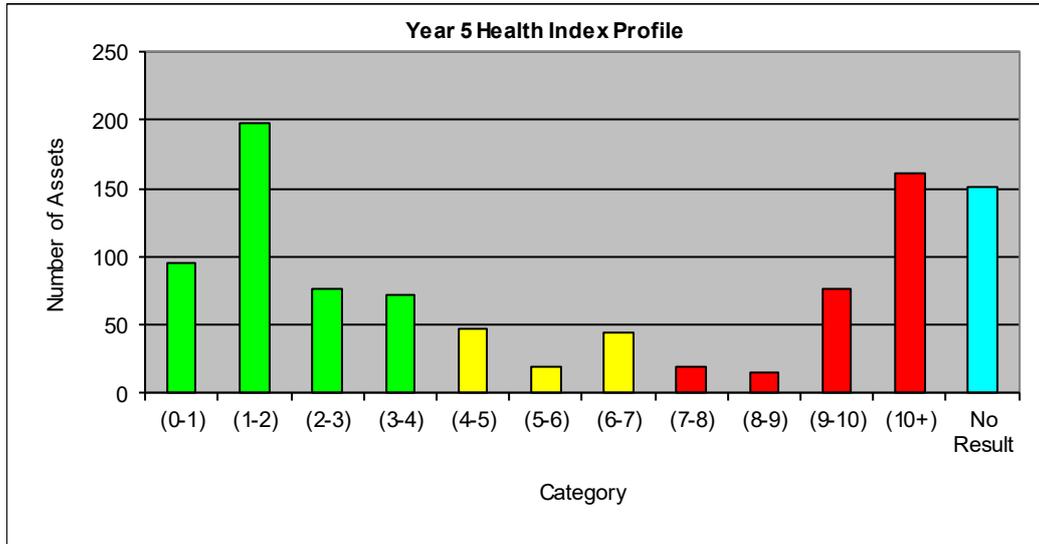
**Figure 4–21: Year 5 Health Indices**

If asset replacement is deferred until 2023 (Year 5) the health index changes as shown in Figure 4–21. A total of 266 assets will be in poor condition with the associated higher probability of failure.

Total risk for all failure scenarios at Year 5 is calculated to be \$104,477.

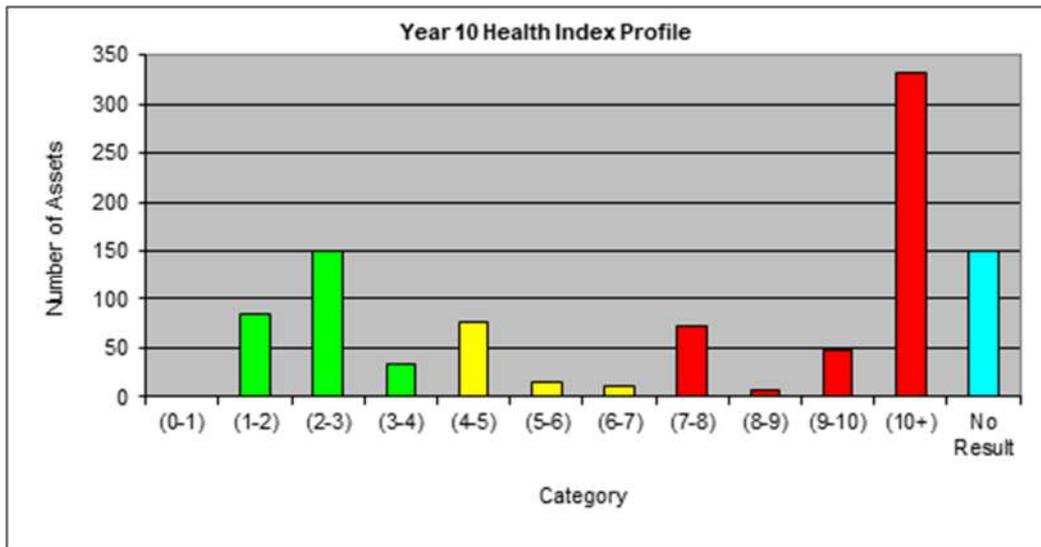
Figure 4–22: Year 10 Health Indices

If asset replacement is deferred until 2028 (Year 10) the health index changes as shown in Figure 4–22. A total of 325 assets will be in poor condition with the associated higher probability of failure.

Total risk for all failure scenarios at Year 10 is calculated to be \$168,243.

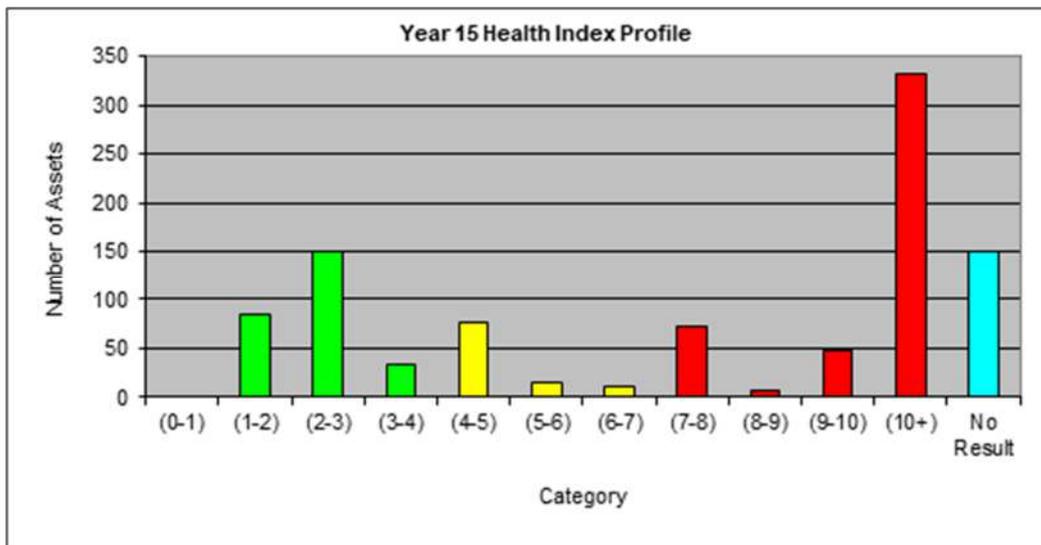
Figure 4–23: Year 15 Health Indices

If asset replacement is deferred until 2033 (Year 15) the health index changes as shown in Figure 4–23. Total risk for all failure scenarios at Year 15 is calculated to be \$250,657.

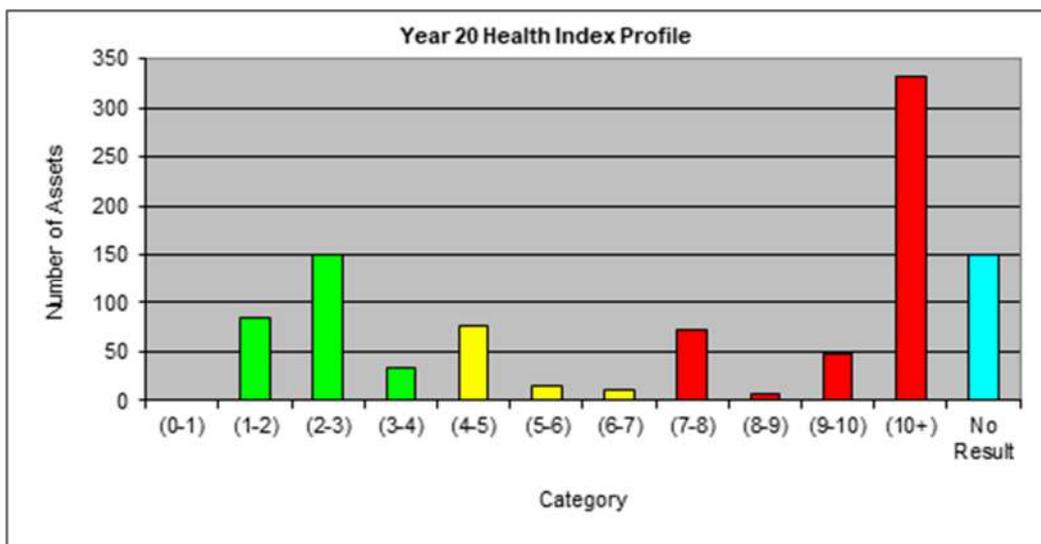
Figure 4–24: Year 20 Health Indices

If asset replacement is deferred until 2038 (Year 20) the health index changes as shown in Figure 4–24. Total risk for all failure scenarios at Year 20 is calculated to be \$309,926.

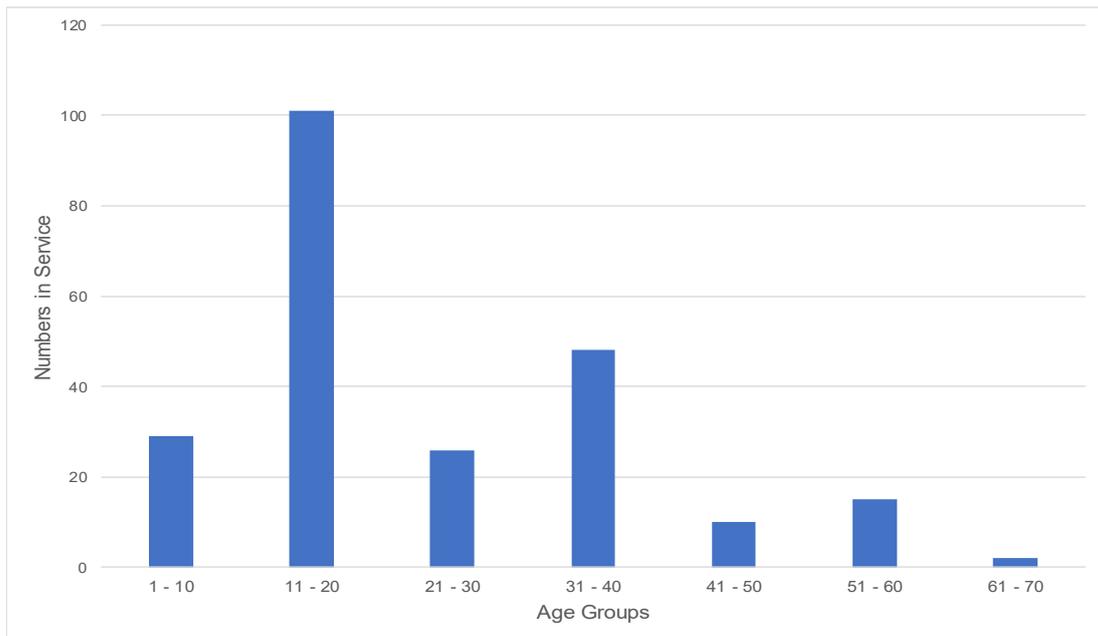
**Figure 4–25: Instrument Transformer Age Profile**

The age profile of the 231 Instrument Transformers installed on the JEN is shown in Figure 4–25. The majority of JEN instrument transformers were installed between 1980 and 2005.

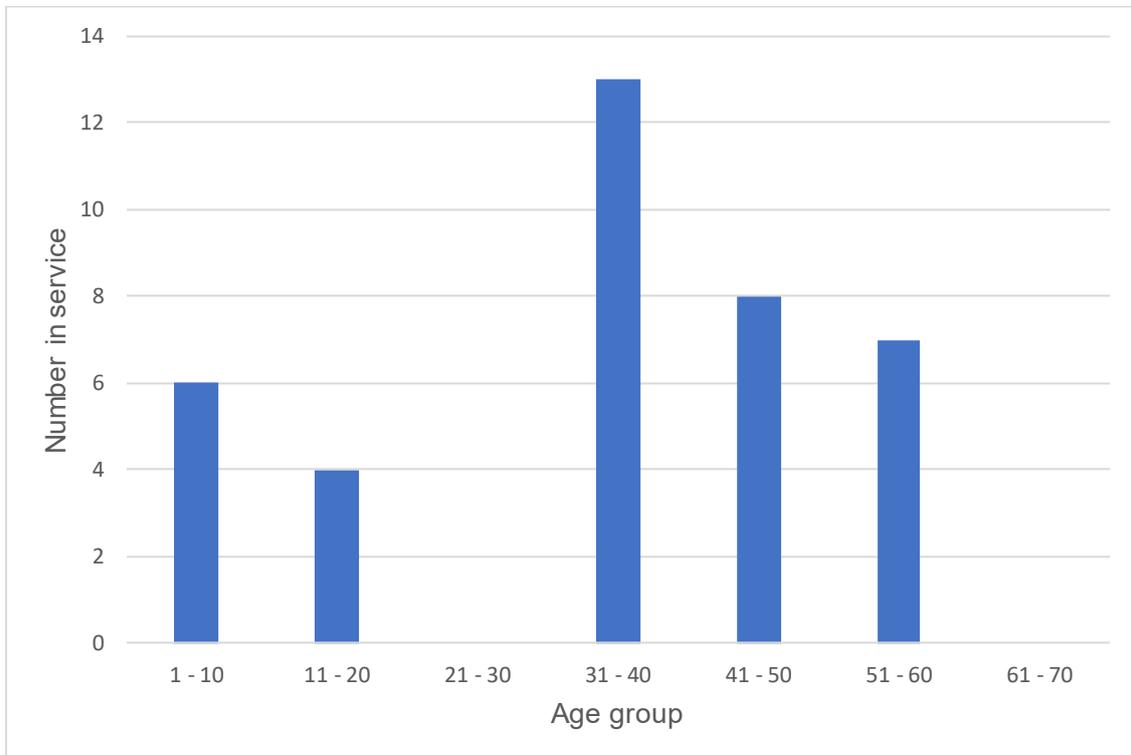
Figure 4–26 shows the current capacitor banks’ age profile (the number of capacitor banks installed by year of manufacture: 38).

**Figure 4–26: Capacitor Bank Age Profile**

Jemena capacitor banks design life expectancy is approximately 50 years. Small capacitor cans have a reduced design life of. The plan is to replace capacitor banks only when they reach the end of their average lives based on condition. The consequence of a capacitor bank failure is low.

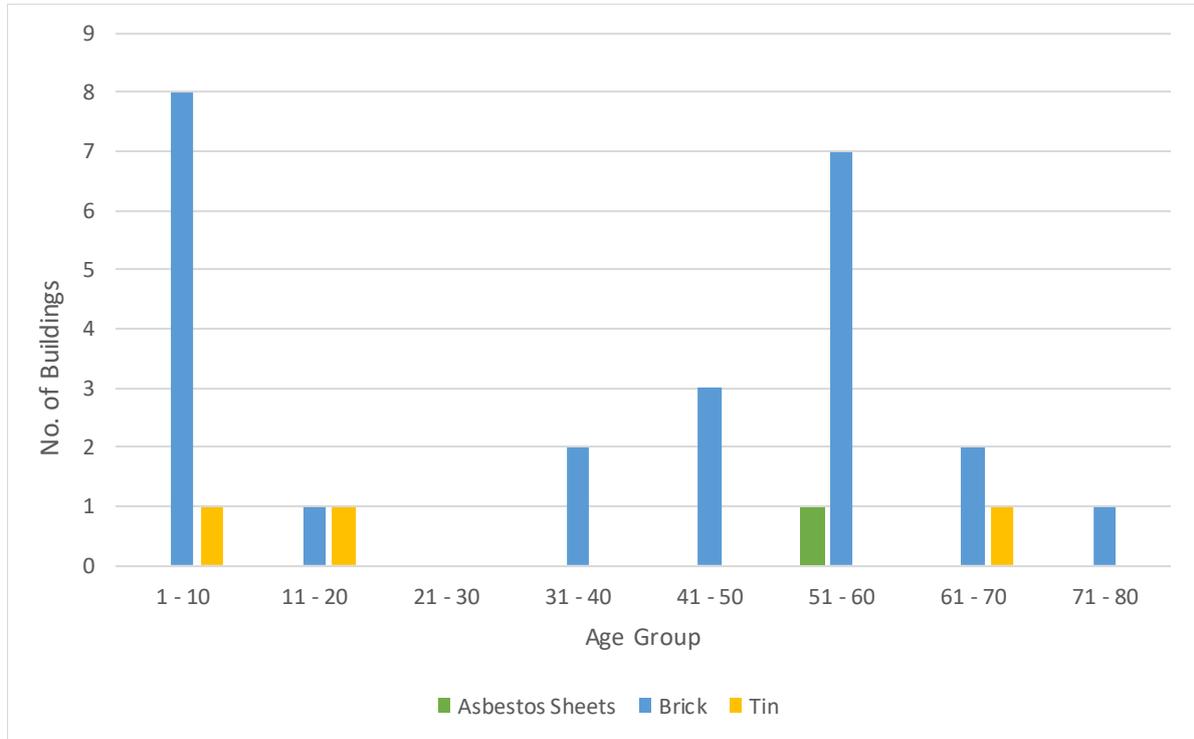
Figure 4–27 shows the current zone substation building age profile.

**Figure 4–27: Zone Substation Building Age Profile**

It can be seen 11 buildings are over 50 years old and 15 are over 40 years old; which indicates considerable investment in building replacement in future years.

The nominal life of zone substation buildings is 50 years for timber and 90 years for masonry type buildings.

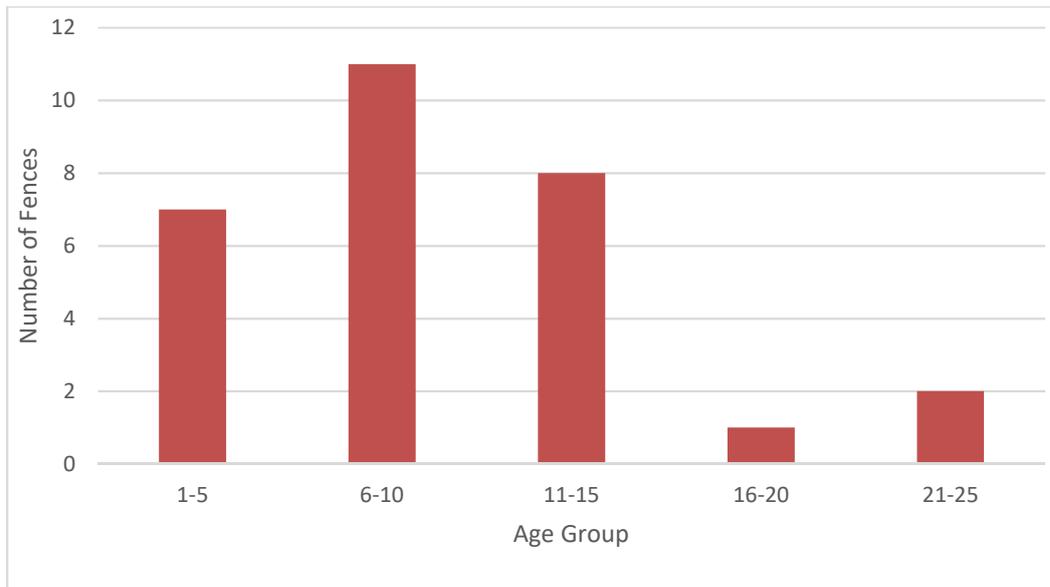
Figure 4–29 shows the current zone substation fence age profile.

**Figure 4–29: Zone Substation Fence Age Profile**

It can be seen that 2 zone substation fences (Timber fence facing residential homes) are over 20 years old and their condition indicated that replacement will be planned.

The nominal life of timber zone substation fences approximately 20 years and 40 years for the welded mesh fences.

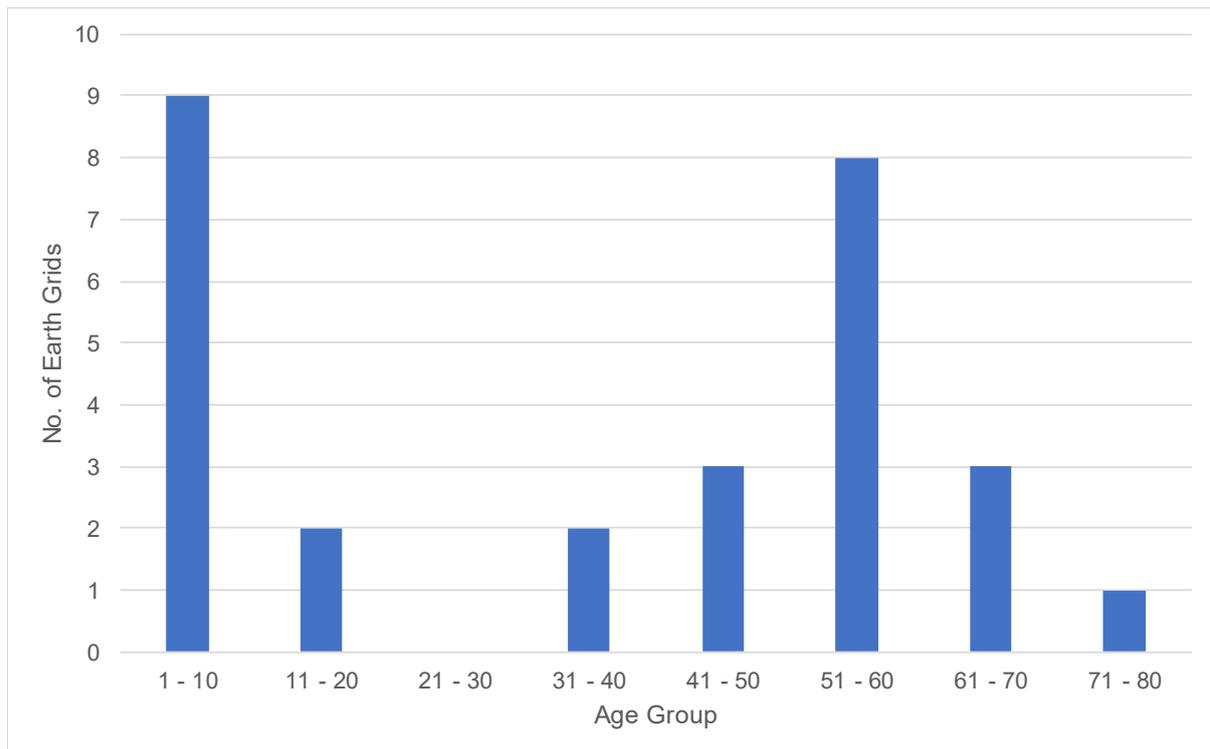
Figure 4–28 shows the current zone substation earth grid age profile.

**Figure 4–28: Zone Substations Earth Grids Age Profile**

The age of zone substation earth grids is roughly equivalent to the age of zone substation buildings as the earth grid and building is established at the same time.

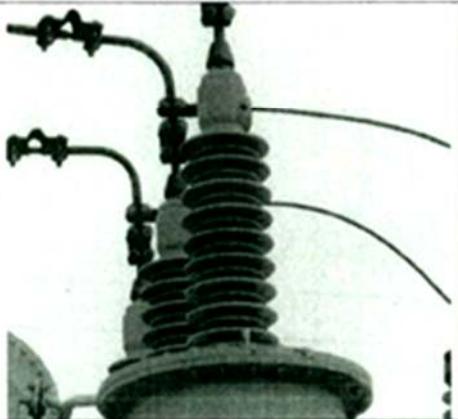
**OIP Bushings (ABB GOB/GSA, after 1982)**

Measured Result	Means...

Result > 0.7 %

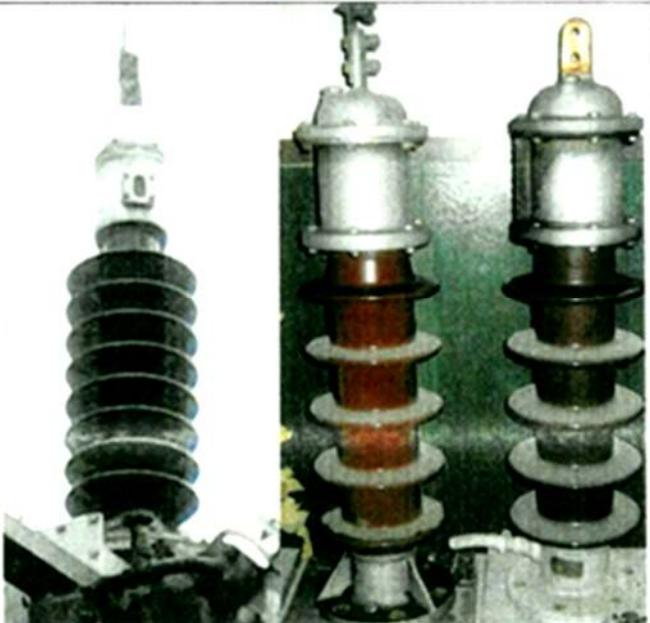
**RBP Bushings (all older types pre-1982, EE, MIC, etc)**

Measured Result	Means...

C1 Result > 1.5 %

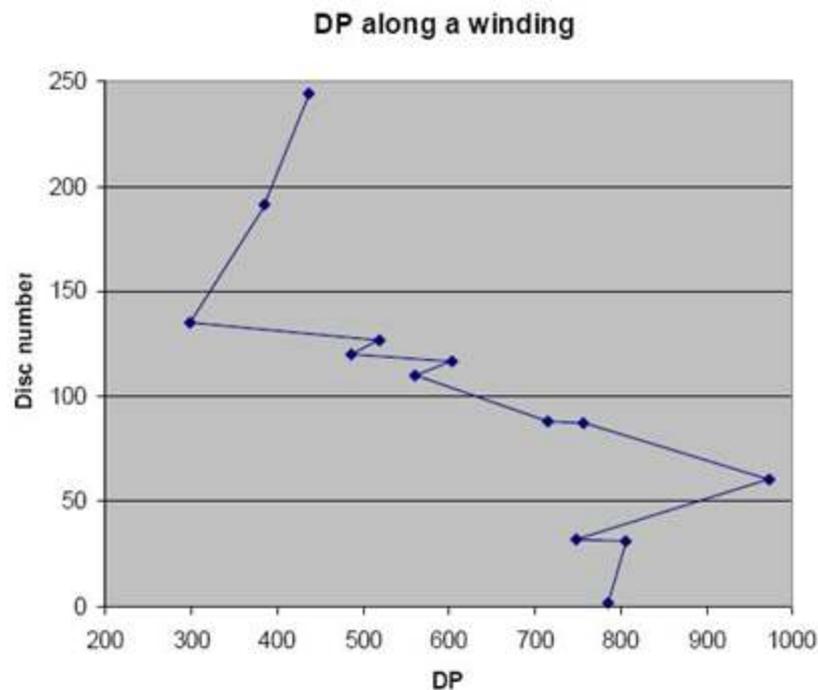
Figure 7–2 shows the results from paper sample Degree of Polymerisation (DP) measurements taken from taken from different positions along the height of the winding of a dismantled transformer.

- The hottest part of the transformer—the middle of the winding—exhibits the lowest DP value.
- The insulation at the base of the transformer remains cool for most of its life and typically suffers little degradation.

**Figure 7–2: Degree of Polymerisation throughout a transformer winding**

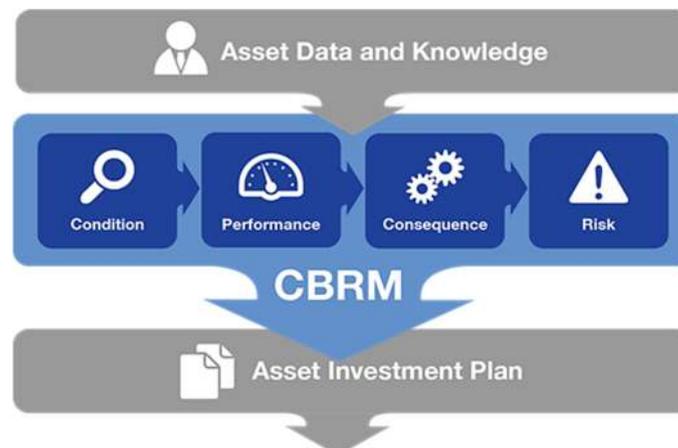
Figure 7–3 shows an overview of the CBRM. The CBRM process followed by Jemena to develop the model was:

- Determine an asset health index (HI) and ageing rate for each power transformer;
- Determine the probability of failure for each power transformer;
- Determine the consequences of failure;
- Evaluate the associated financial risk, and
- Assess future scenarios and options

**Figure 7–3: CBRM Overview**
