**Power and Water Corporation
Preliminary Business Case – Category B**

PRD33006

Replace Port Feeder

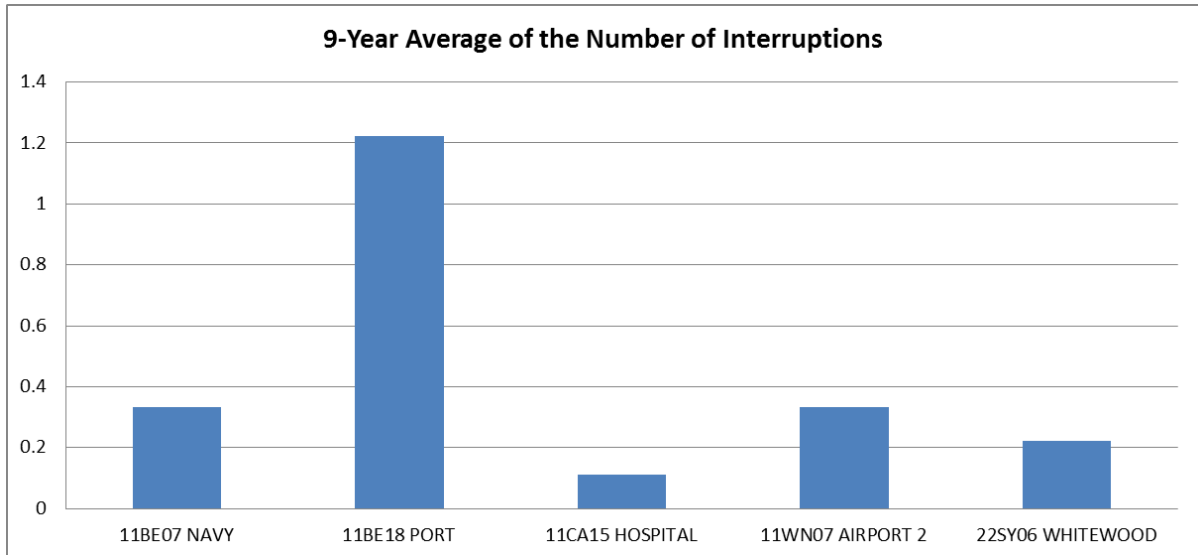
Figure 3. Average number of Interruptions in comparison to similar feeders
