## Program Business Need Identification

### Power and Water Corporation

**NMP3/PRD33395**

### 66kV HLC Circuit Breaker Replacement Program

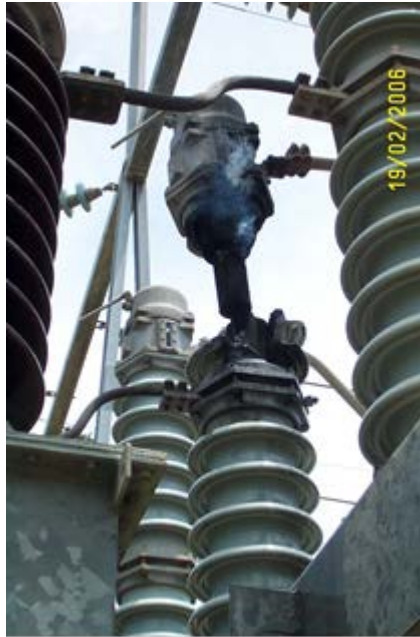
Figure 2 – Failed HLC circuit breaker at Snell Street zone substation

HLC circuit breakers have also failed catastrophically at Berrimah zone substation circa 2002 and Snell St zone substation in 2006. Other utilities in Australia have had catastrophic failures of HLC circuit breakers due to similar failure modes, including at least three failures out of less than 100 installed at a utility<sup>2</sup> in a similar climate zone to PWC.

Figure 2 below shows the aftermath of the 2006 failure at the Snell Street zone substation in Darwin.
