Program Business Need Identification

Power and Water Corporation

NMP1 / PRD33433

Darwin Northern Suburbs High Voltage Replacement Program

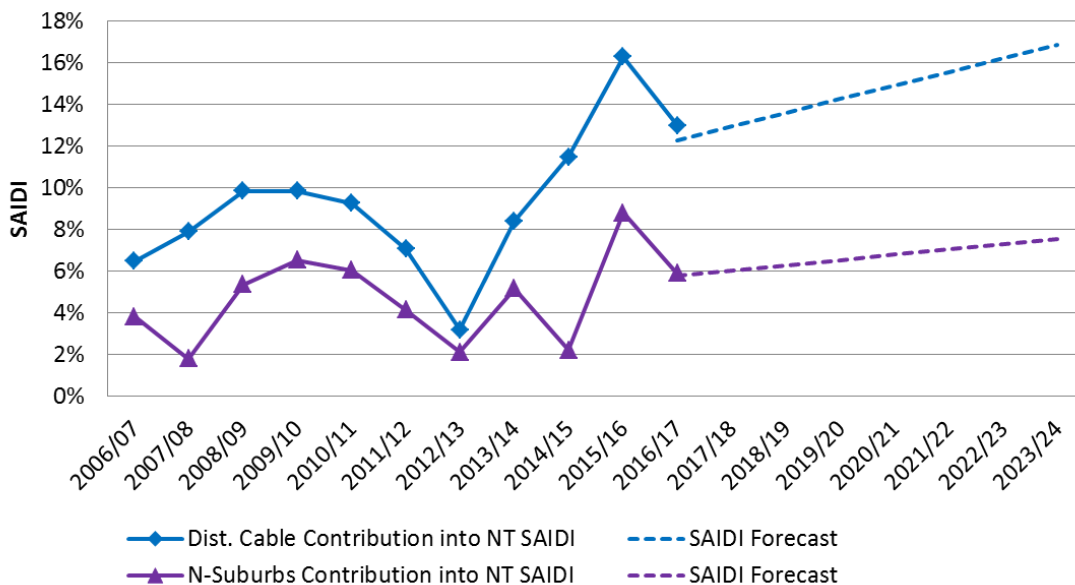
cables with aluminium screen conductors typically account for more than half of HV cable NT SAIDI contribution.

Figure 1 - Northern Suburbs Cable NT SAIDI Contribution and Forecast Trend (Linear)

Increasing XLPE cable fault rates have been observed in these installations in recent years, nearly doubling over the last 9 years, and contributing 5% and 3% to the total Darwin System SAIDI and SAIFI respectively for the period July 2013 to June 2017. The XLPE cable faults over the last four years calculate to 3% of the customer minutes lost (CML) in Darwin⁵. Figure 1 below demonstrates the trend and contribution of cable failures in the Northern Suburbs. While only making up 12% of the total HV cable population, the XLPE

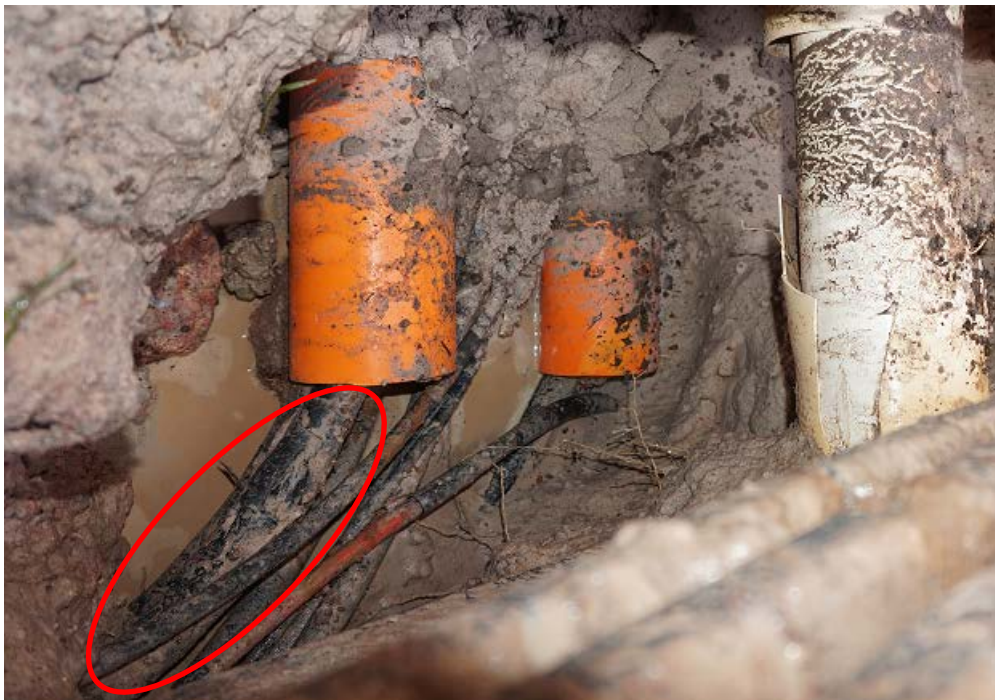
Personnel working adjacent in the proximity of live HV cables are also at risk. This is a relatively frequent occurrence during emergency repairs or preliminary inspections for capital works. There has been at least one instance of a cable failing in the months after it was inspected via vacuum excavation of a cable pit. The photo in Figure 2 was taken during the inspection, and shows the cable and the location of the fault prior to the fault occurring.

Figure 2 – Cable inspected prior to failure

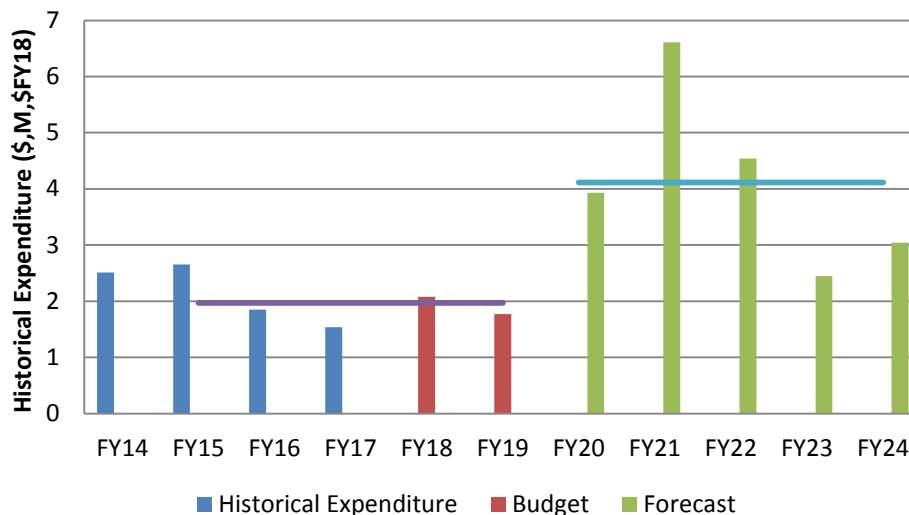
Figure 3 below summarises the historical and forecast expenditure for 11kV cables. The increase in expenditure in the next period reflects the increasing risk associated with continued deterioration of 11kV cables in Darwin’s Northern Suburbs and the Port Feeder⁹. Note that the increasing failure rate may lead to increased expenditure in the FY18 and FY19 budget years to replace cables that fail and are not able to be repaired.

Figure 4 Historical and Forecast Expenditure 11kV Cable Replacement

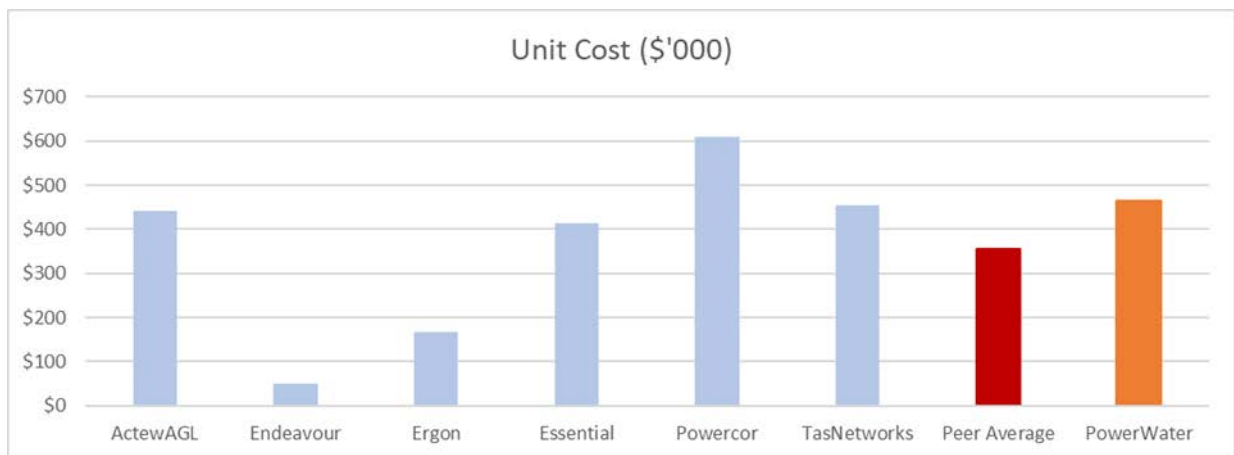
Figure 5 Unit cost comparison with other utilities

The comparison has been based on publicly available data sourced from the Australian Energy Regulator's (AER's) Repex modelling and utilities' Regulatory Information Notice (RIN) submissions. There are a number of internal and external operational, asset type, and environmental factors that influence the benchmark costs and provide a challenge in respect of the ability to undertake accurate comparisons. Normalisation for these factors has not been undertaken and the benchmark comparisons provided are an indicative measure of reasonableness only.

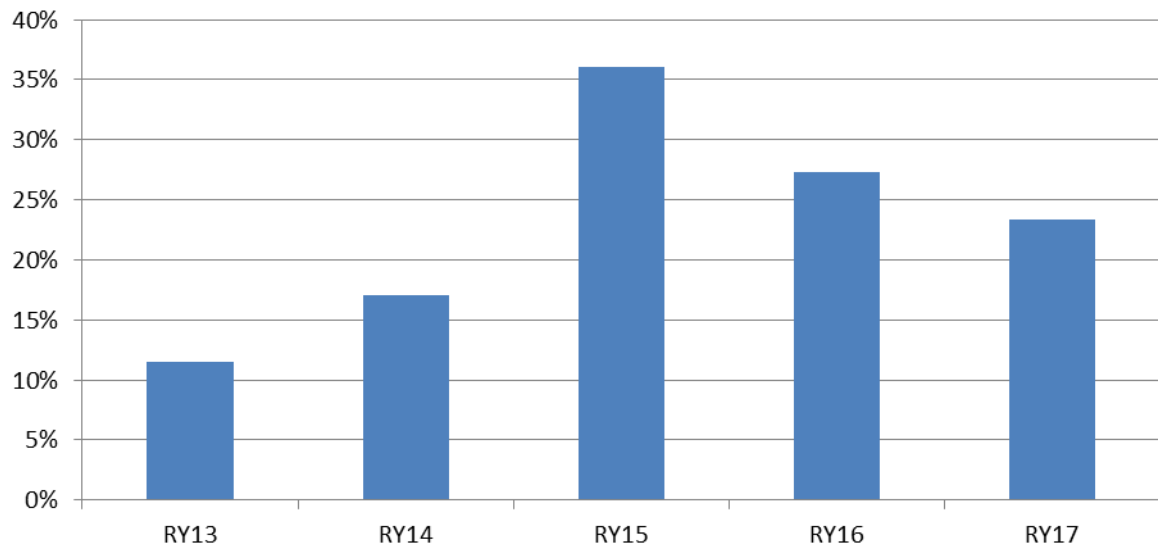
Corrective maintenance expenditure associated with the Northern Suburbs cables is significantly over represented in comparison with the wider cable population. The 103km of affected cables represents 6.5% of the total LV and HV cable population, but the maintenance costs associated with the population is significantly higher (approximately 23% on average) as demonstrated by Figure 5 below. The proportion of spend has reduced in recent years due to a cable joint type issue emerging in the Palmerston area.

There has been a reduction in cable related expenditure during the current period, despite the increase in failures, as result of improved repair and testing practices and an improvement in the capitalisation processes for cable replacement activity. Expenditure prior to the introduction of contemporary testing practices was much higher, due to a combination of additional time required to locate faults and attempting repairs multiple times on cables that were not serviceable.

Figure 6 Historical Maintenance Expenditure – All cables and Northern Suburbs Cables
