Program Business Need Identification

Power and Water Corporation

NMP2

Low Voltage Cable Replacement Program Cullen Bay and Bayview

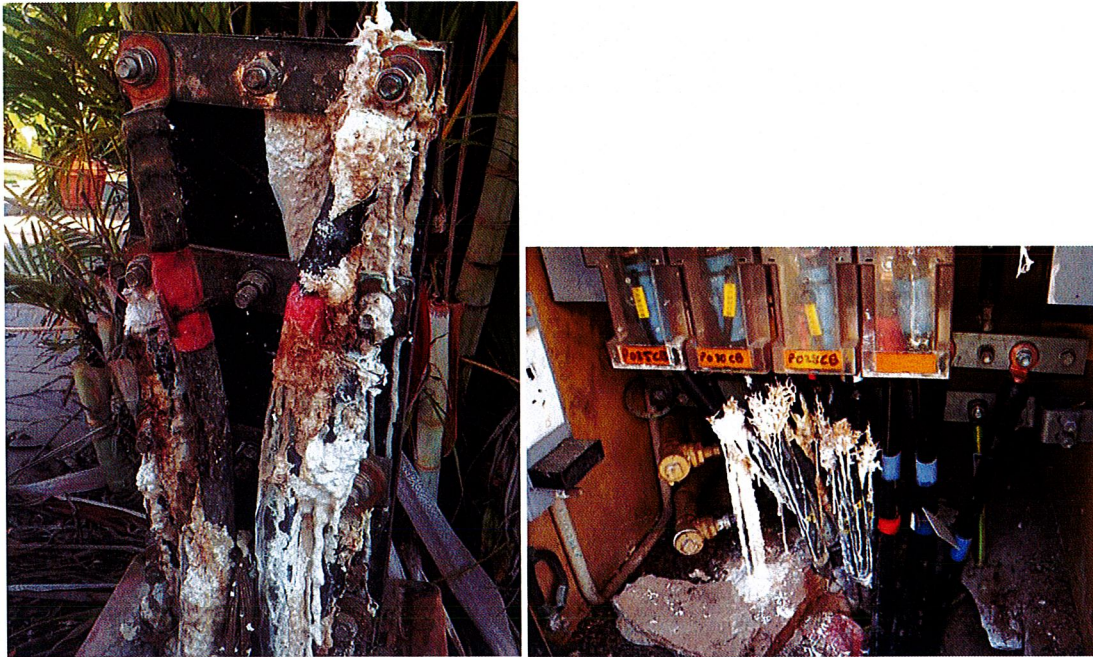
Figure 1 - Examples of Calcium Adipate in Pillars (left) and Substations (right)

Risk Factor	Description of Hazards
Calcium Adipate	<p>Calcium adipate is produced when water reacts with certain compounds or "fillers" in the cable insulation². Examples shown in Figure 1</p> <p>Places high physical stress on the cable insulation, resulting in localised insulation and sheath cracking and swelling.</p> <p>The adipate enters cable lugs, expanding the lug and causing high resistance joints, these are undetectable on neutrals.</p> <p>Conductive when wet placing personnel at risk when working on pillars or fault finding.</p>
Sheath Degradation	<p>Cables excavated for failure replacement or other works have consistent damage to the outer sheath.</p> <p>The damage allows water into cable to which then reacts with the cable insulation fillers to produce calcium adipate.</p> <p>Reduces insulation performance due to water ingress into cable and XLPE insulation.</p>
Insulation Resistance	<p>Insulation Resistance (IR) of 50% of cables sampled was very low, with a high proportion below 1MΩ. Refer to Appendix B for a summary of testing performed.</p>
