Program Business Need Identification

Power and Water Corporation

NMP7 / PRD33448

Darwin Distribution Substation Fault Level Replacement Program

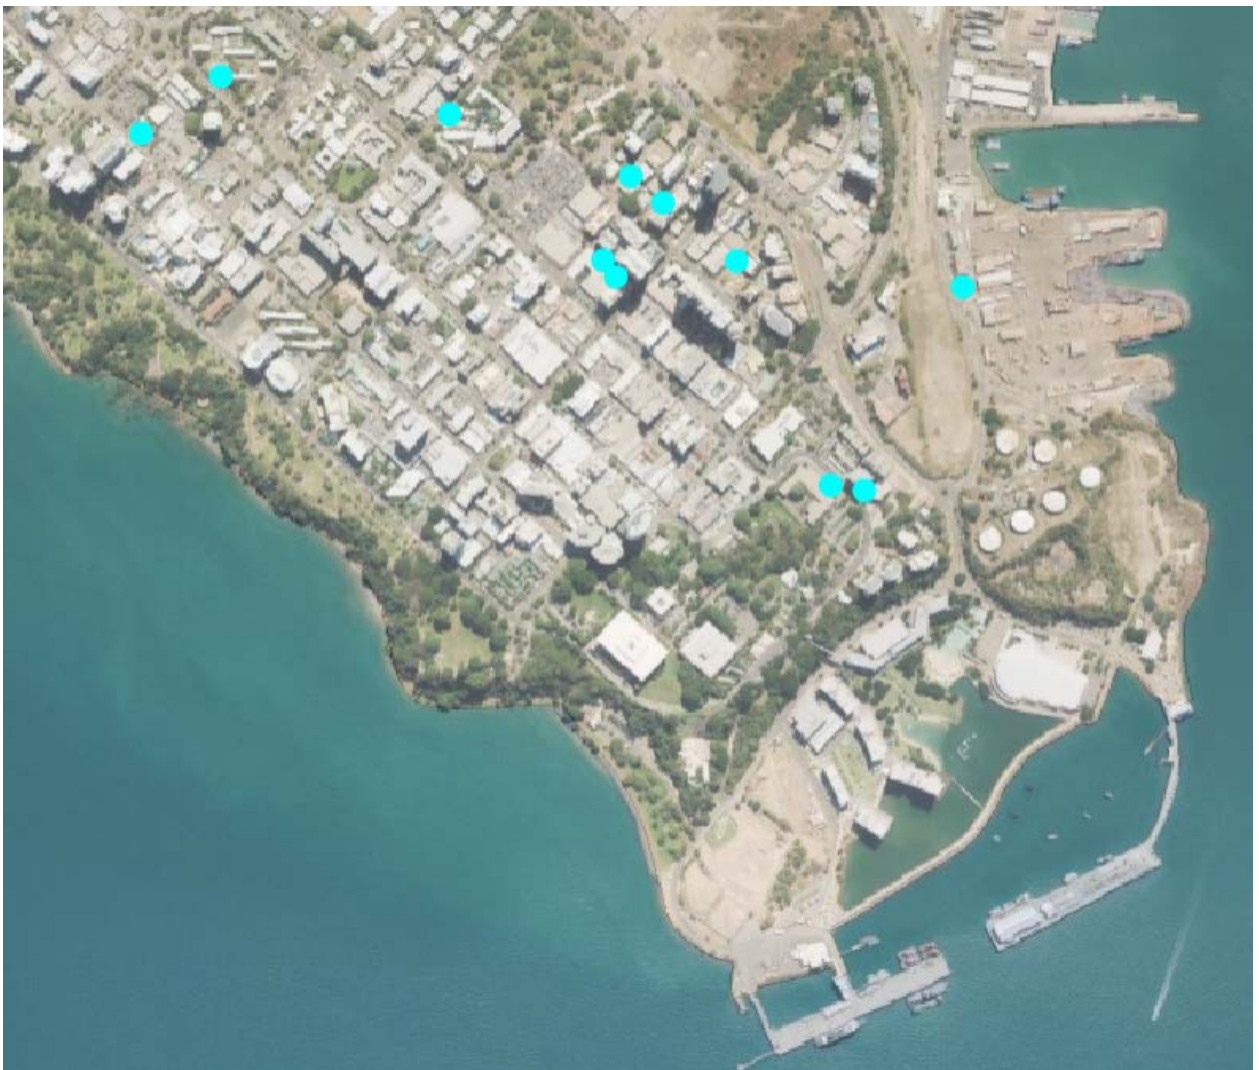
The affected switchgear is mainly located in the Darwin region, with the majority installed in the CBDs of Palmerston and Darwin City. These areas are characterised by high pedestrian traffic, increasing the likelihood of interaction with the public and therefore the risk associated with switchgear failure. Figure 1 shows the location of the units exceeding fault level rating in the Darwin CBD.

Figure 1 – Location of Magnefix units exceeding fault level ratings in Darwin CBD

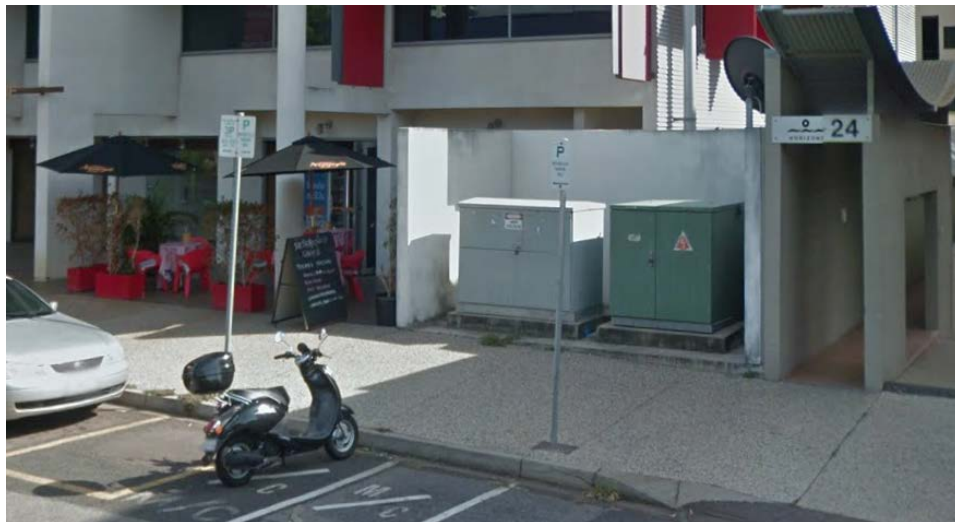
Figure 2 shows a unit exceeding fault level capacity installed in a high-traffic CBD location.

Figure 2 – High Traffic Location in Darwin CBD
