Program Business Need Identification

Power and Water Corporation

PRD33394

Transmission Line Pole Top Replacement Program

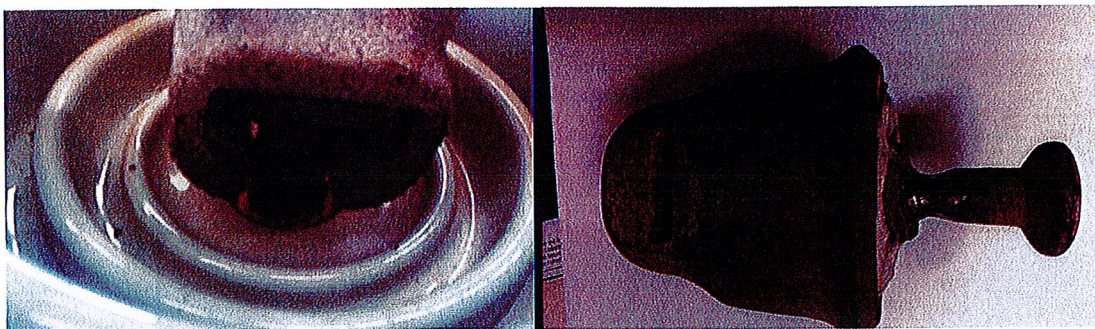
Corrosion of porcelain insulators in suspension configuration is known in the industry as a common failure mode of insulators¹. Corrosion generally occurs at the live or “hot” end where they connect to the conductor due to leakage current through the insulator, particularly when wet. In the Darwin region, a concerted condition based replacement program was undertaken over the last five years, targeting transmission line insulators where advanced corrosion or damage from lightning was identified. An increased awareness of corrosion issues has also led to more insulators being identified for replacement during tower inspections. The program replaced around 5.5%, or 142 transmission insulator installations. Despite this active replacement effort, recent inspections confirmed an ongoing need for investment in upholding the health of the transmission network insulator population.

Figure 2 - Example Corrosion and section loss after cleaning on 132kV Insulator Disc from Tower 9A
