Cox Peninsula Centre Yard Substation Condition Assessment Report

Cox Peninsula Centre Yard Zone Substation Condition Assessment Report

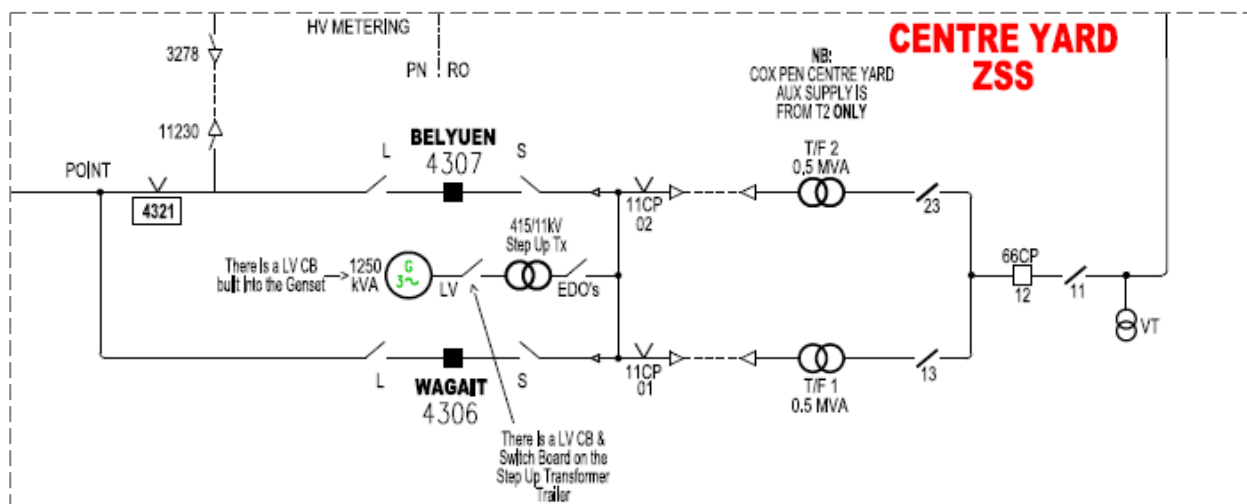
4 Single Line Diagram

Cox Peninsular Centre Yard Zone Substation was established in 1972. The substation is supplied by a single overhead 66kV line which is fed via a subsea cable from Darwin. The 66kV yard is an outdoor type and the 66kV CB is an ASEA HLC minimum oil type. There are two 66/11 kV 0.5MVA transformers supplying two overhead feeders which supply the township of Wagait and local communities.
