Power and Water Corporation

Darwin to Katherine Transmission Line (DKTL) Substations Condition Assessment Report

Channel Island Substation Condition Assessment Report

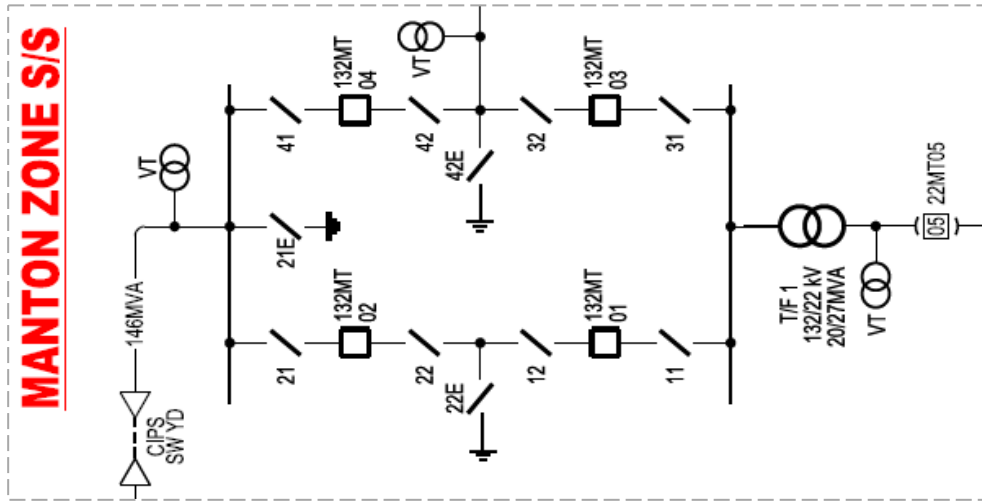
4 Single Line Diagram

132kV Outdoor Switchyard

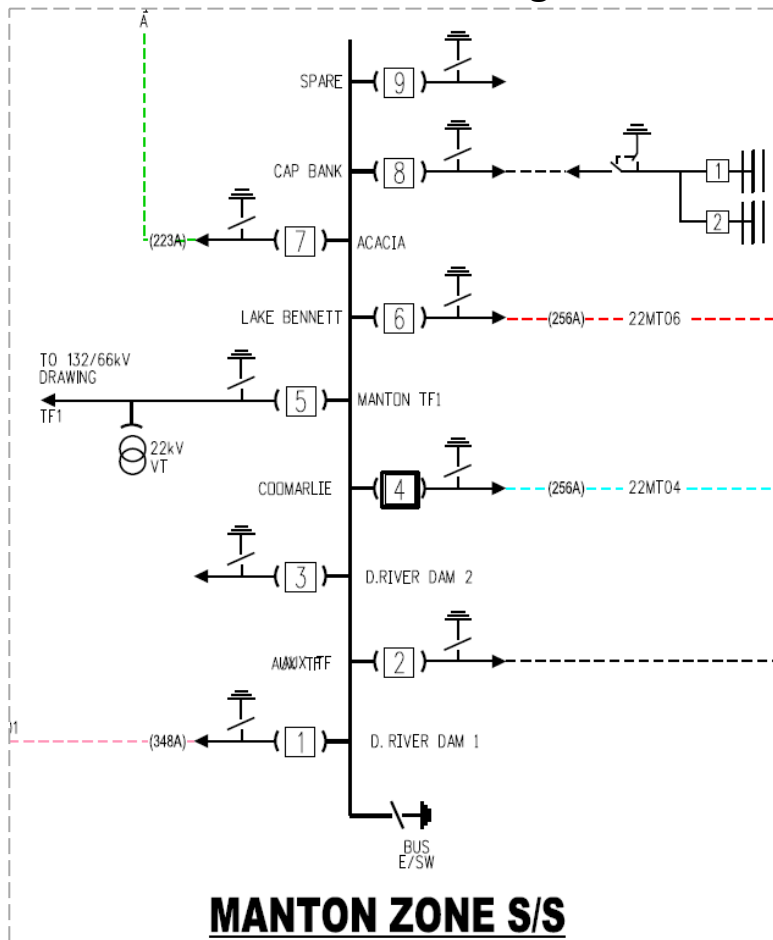
22kV Indoor Switchgear

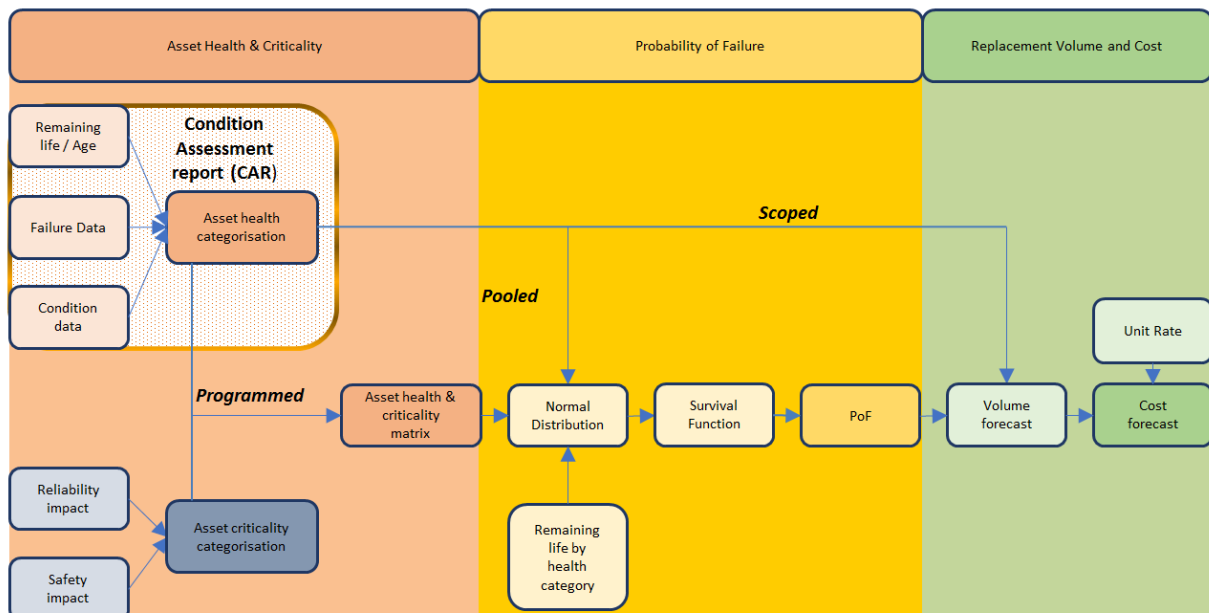
Figure 1 - Role of CAR in the PWC asset management process

This condition assessment report (CAR) provides a structured condition assessment of all the assets in a format aligned to the PWC asset hierarchy¹ and applying the condition assessment criteria² for each asset class within the Batchelor ZSS. The CAR collates and summarises information from various PWC data sources that are either in raw data format or conditioned data and is traceable to the source. The following diagram illustrates where the CAR sits within the asset management process within PWC.

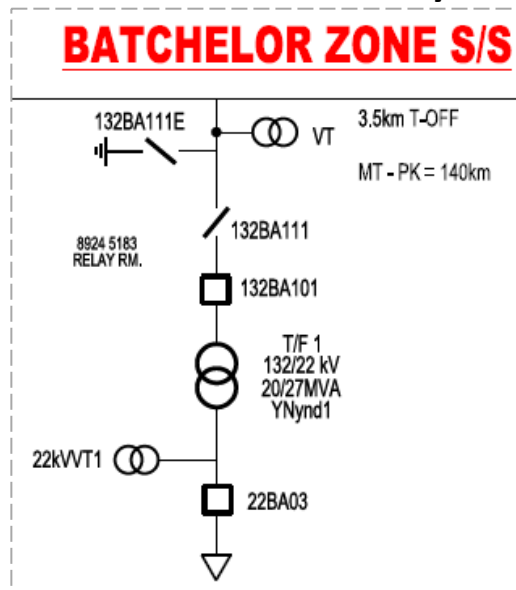
4 Single Line Diagram

132kV Outdoor Switchyard

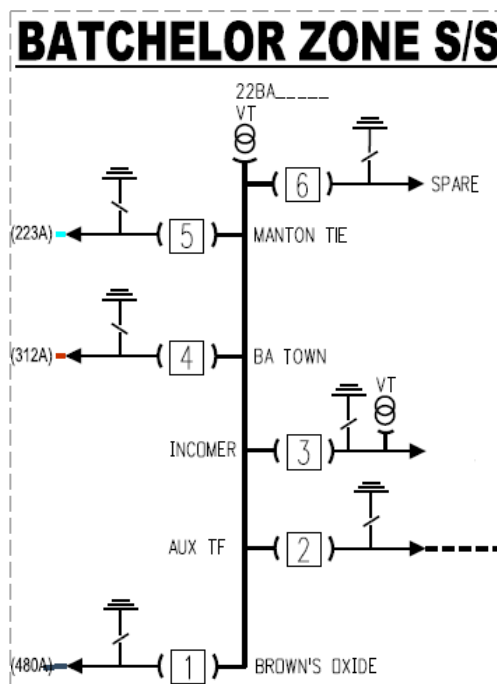
22kV Indoor Switchgear

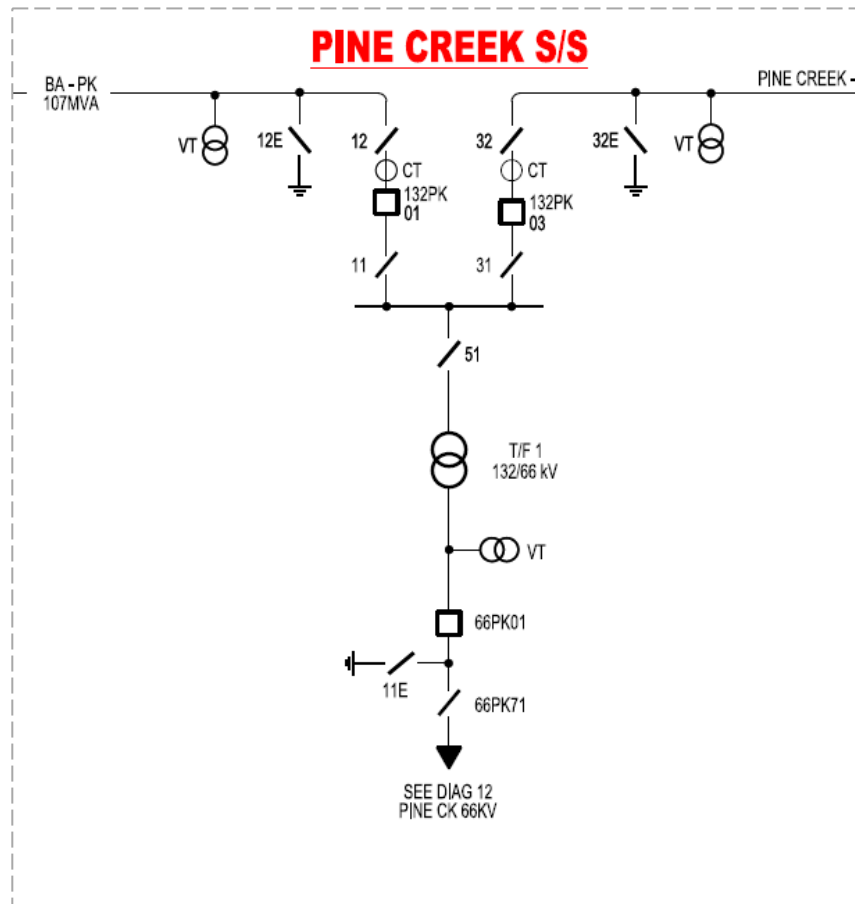
4 Single Line Diagram

Pine Creek 132kV substation is part of the Darwin – Katherine 132kV system. It also radially supplies the Pine Creek ZSS and the radial 66kV sub transmission system.

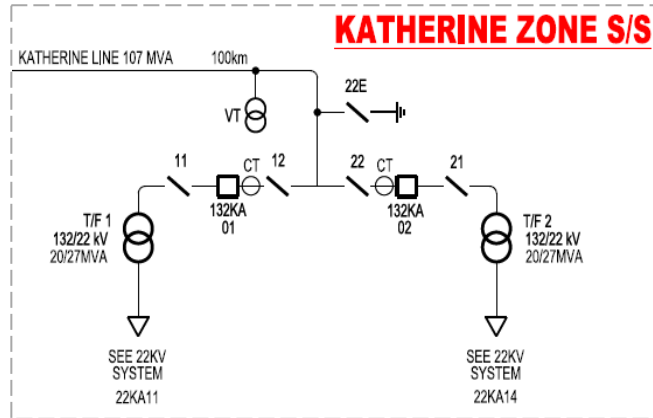
3 Single Line Diagram

132kV Outdoor Switchyard

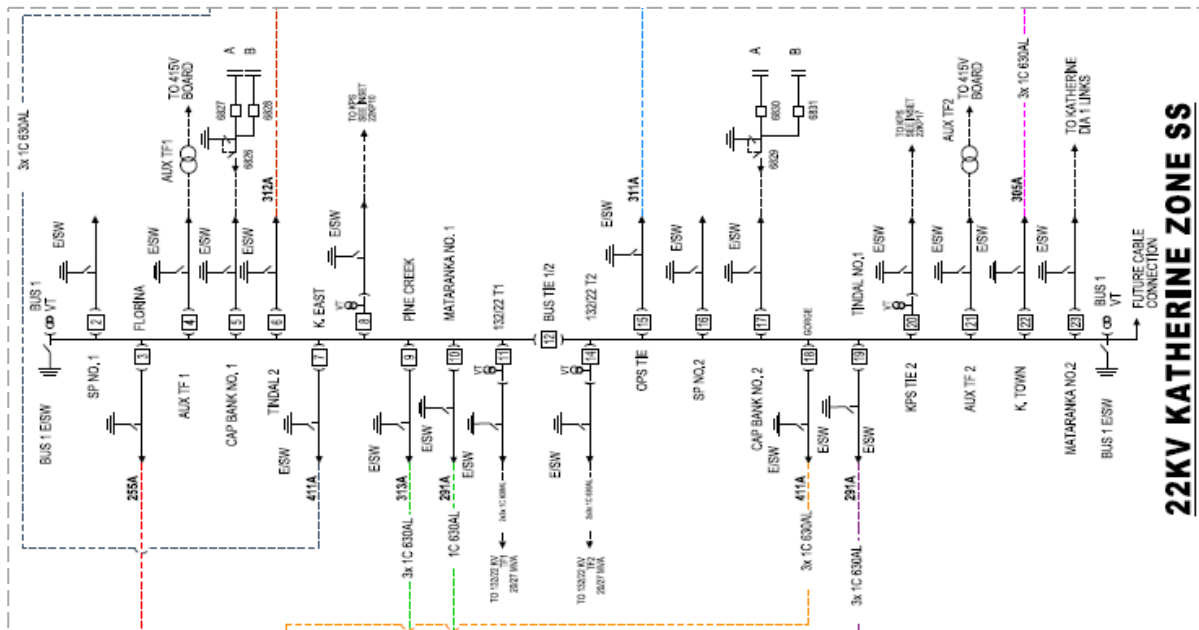
22kV Indoor Switchgear
