# Distribution switchgear

Regulatory Business Case (RBC) 2024-29

**This business case addresses the high safety risk of the Hazemeyer MD4 type distribution switchgear.**

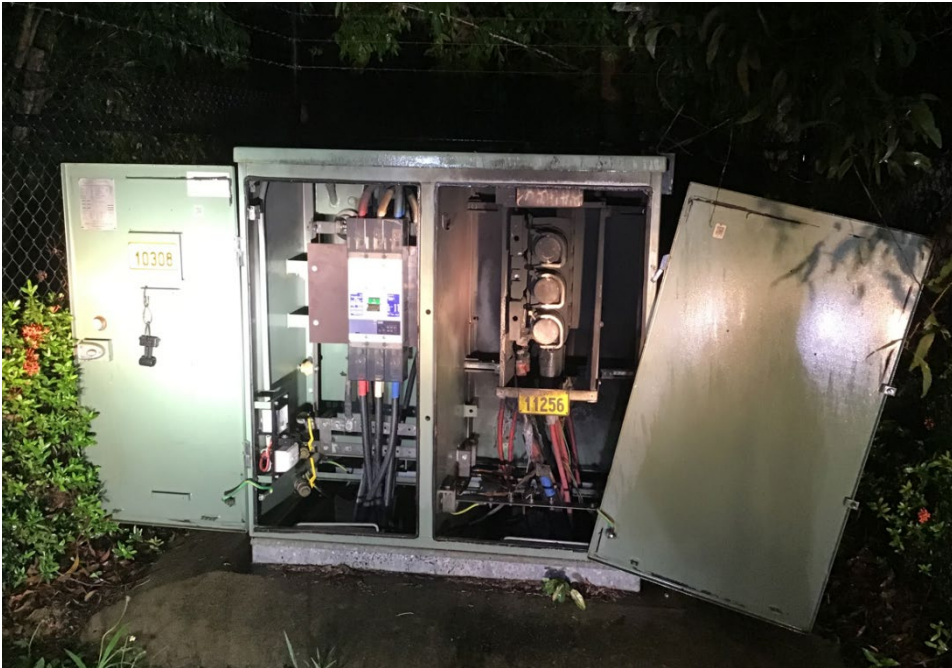
- A failure on Salonika Street, Stuart Park (DT-2510, identified in GRACE Incident 3811) that resulted in the doors being blown off. The investigation report noted anecdotal reports of other similar events occurring, prior to investigation processes being established for these types of asset failure events.
- Figure 2 shows DT-2850 following explosive failure. This failure resulted in a prolonged outage of 6 hours and 20 minutes that affected 96 customers.

This indicates a systemic issue with the insufficient fault rating of the switchgear type, and the resultant safety hazard.

Figure 2 Photo of switchgear enclosure following explosive failure (DT2850)
