Cullen Bay and Bayview LV Cable Replacement (NMP2)

Regulatory Business Case (RBC) 2024-29

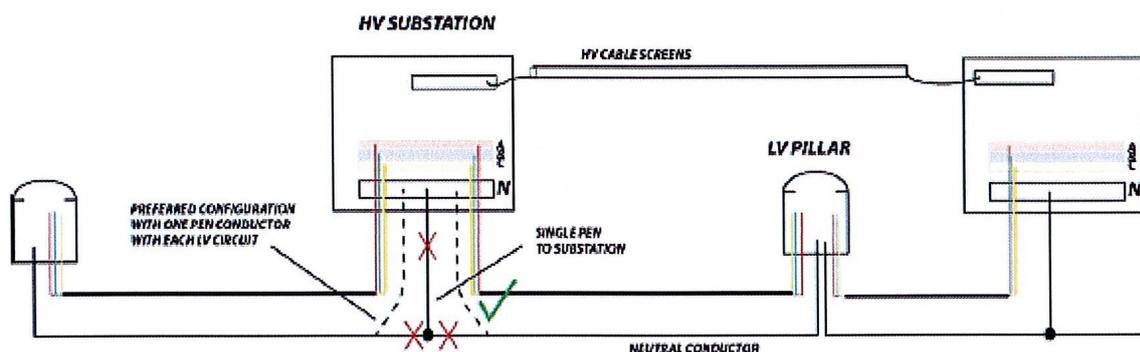
In Cullen Bay Neutral conductors are "shared" creating many single points of failure as explained in Figure 1.

Figure 1 Cullen Bay Neutral Configuration and Single Points of Failure

The LV neutral earthing system in Cullen Bay is also compromised. The LV neutral conductor connection between a substation and the network being supplied is one of the fundamental components of the TN-C-S (Australia's MEN) network configuration as described by AS/NZS 3000. As such, an LV neutral conductor is reticulated to all locations of the supplied LV network (Protective Earth and Neutral, PEN). Throughout Australian utilities, this is generally achieved through the installation of a neutral conductor with each LV circuit leaving a substation. This is to ensure redundancy and interconnectivity of the Multiple Earthed Neutral (MEN) system. This is not the case in Cullen Bay.

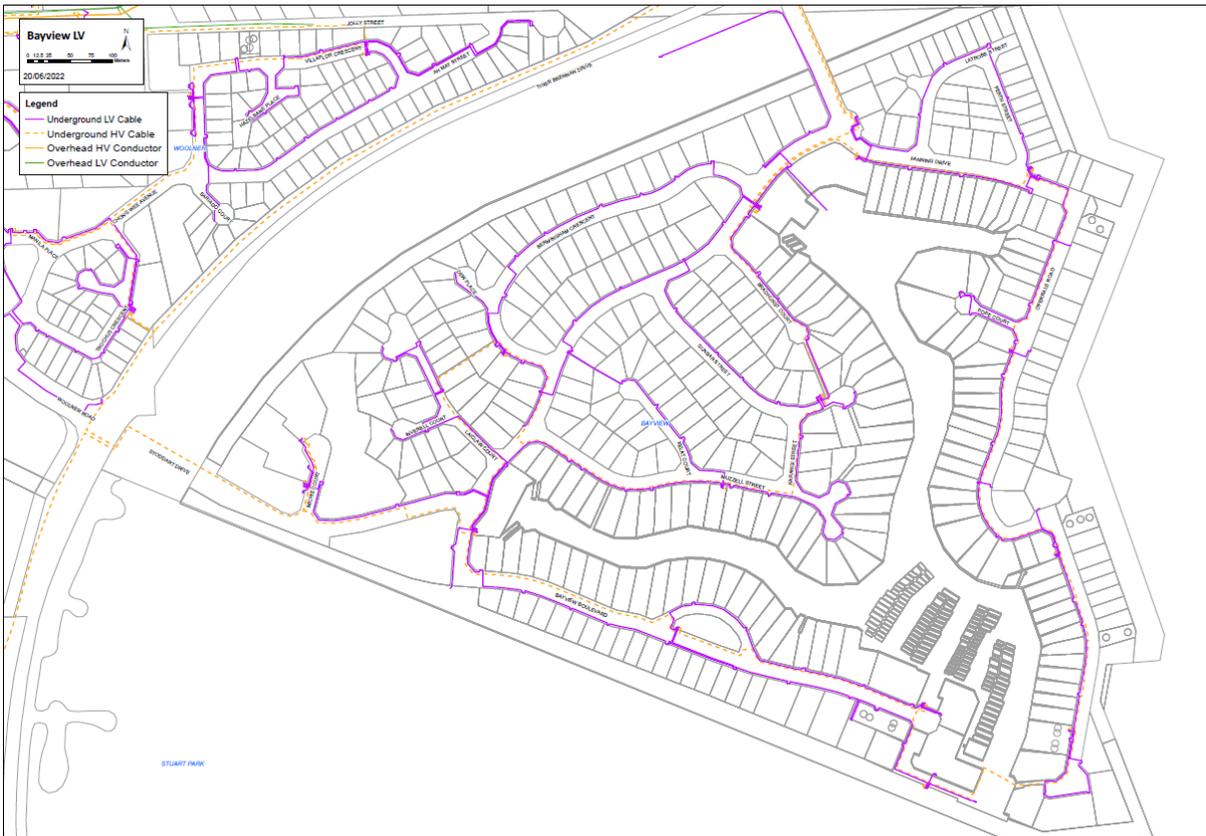
Figure 2 Bayview area

The location of these assets on the network is shown in Figure 2 and Figure 3. The geographical areas are small, however, access to the cables is complicated due to other underground services (that were built in close proximity to each other with the cables direct buried) and assets (such as footpaths) that have been built over the top of the cables since installation.

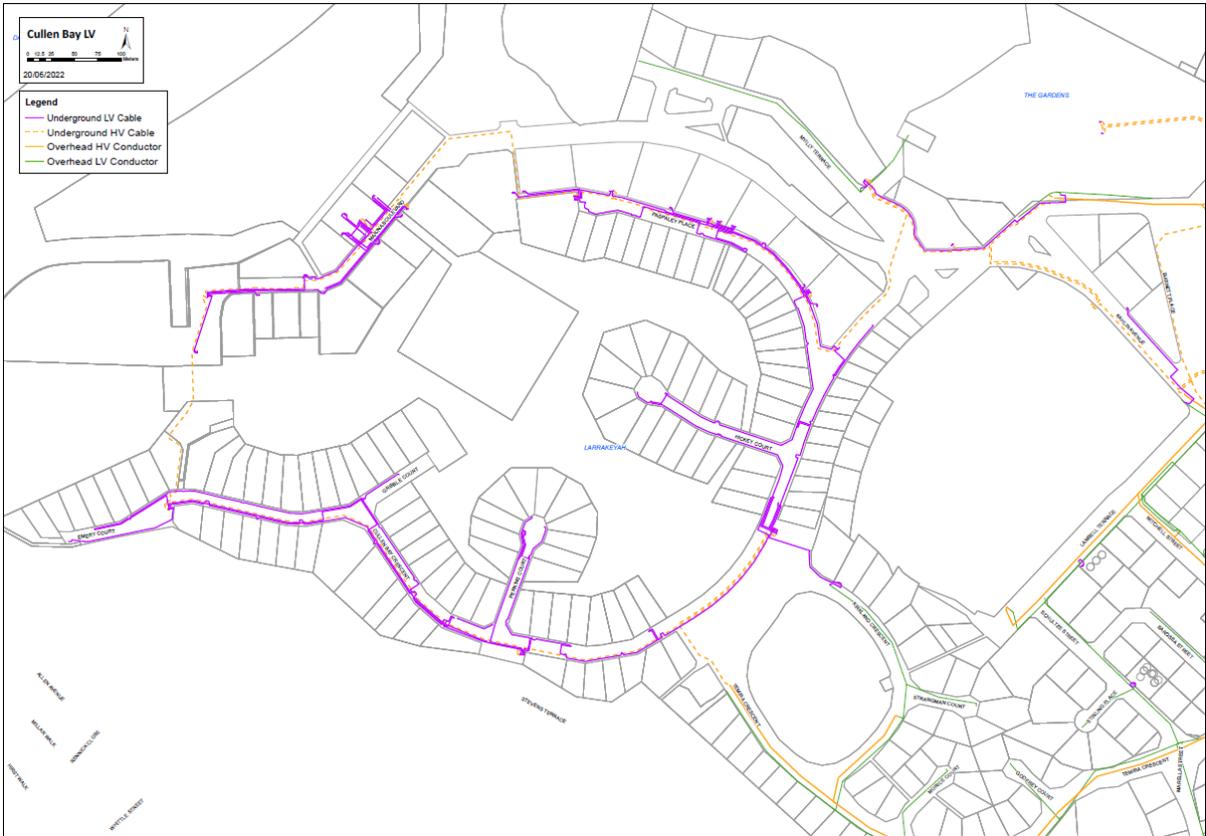
Figure 3 Cullen Bay area

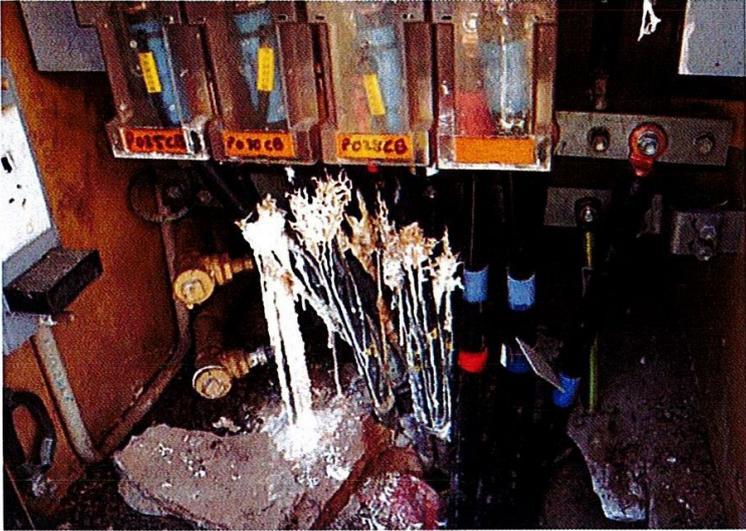
Risk factor	Description of hazards
<p>Calcium Adipate</p>	<p>Calcium adipate is produced when water reacts with certain compounds or "fillers" in the cable insulation². Issues caused by calcium adipate include:</p> <ul style="list-style-type: none"> • The adipate expands inside the cable and places high physical stress on the cable insulation, resulting in localised insulation and sheath cracking and swelling. • The adipate enters cable lugs, expanding the lug and causing high resistance joints, these are undetectable on neutrals. On phases these cause hot spots and eventually result in failure of the joint. • It is conductive when wet placing personnel at risk when working on pillars or fault finding. • A safety alert was issued by Ausgrid in 2015 describing the same issue. The issue affects cables that were produced prior to 1995. <p>Examples are shown in Figure 4 below.</p>

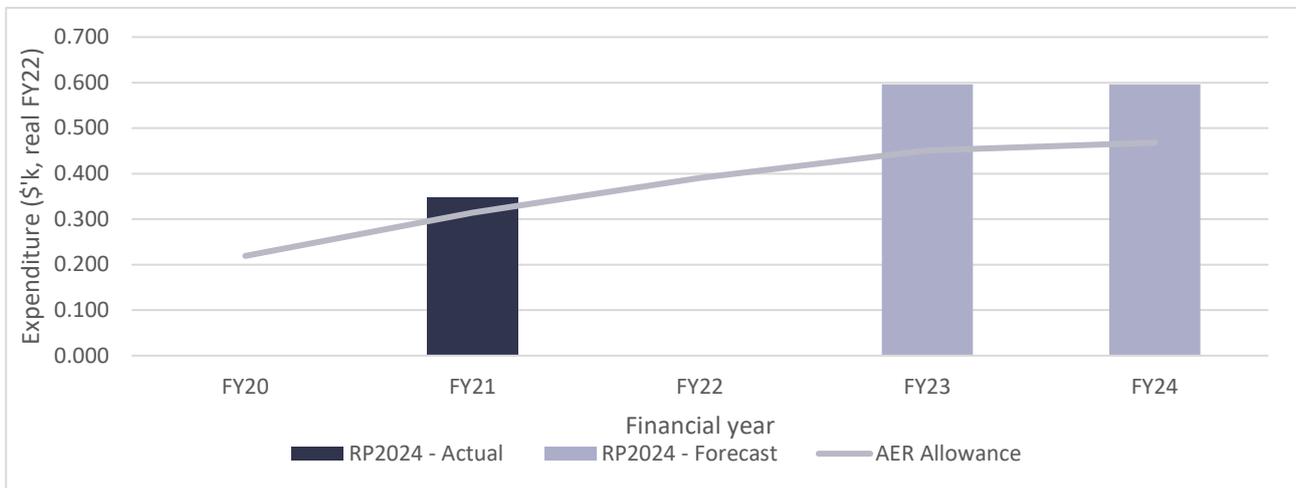
Figure 5 shows the actual historical volumes and costs (adjusted to real 2021/22 dollars) that have been implemented and the projected volumes and expenditure to the end of the current regulatory period. The step increase evident in 2022/23 is the direct result of the new contracting arrangement enabling rapid replacement, and following completion of the procurement processes.

Figure 5 Expenditure on the Cullen Bay and Bayview LV cables

By the end of this regulatory period, Power and Water expects to have replaced 4km. The total cost to achieve this will be \$2.2 million (real 2021/22) being 121% of the original forecast expenditure. The focus of the current regulatory period is primarily on the Cullen Bay area to rectify the deficient earthing arrangement. Following Cullen Bay, the program will continue with Bayview.

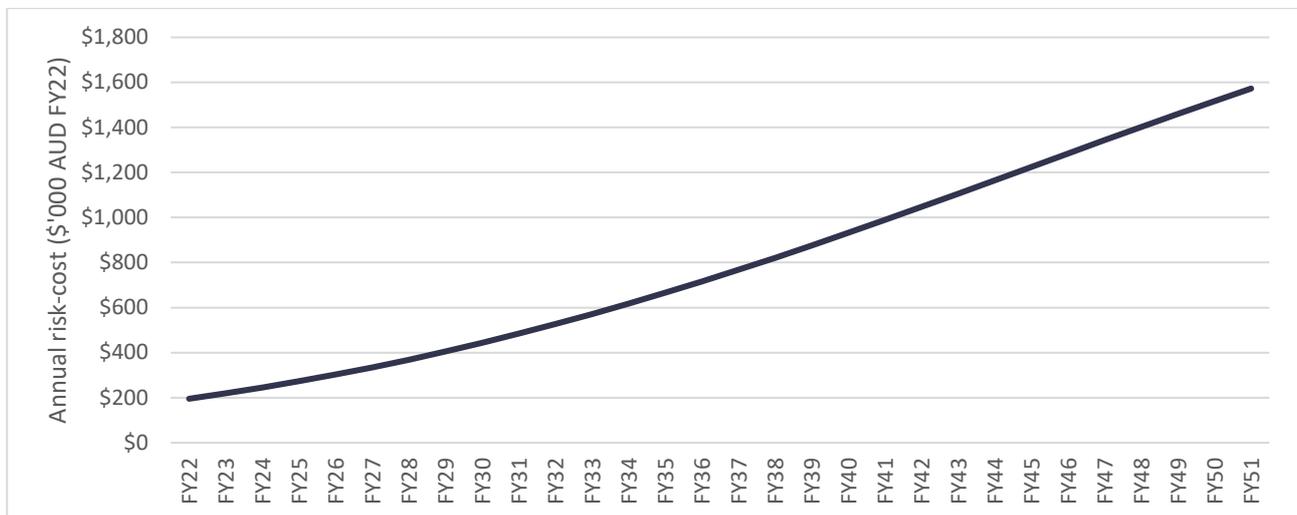
The assessment has been undertaken based on the counterfactual case, that is, on the basis that Power Services does not undertake any specific measures to address the risk and only addresses faults reactively. Figure 6 below shows the increasing level of risk that would be incurred by Power Services in the absences of any mitigating actions.

Figure 6 Current risk with base case scenario

The dominant components are the economic impacts of outages, calculated based on the Value of Customer Reliability (VCR). While the consequences of health impacts are significant, the probability of them materialising is very low and we have no historical data to use, so we have relied on the probabilities suggested by Ofgem as documented in our Risk Quantification Procedure.

The risk assessment demonstrates that there is an increasing risk, that across the fleet of assets, is likely to materialise. The reduction in risk that is achieved by different credible mitigation options, along with the cost of the option and any other direct financial cost savings, is used to identify the preferred option in section 3.

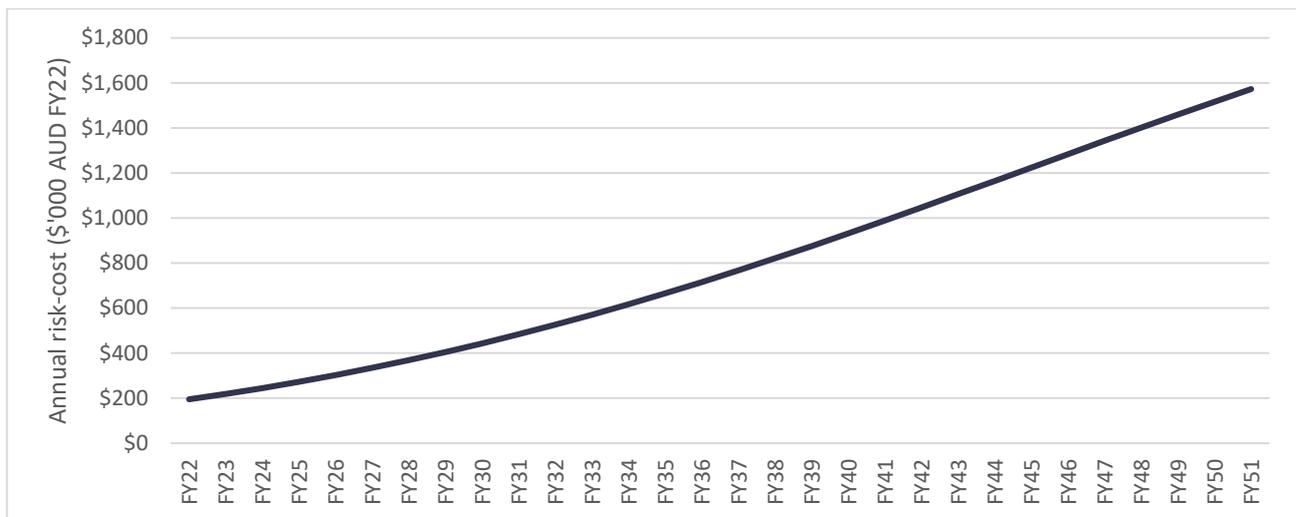
Figure 7 shows the risk profile outcome from applying our Risk Quantification Procedure. This option was assessed to result in the highest risk cost of the three options, indicating the worst network performance.

Figure 7 Risk profile achieved through Option 1

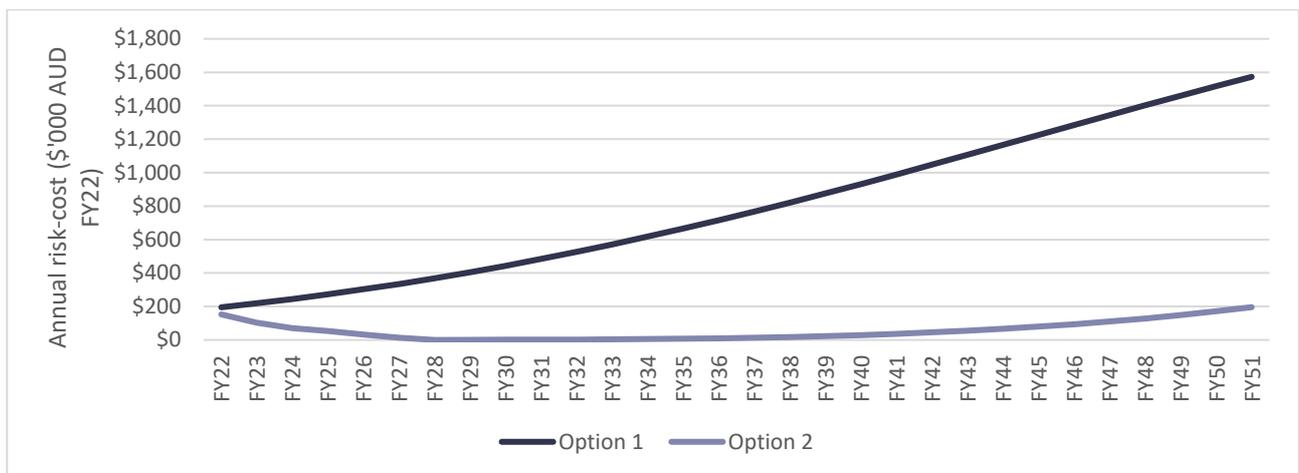
The risk-cost outcomes for this approach, based on continuing the current program, have been determined through the Risk Quantification Procedure, shown in Figure 8.

Figure 8 Risk profile achieved through Option 2

The modelling assumed the works would be carried out across a five year period (at 1.5 km per year). The outcome was that continuing the current program has the highest benefit, as shown in Figure 8.
