POWERLINK QUEENSLAND REVENUE PROPOSAL

CP.02369

Blackwater Transformer 1 & 2 Replacement

ID&TS - Reset 2017/18-2021/22 Project Proposal for CP.02369 T032 Blackwater No. 1 & 2 Transformer Replacement

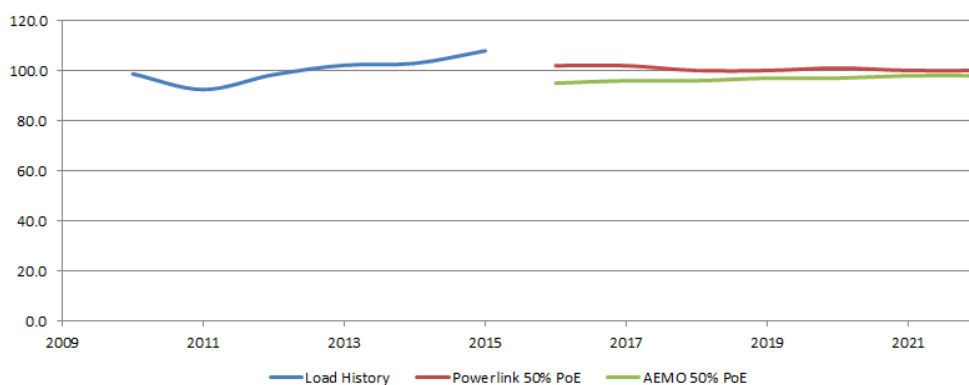
Figure 1: Historic and Forecast loads for T032 Blackwater

The historic and forecast loadings on the T032 Blackwater 132/66kV transformers are shown in Figure 1.

Load History						50% PoE Forecast						
2010	2011	2012	2013	2014	2015	2016	2017	2018	2019	2020	2021	2022
98.8	92.6	98.6	102.3	103.0	108.0	102.1	102.1	100.2	100.2	101.1	100.2	100.2
						95.1	96.1	96.1	97.1	97.1	98.1	98.1

Powerlink MVA
AEMO MVA

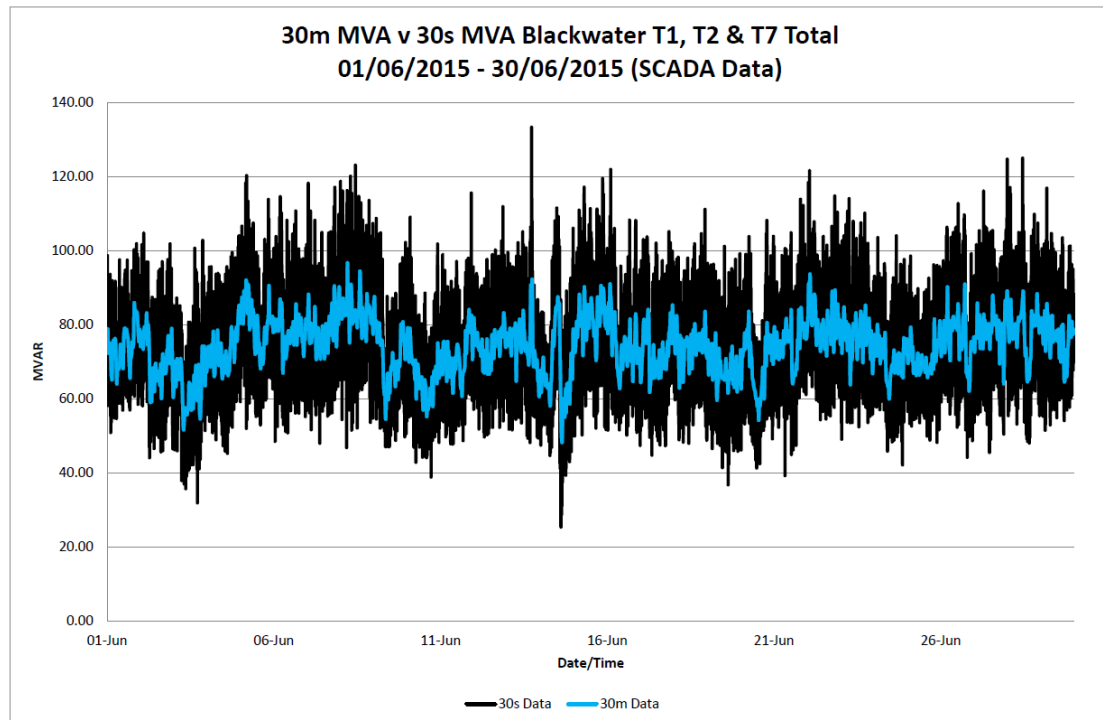
Figure 2: Load variance at T032 Blackwater

Due to the nature of the loads at T032 Blackwater, being predominantly mining load, significant fluctuations in load occur and the instantaneous load can be up to 30% higher than the 30 minute average, as shown in Figure 2. This should be taken into account when selecting appropriately rated transformers.
