Essential Energy

10.06.06 Resilience Gresford Network Investment Case

Network Resilience Project

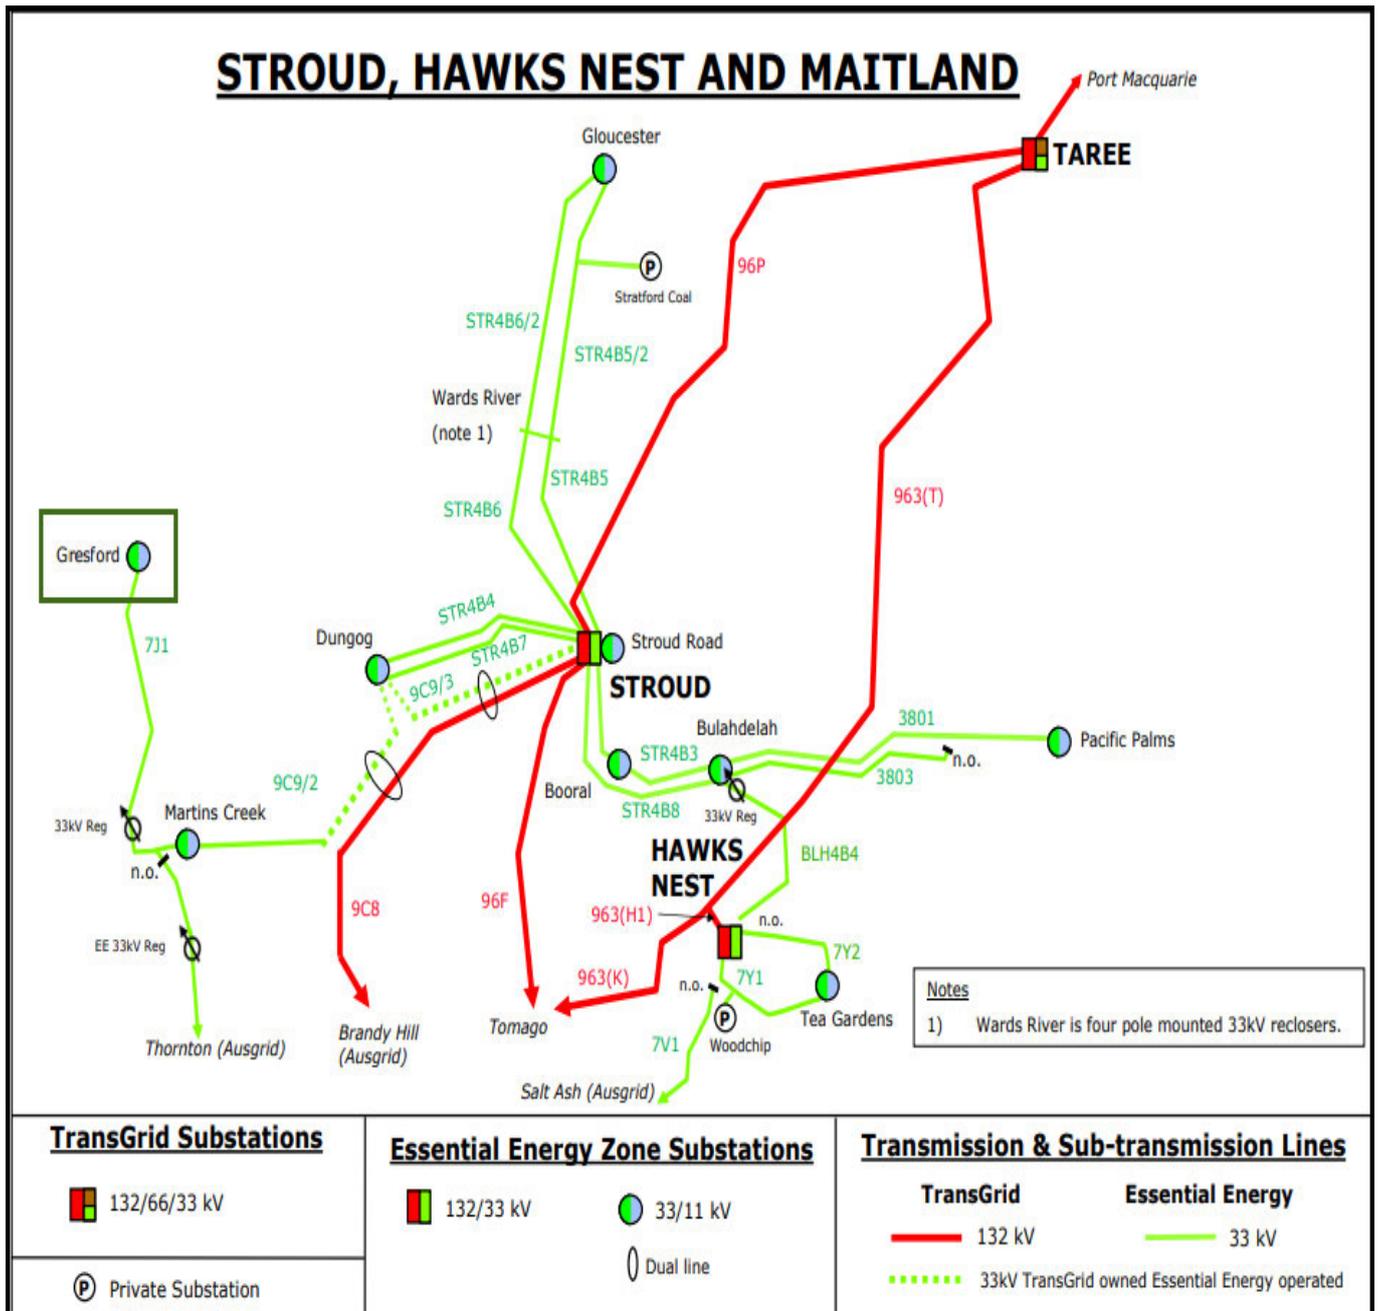
Figure 1 - Simplified Subtransmission Network

The network at this location is highly susceptible to lightning strikes, with storm/lightning fronts impacting the full length of the line which has no OHEW other than the 1km emanating from each zone substation. The forecasted load for Gresford ZS is 2.6MVA.

A significant constraint on this feeder is its co-existence with the 11kV networks GRS3B3 Gresford Rd and MCR3B4 Vacy. If works, planned or unplanned, are required on the 11kV network, it will often require the 33kV network to be isolated for safety resulting in the loss of all load at Gresford ZS.

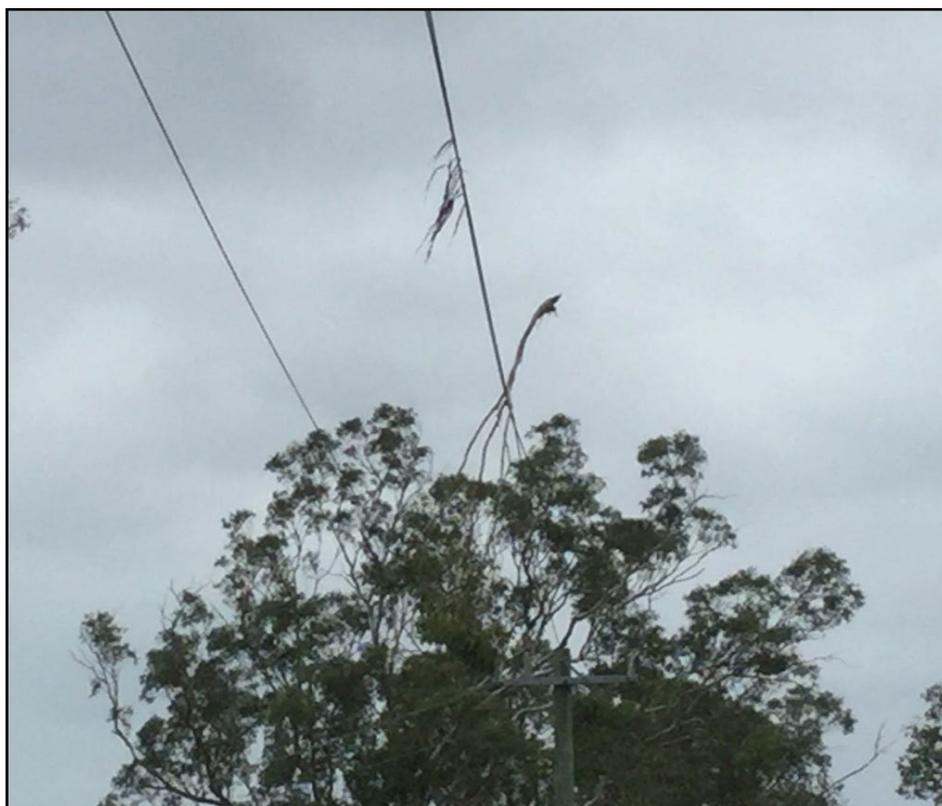
Figure 2 – Vegetations fallen across the wire INCD-2095253-a

6/03/2019: 25 hours; Due to lightning and storm multiple faults reported as vegetation fallen from outside the corridor. Multiple spans wires down from pole to pole.

| DATE | ZONE | REGION | EQUIPMENT | CAUSE | Sut | IR | Min | LCM | Comment (New Field) |
|---|---|---|---|---|---|---|---|---|--|
| Wed 06/03/19 | GRESFORD | Mid North C | Conductor - HV Failed | Veg - Trees Blown into ConN | | INCD-2095253-a | 1031 | 1187443 | Multi reports: multiple spans wires down, wires in tree, tree over 33kV and 11kV conductors, s |

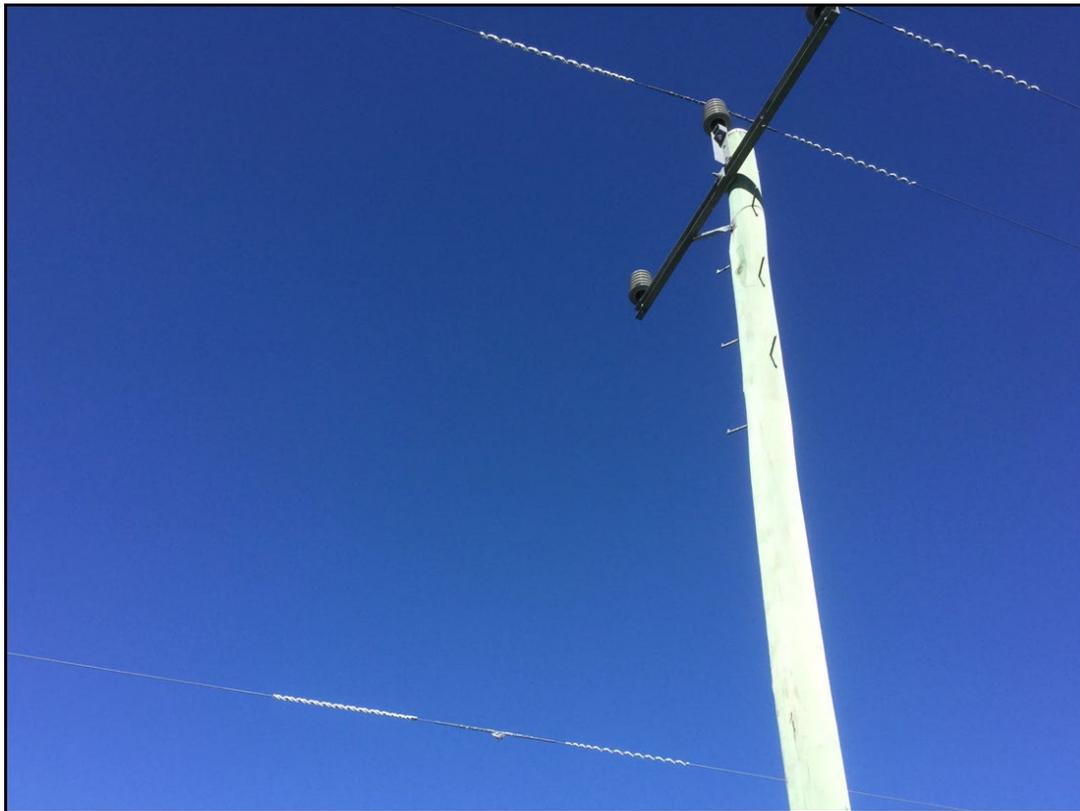
Figure 3 – Broken insulator INCD-20100-r

4/04/2020: 3 hours; Due to wind contributed to the equipment fatigue. The main cause was a broken insulator pin Pole 97069077.

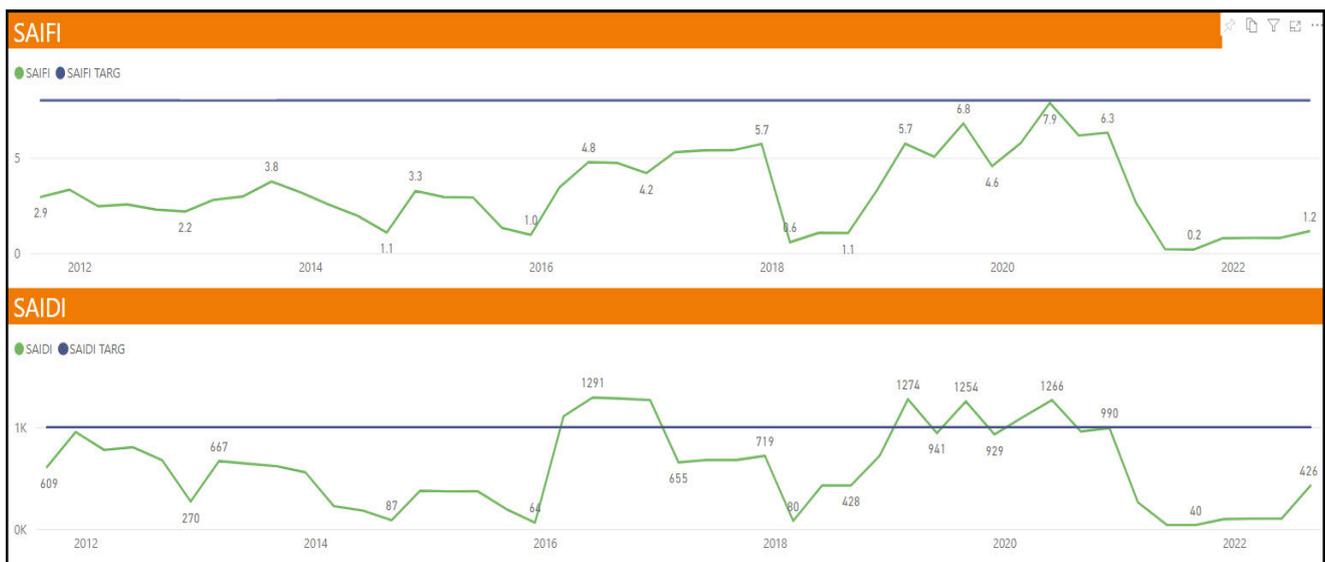
Figure 4 - SAIDI/SAIFI Performance of the GRS3B1 feeder

Further historical reliability data for this feeder can be found in Appendix A which shows the vast majority of outage causes attributed to adverse weather conditions. The SAIDI and SAIFI of the 3 feeders is as shown in Figure 4. The longest feeder is 126km in length with 486 customers.

The breach of Licence Conditions reliability standards has occurred primarily due to SAIDI thresholds being exceeded. The feeder GRS3B1 is currently compliant but was non-compliant in June 2020 quarter.

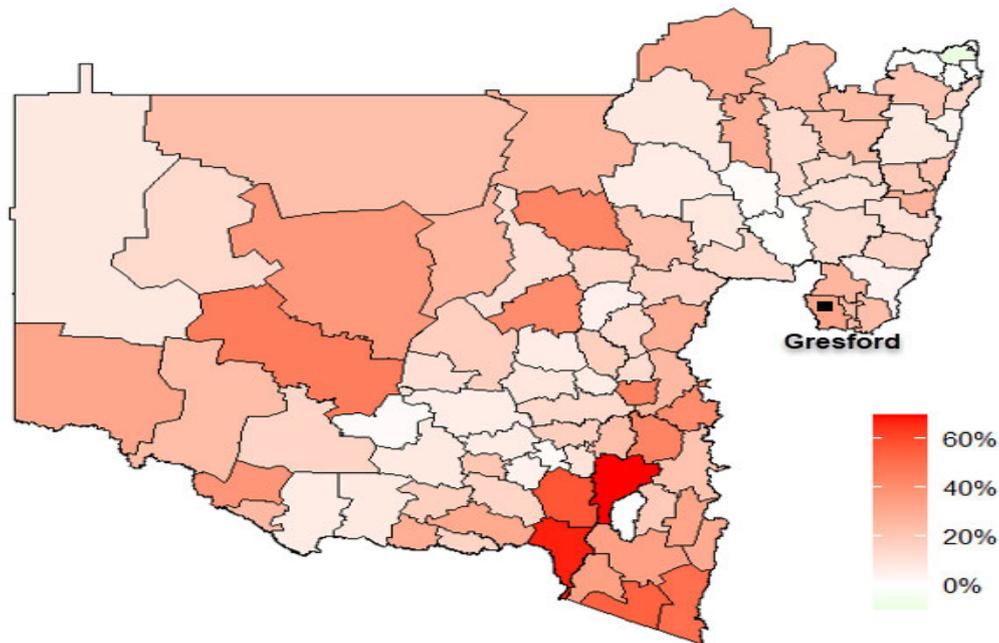
Figure 5 – Expected increase in asset replacement due of climate impact (Attachment 6.01 Climate Impact Assessment)

This project forms part of our Resilience Plan (**Attachment 6.02**) and strengthening the network. As shown in Figure 5 below, the line is located in an area forecast to have increased asset damage of approximately 30% combined impact from bushfire, flood, and windstorm by RCP4.5 in 2070, as informed by the findings of our climate change impact assessment.

Change in expected number of replaced assets due to the combined impact of bushfire, flood, and windstorm from 2022 to RCP4.5 2070

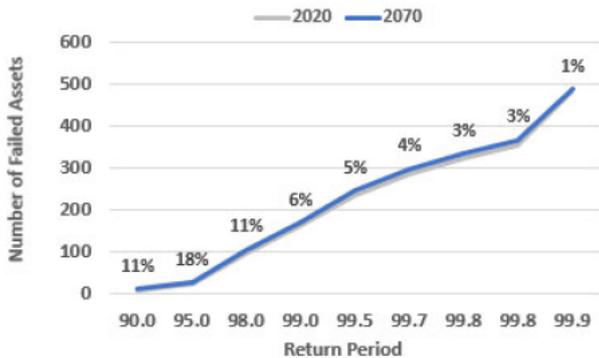
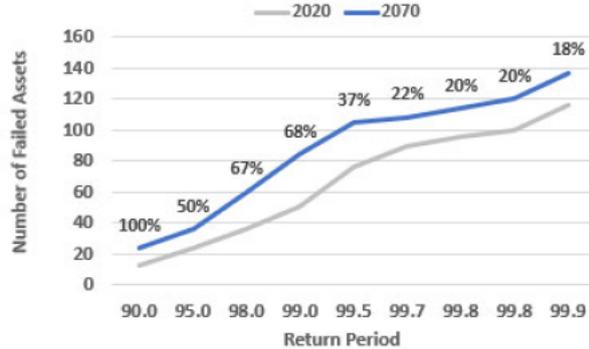
Figure 6 - Forecasted analysis of climate impact (Source 6.01.01 Climate Summary Line Graph)

Based on the climate modelling analysis, climate is predicted to have an increasing impact on the network in this area as shown in Figure 6, thus increasing the criticality of the electrical supply for at risk customers.

Dungog Depot - Climate Impact on Number of Failed Assets due to Bushfire under RCP4.5

Dungog Depot - Climate Impact on Number of Failed Assets due to Windstorm under RCP4.5
