**SAPN\_GHD\_Vegetation Management  
Bushfire Program**

**SA Power Networks**  
Vegetation Management Program Proposals –  
2015 – 2020 Regulatory Proposal  
Report

June 2015

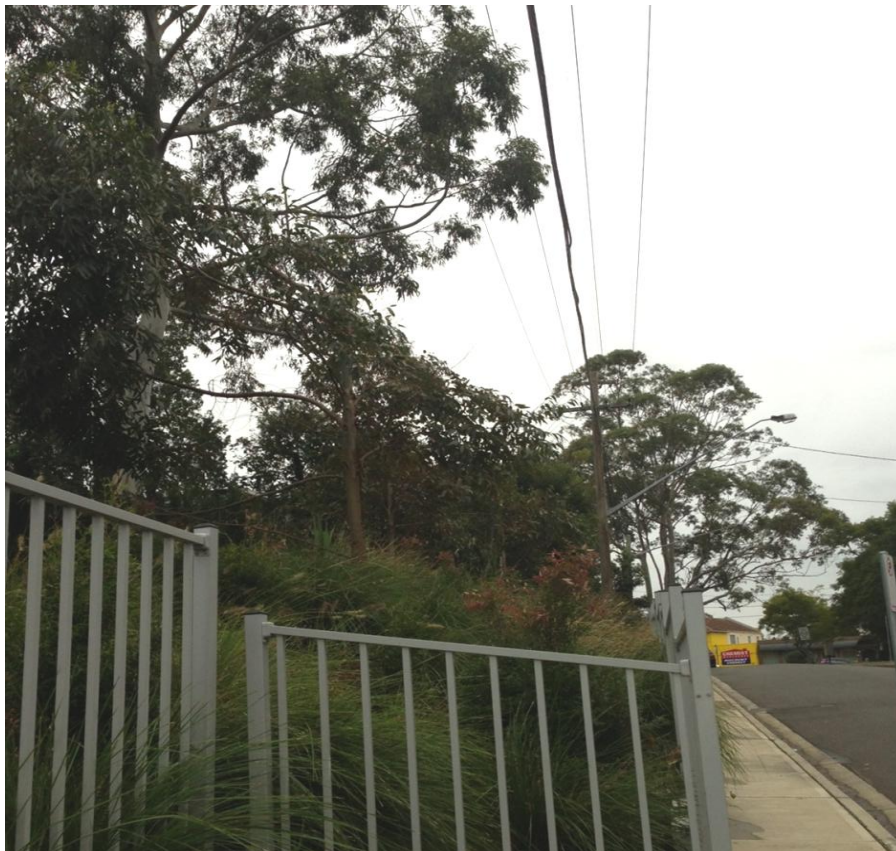
- As inappropriate trees continue to grow into areas that are increasingly difficult for cutting crews to access, safety risks increase as does reliability risk due to branches reaching positions where they have increased probability of falling on power lines. Figure 1 below shows an example of inappropriate tree planting in which fast growing Eucalypts (four in

25 metres) have been planted almost directly under the power line (middle foreground). Cutting treatments applied by utility arborists have cut the leader (top) out of the trees. Branching from the cut has been removed on the power line side of the tree but left on the other side. It is apparent that pruning effort is being applied in an attempt to direct stem and branch growth away from the lines. The result of such an approach will be a highly unsightly tree which requires frequent treatment, with access made increasingly difficult as the tree grows above power line height in the next few years, and thereafter for its life. Safety and reliability risks are significantly increased. These trees should be removed, and either replaced with low growing shrubs or setback further from the power line.

**Figure 1 - Inappropriate trees requiring removal and replacement**

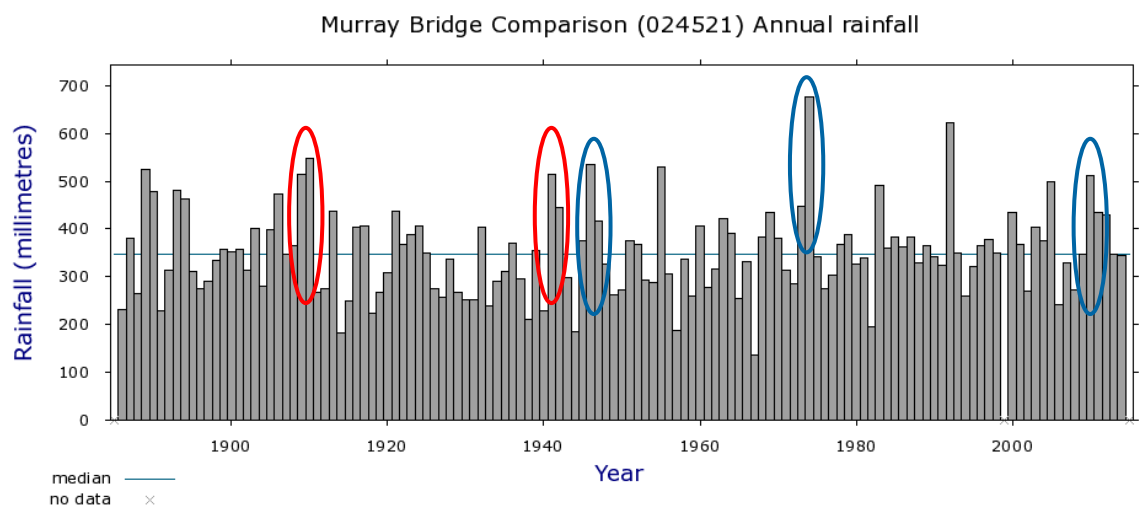
**Figure 2 - Annual rainfall (1886 – 2014) at Murray Bridge SA**

Figure 2 graphs annual rainfall totals from 1886 to 2014 at Murray Bridge in South Australia. This graph demonstrates that years with consecutively above average rainfall are uncommon. Furthermore, of those periods when there are two or more consecutive years of above average rainfall, it is important for pulse-regeneration events to occur that above average rainfall is experienced through the summer periods to facilitate seedling survival. Such conditions occurred in the 2010/2011, 1973/1974, and 1945/1946 (highlighted with blue ellipses). By comparison, for the two years above average rainfall events in 1910/1911 and 1941/1942 (highlighted with red ellipses), dry summer periods occurred. The summers of 1909/10 and 1911/12 were among the driest on record. The 1941/42 summer was drier than average (with five consecutive months of below average rainfall from November to March). The key point is that sustained wet periods with favourable growing conditions in summer are uncommon and unpredictable events, which give rise to pulse regeneration event conditions. SA has recently been through such an event in 2010/2011. It is reasonable to expect that in locations where there are mature Eucalypt trees to provide seed source and ground conditions conducive to germination of seed - such as ground grazed bare by previous drought (as occurred in the millennium drought from 2002 to 2009), features such as graded drains, batter slopes and areas with poor soils - pulse regeneration events are primed to occur.

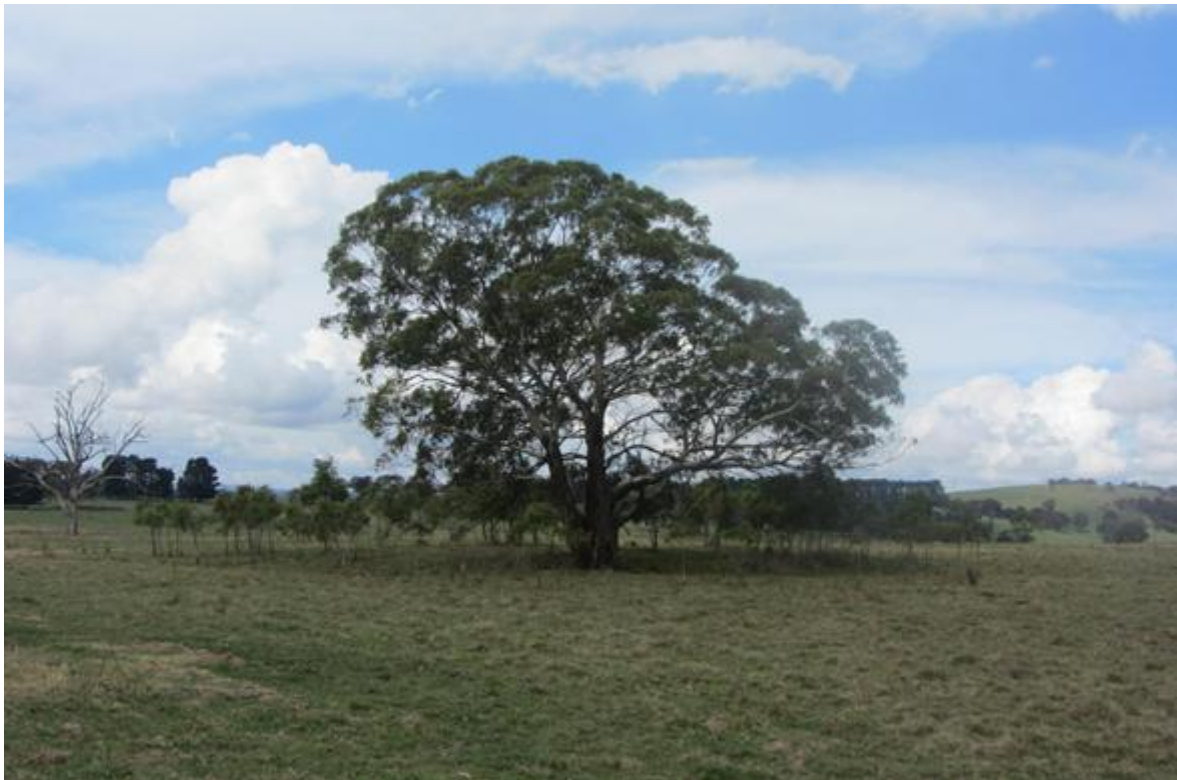
**Figure 5 - Pulse-regeneration around a paddock tree**

Figure 5 above is illustrative of the pulse regeneration effect that is associated with favourable periods of sustained rainfall. A paddock tree (Eucalypt) can be seen with prolific regeneration surrounding it. In the lead-up to the 2010/2011 ‘big wet’ period, preceding sustained drought led to ‘eating-out’ of pasture and exposing of mineral soils. Drought forced substantial de-stocking. With the advent of the 2010/2011 ‘big wet’, Eucalypt seed released by this tree found exposed soils, with moisture levels recharged and favourable for germination and growth. Favourable summer rainfall through the first two summers following germination has facilitated survival of the seedling cohort (which in hot dry summers typically dies out due to surface soil moisture deficiency). The cohort becomes established with robust lignotuber development and is able to survive subsequent reintroduction of stock which preferentially graze on abundant grasses which reduces grass competition to the cohort of Eucalypt

regeneration. The absence of other regeneration cohort age-classes in this scene is indicative that over previous decades conditions have not been favourable for regeneration, and the current event represents an uncommon pulse-event.

While the example in Figure 5 represents an agricultural land example, this regeneration process is occurring widely in Southern and Eastern Australia following the 2010 and 2011 'big wet' and is particularly evident where Eucalypt seed from nearby trees can fall onto bare soil. At Figure 6 below, a cohort of regeneration can be seen surrounding a tree on an alluvial flat in a National Park where livestock grazing was ceased more than two decades before. A pulse regeneration event is established.

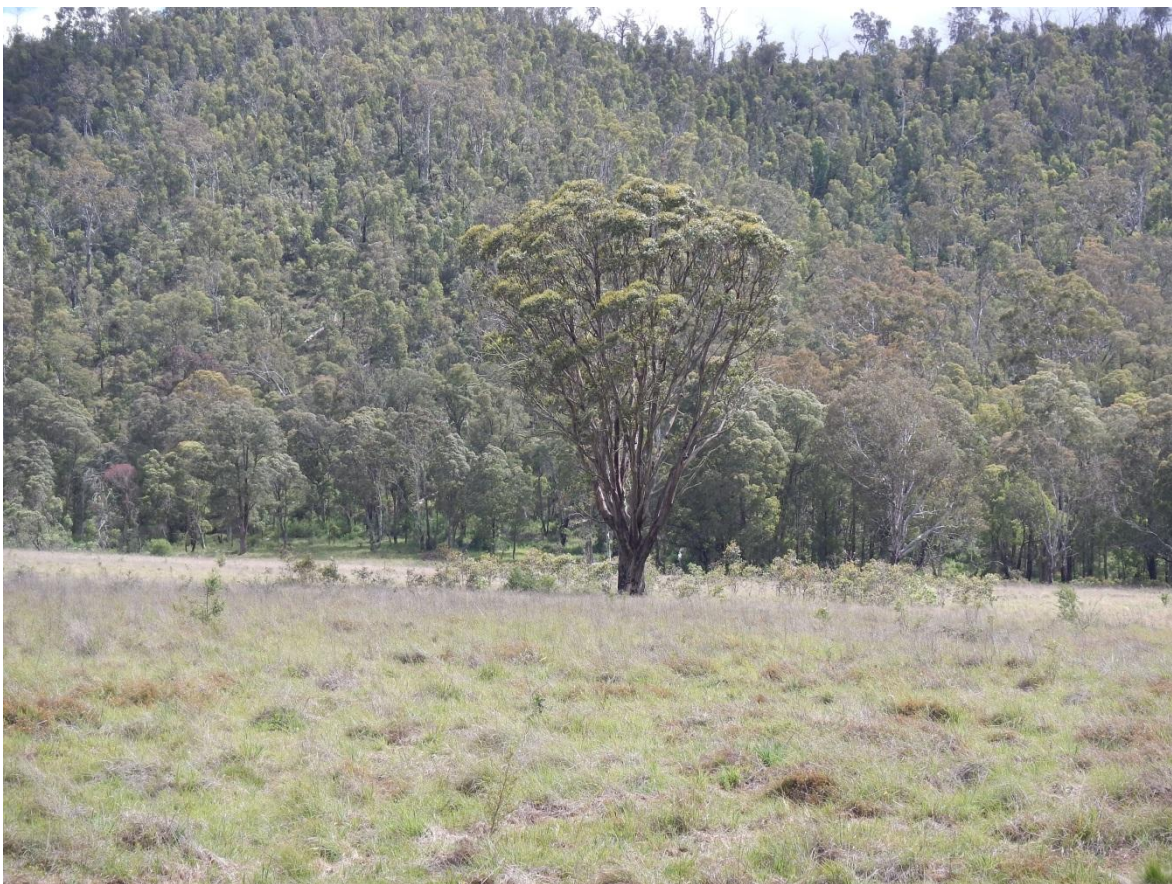
**Figure 6 - Pulse-regeneration around an isolated tree (no livestock grazing)**

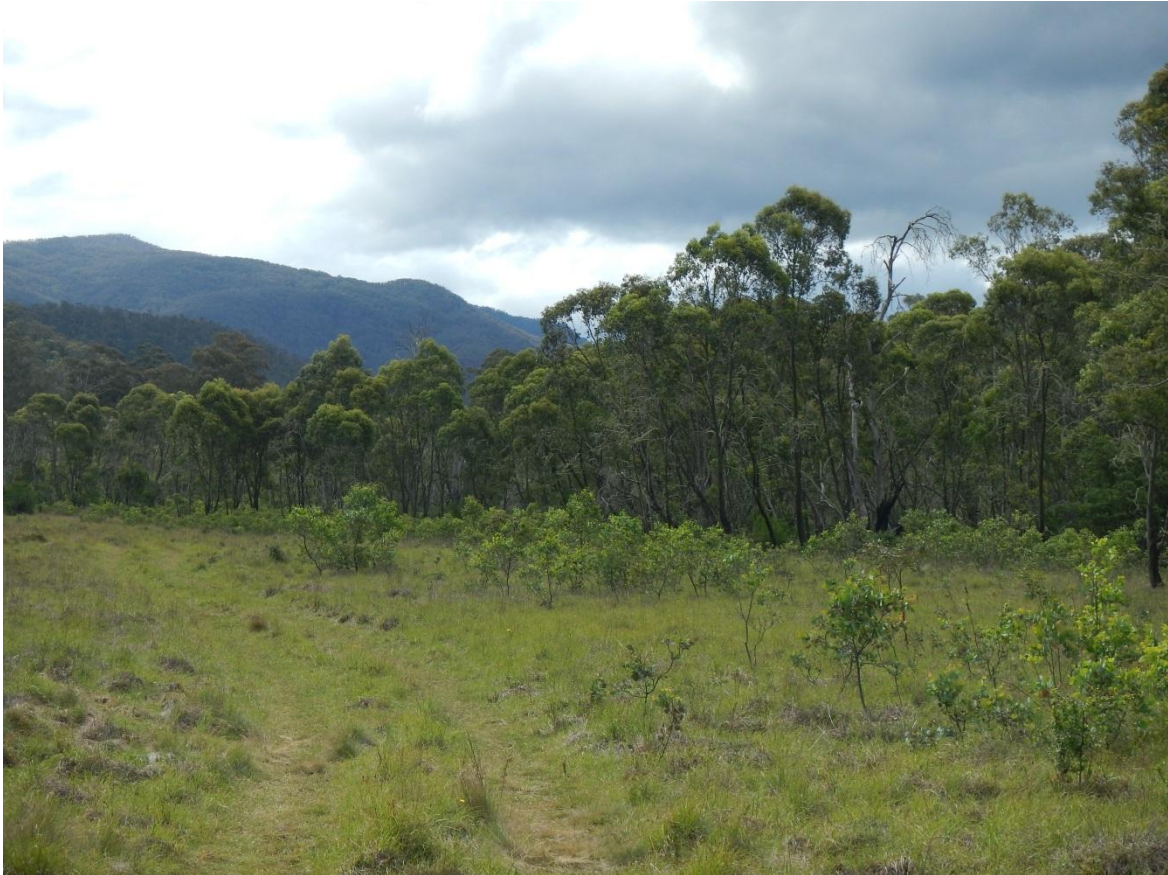
Figure 7 on the following page shows a pulse regeneration event extending from a forest/grassland edge, where trees are in the process of reoccupying clear land. Parallel processes are observable in cleared areas under power lines where cohorts of Eucalypt regeneration are establishing under and in close proximity to power lines. Their seed source trees are considered to be at an acceptable distance from power lines, however the new cohort becoming established is not. Many such trees are now much taller than those shown here, and are in the sapling stage. The routine practice for cutting crews is to only begin cutting these saplings as they approach the clearance space.

**Figure 7 - Pulse regeneration occurring in grassland at the fringe of Eucalypt forest**

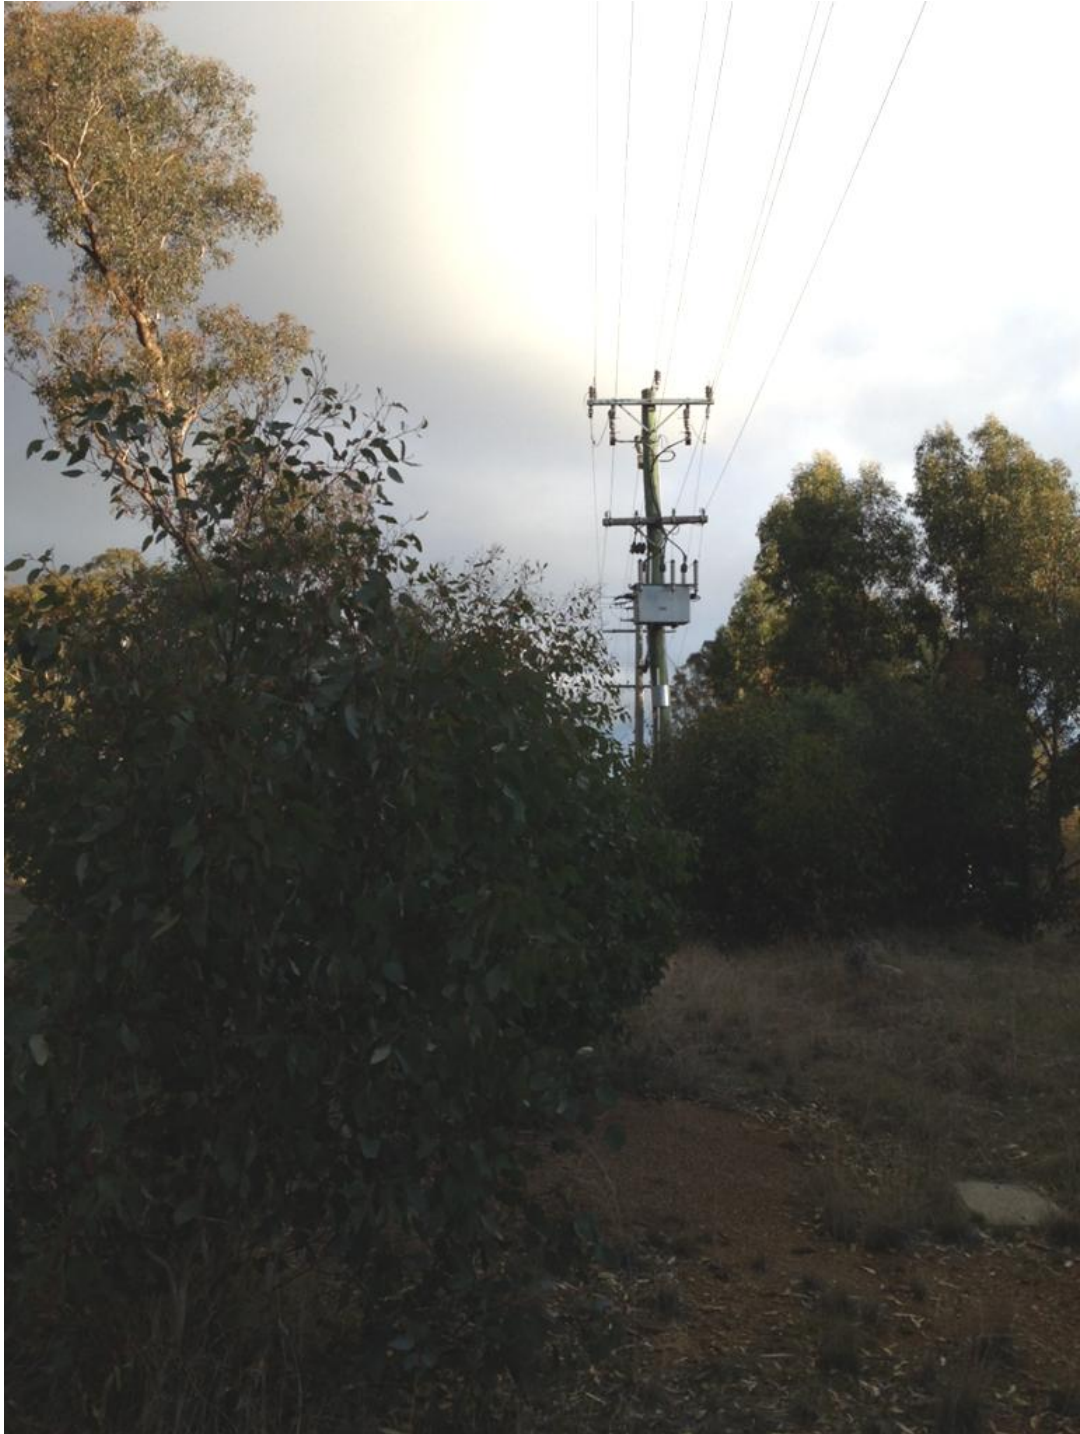
In Figure 8 below, an example of Eucalypt regeneration under power lines can be seen. In the foreground is Eucalypt regeneration which if left to grow until it approaches the clearance space will become established trees. In the middle-ground more regeneration can be seen in front of the power pole. Along this feeder section there were hundreds of young saplings that have grown from seed, in sustained favourable growth conditions, in previously cleared areas under the power line.

**Figure 8 - Eucalypt regeneration under power lines**

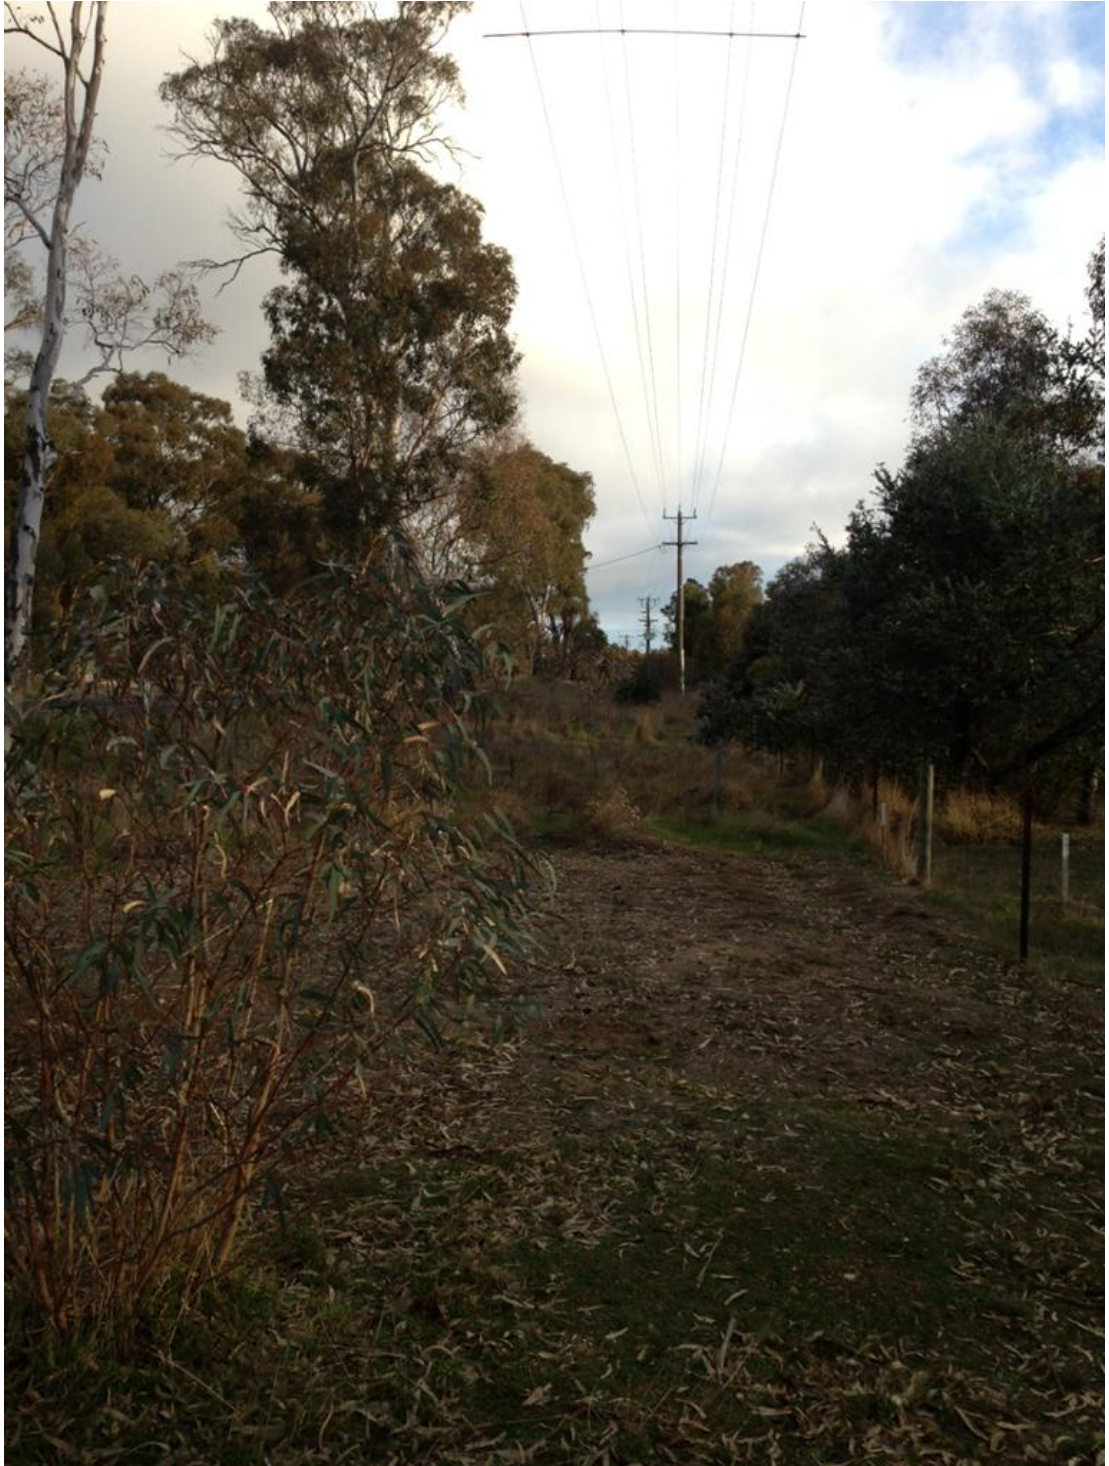
In Figure 9 on the following page, in the left foreground a Eucalypt sapling which has been cut back to ground level can be seen regenerating multiple stems (coppice) and resuming growth toward the overhead power line. A cutting treatment alone has failed to remove this Eucalypt. With a large underground lignotuber already developed from before it was cut, this regenerating Eucalypt will be able to grow at much faster rate than a new seedling. It is possible for saplings with well-established root systems and a large healthy lignotuber, after being cut back to ground level, to re-sprout and grow to overhead power line height in just two or three favourable growth seasons.

**Figure 9 - Eucalypt coppice after a sapling was cut at ground level**

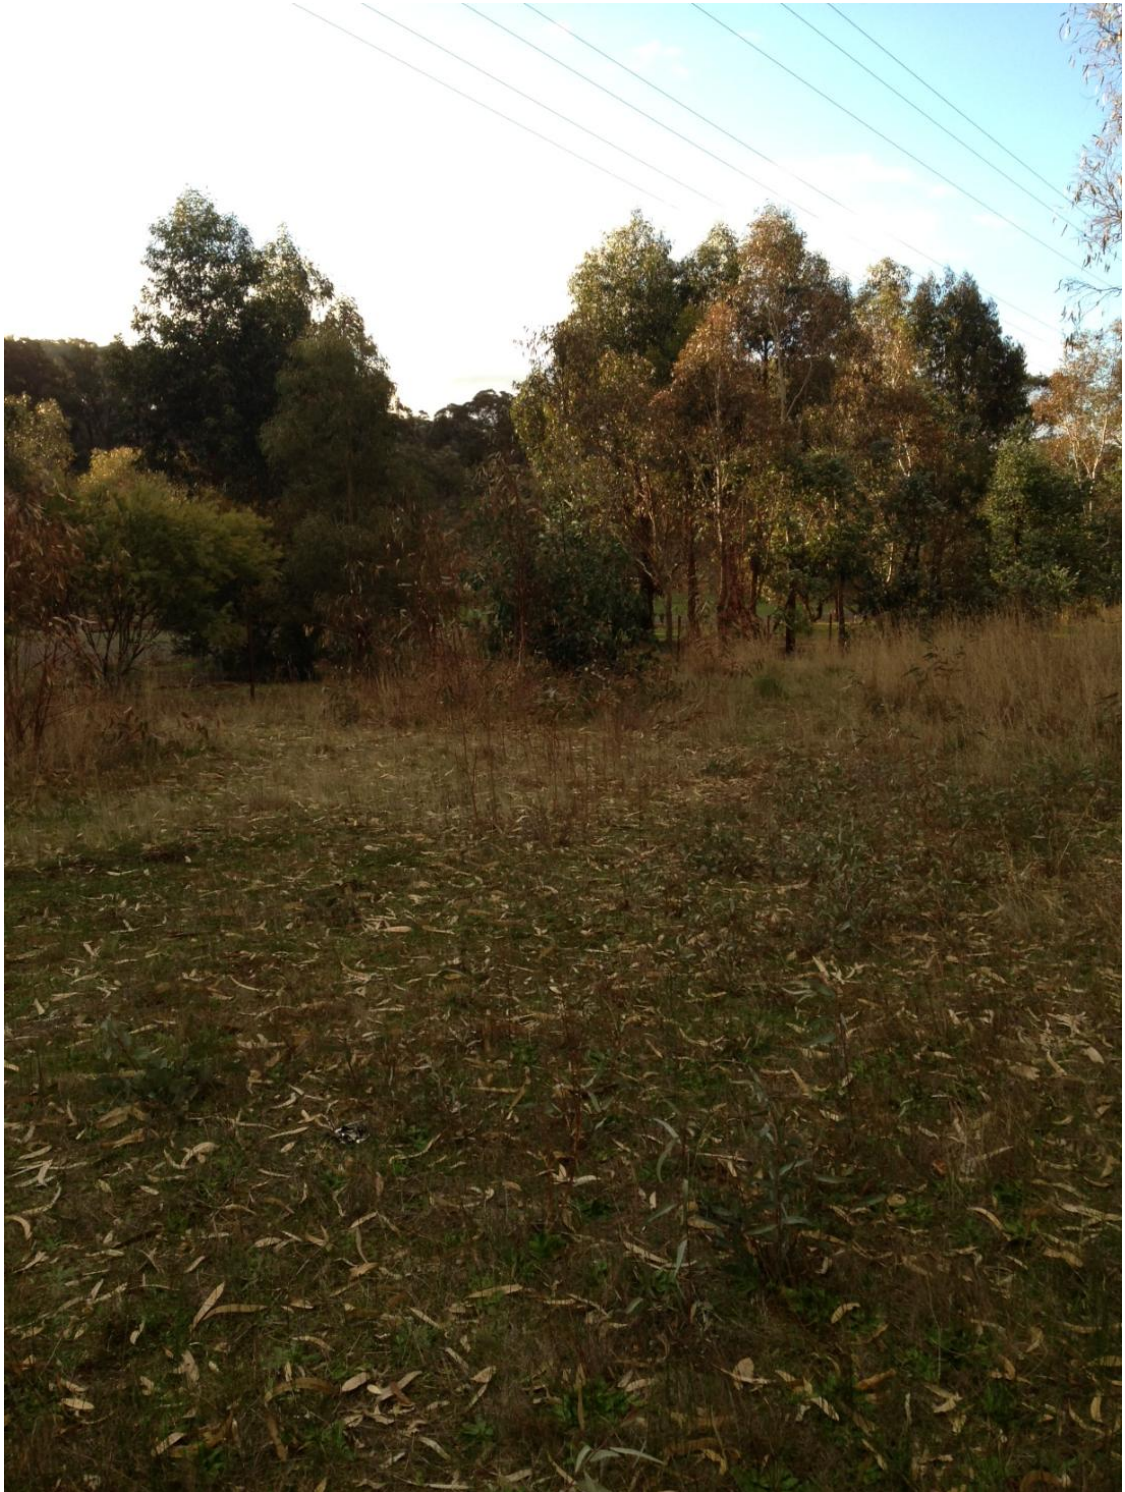
When Eucalypt regeneration is prolific, and tall grass or regenerating shrub cover is also present, it is not uncommon that some young regenerating Eucalypts are not seen and therefore evade treatment by cutting. In Figure 10 on the following page, in the close foreground (right-side of picture) Eucalypt seedlings can be seen that were not seen/treated at the time this span was treated. In the near-middle ground, regeneration can be seen. In the middle-ground a mix of dying and surviving Eucalypts, previously cut can be seen, with some original saplings that escaped cutting also still present and well-established. Without a rigorous purpose-designed sapling removal program, this span will become more densely occupied by woody vegetation, increasing safety, reliability and bushfire risk, as well as the future vegetation management cost.

**Figure 10 - Various stages of Eucalypt regeneration under power lines**

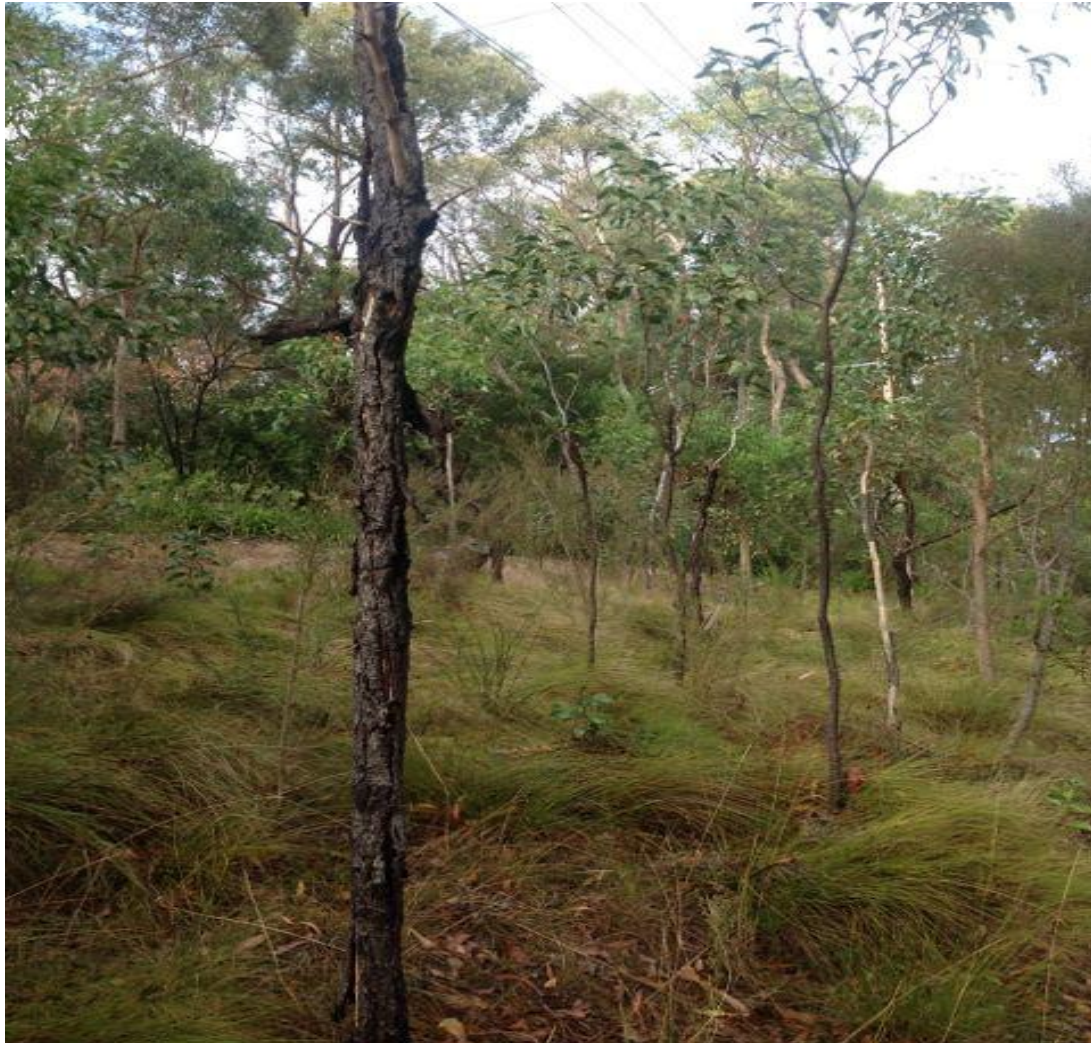
**Figure 11 - Multiple saplings occupying a formerly grassy slope adjacent to power lines**

Figures 11 to 16 show examples of sapling establishment near power lines in South Australia. Without a program to address saplings, these will become established trees that can grow into clearance spaces increasing safety, reliability and bushfire risks to SA Power Networks' distribution system, SA Power Networks' employees and the community, and the future scope of vegetation line clearance programs.

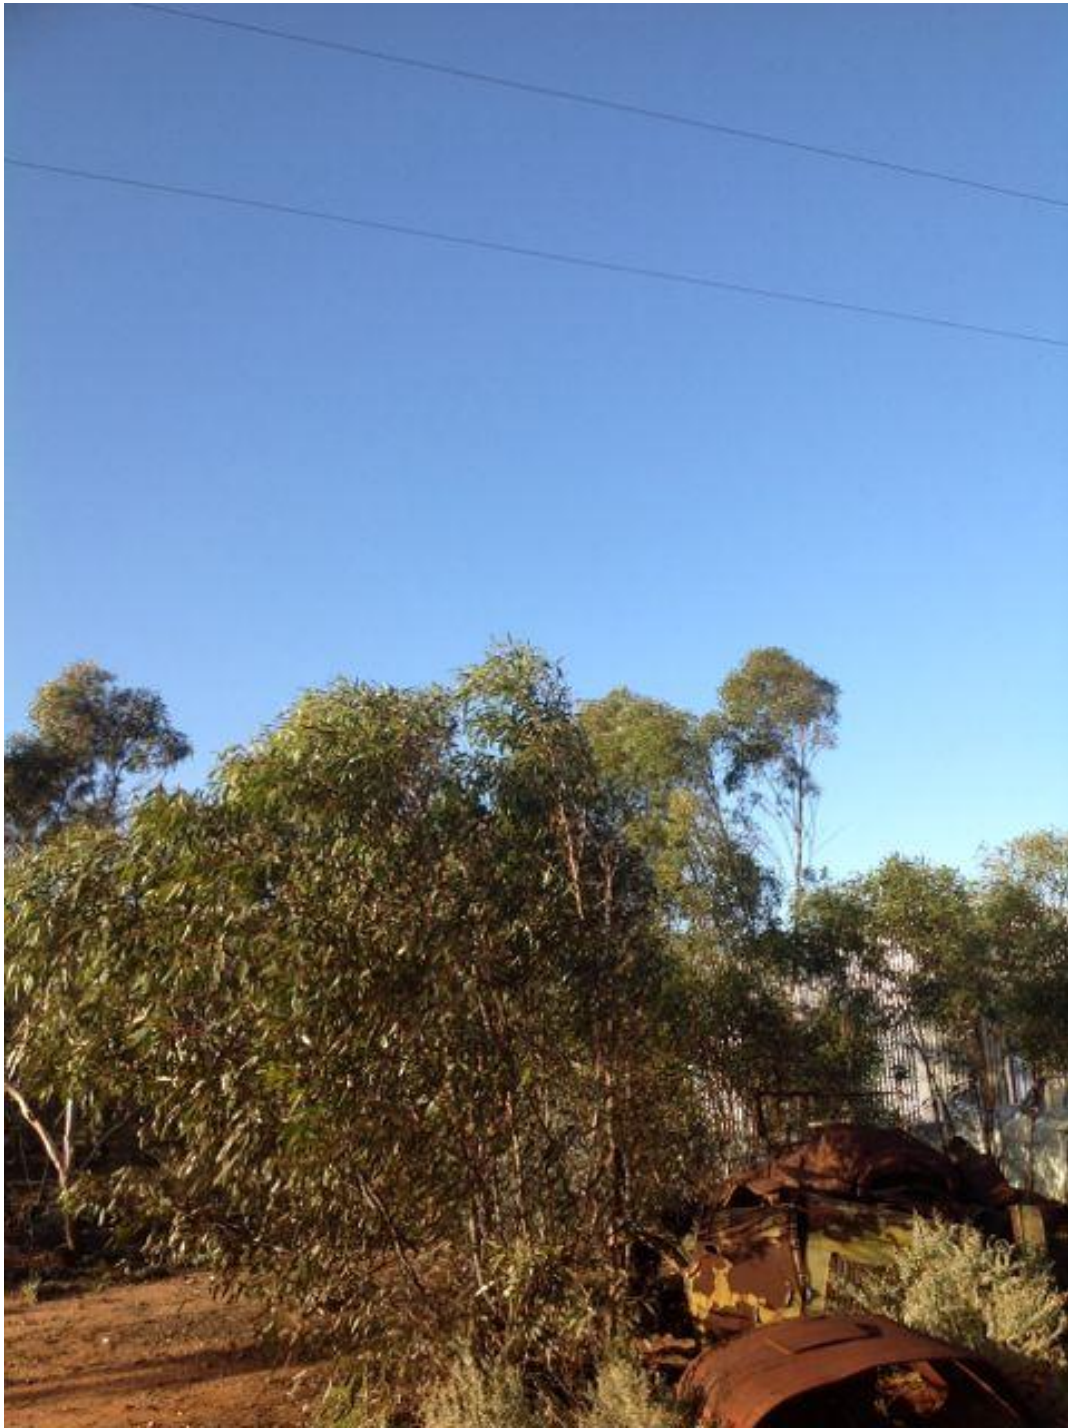
**Figure 12 - Sapling occurrence on bare ground under power lines**

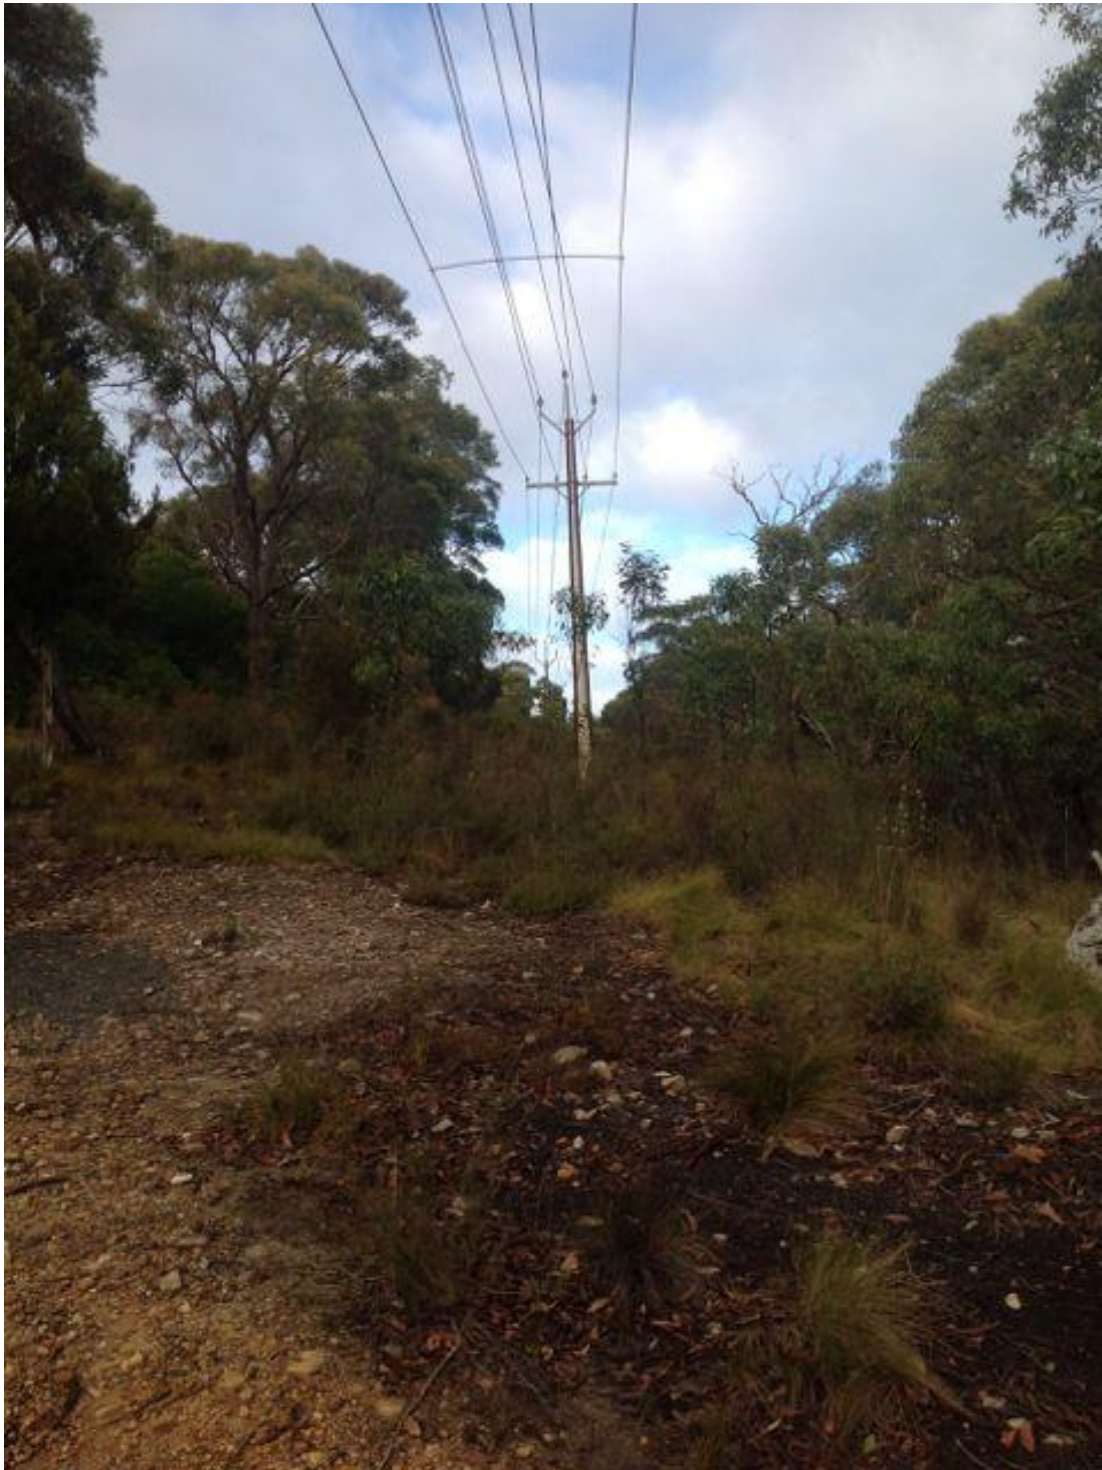
**Figure 13 - Saplings re-occupying a cleared power line easement from adjacent forest**

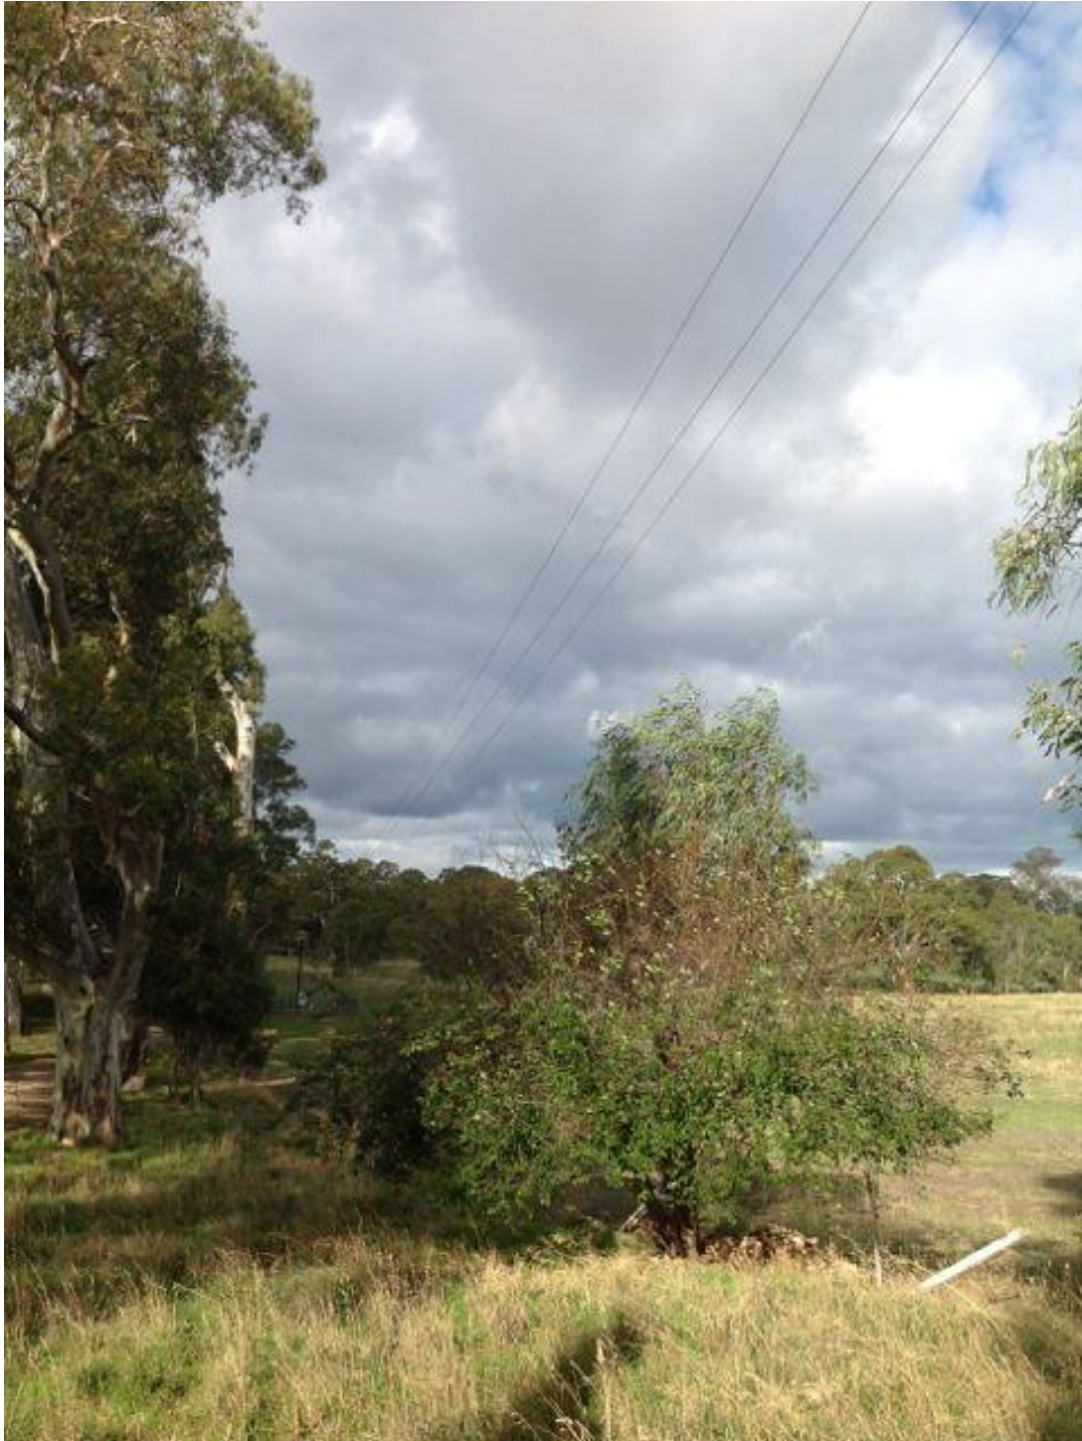
**Figure 14 - Saplings regenerating along fence lines under power lines**

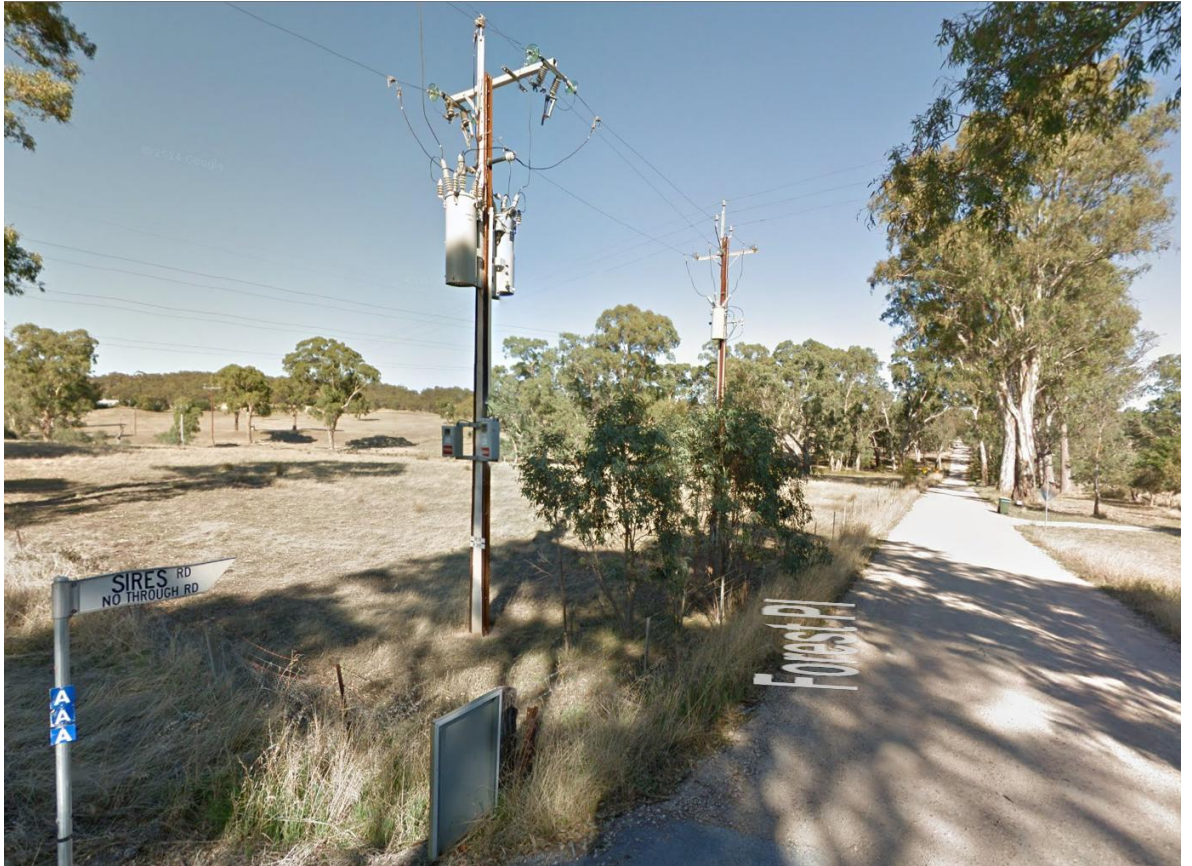
**Figure 15 - Formerly grassy paddock with power lines being occupied by saplings**

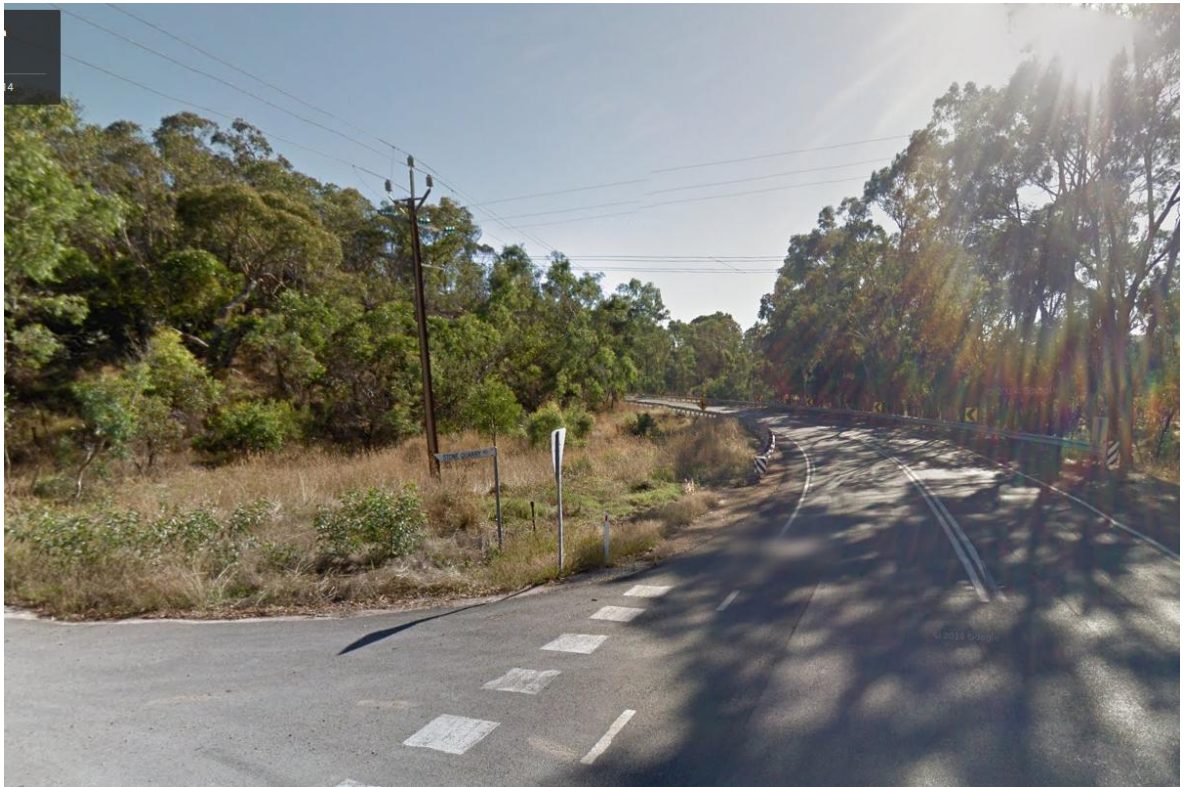
**Figure 16 - Pulse regeneration under roadside power lines**
