Northfield 66kV GIS Replacement Business Case

2020-25 Revised
Regulatory Proposal
10 December 2019

SA Power Networks

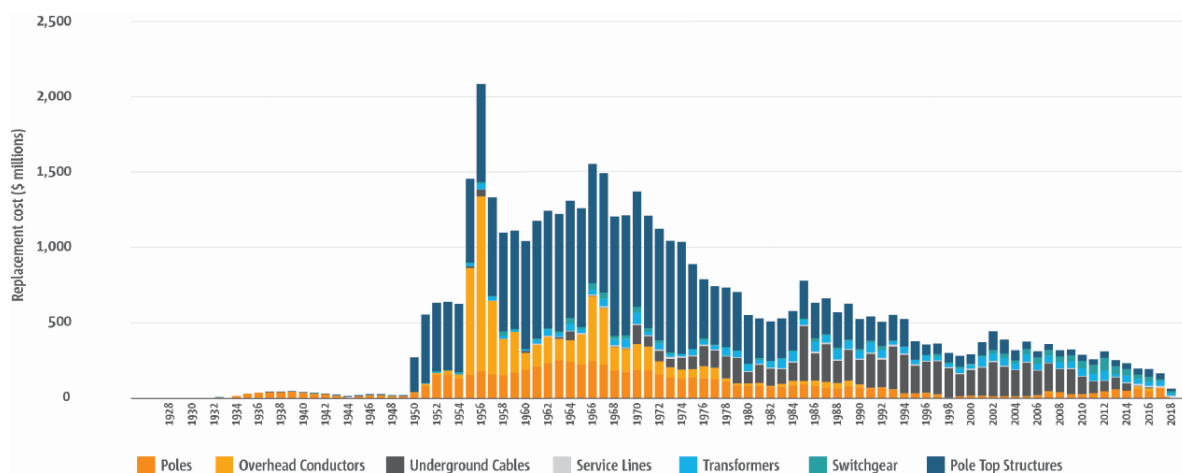
Figure 1: Asset Age Profile²

SA Power Networks network has the oldest electricity infrastructure in the National Electricity Market (NEM), with the majority of assets having been built in the period between 1950 and 1970. SA Power Networks employs sound asset management strategies to maximise the life of assets while achieving target network performance outcomes. However, it is now at the risk of entering a phase of declining reliability and costly reactive asset replacements for network assets with equally well planned and timely asset replacement programs. A significant proportion of the asset base value is between 45 and 60 years of age as shown in Figure 1 which corresponds to the period when major electrification of South Australia happened.

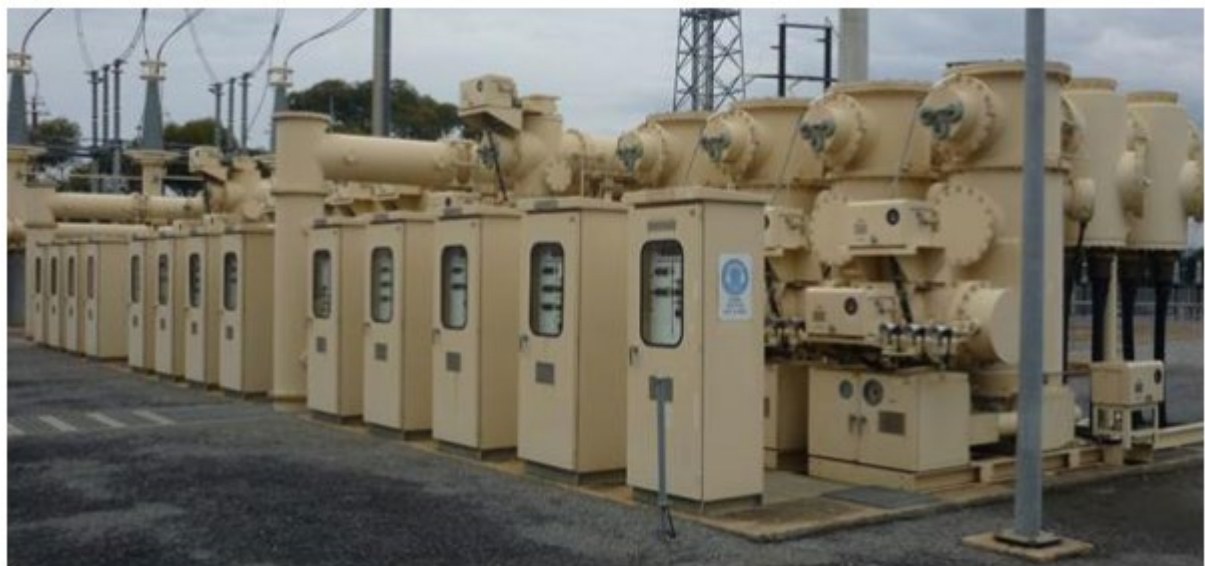
Figure 3: Present 66kV GIS configuration

Figure 3 below shows the 66kV GIS at the Northfield substation and a corresponding simplified single line diagram is shown in Figure 4.

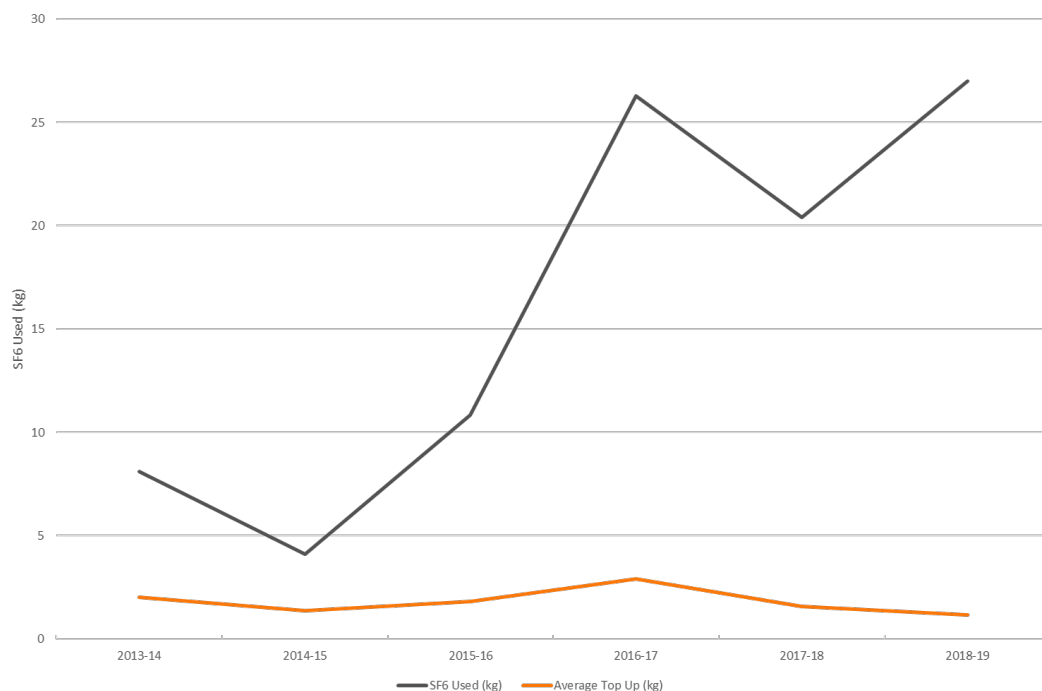
Figure 5 SF₆ required to top up losses at Northfield GIS⁷

Figure 5 and Figure 6 show the required SF₆ top-ups at Northfield GIS over the 2013 to 2019 period, and the top-ups and repairs at the Northfield GIS site.

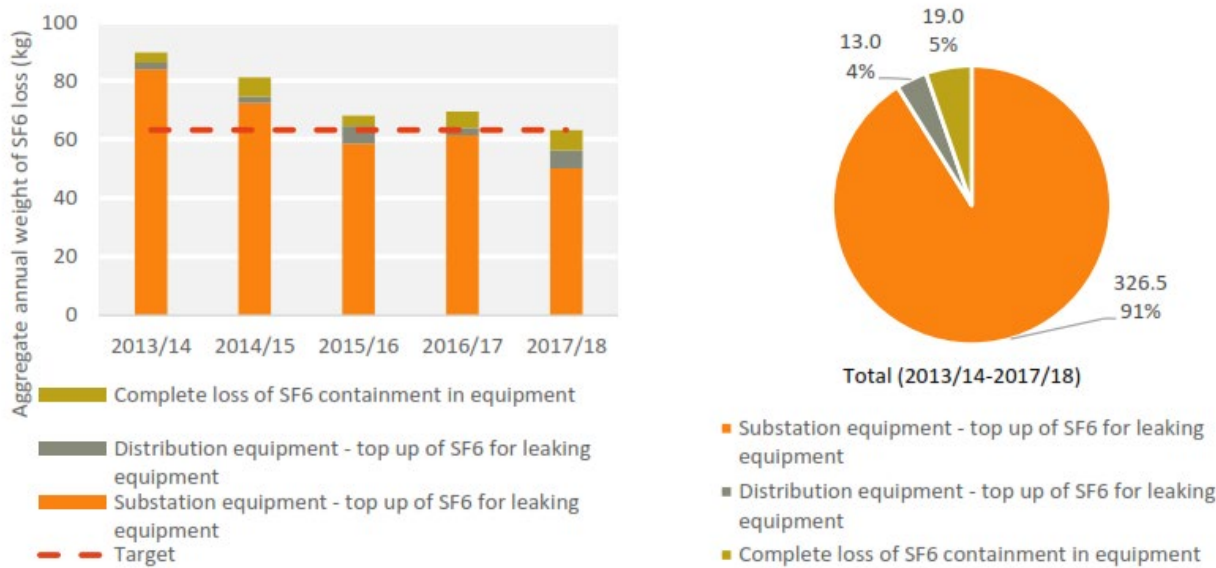
Figure 8: Aggregate annual weight of SF₆ loss (kg) 2013-14 to 2017-18

The SF₆ leaks from the Northfield Substation are the largest component of reportable greenhouse emissions for SA Power Networks. Figure 8 depicts the quantity of SF₆ emissions over the period 2013-14 to 2017-18.

Figure 8 shows that substations contribute the largest emissions of SF₆, which is primarily caused by the common use of SF₆ gas as an insulation and interrupting medium in 33kV and 66kV circuit breakers. The majority of the reportable SF₆ emissions in substations are attributable to the 66kV GIS at the Northfield Substation (approximately 27 kg out of a total of 105 kg in 2018-19).
