SA Power Networks

Northfield 66kV GIS Replacement Business case

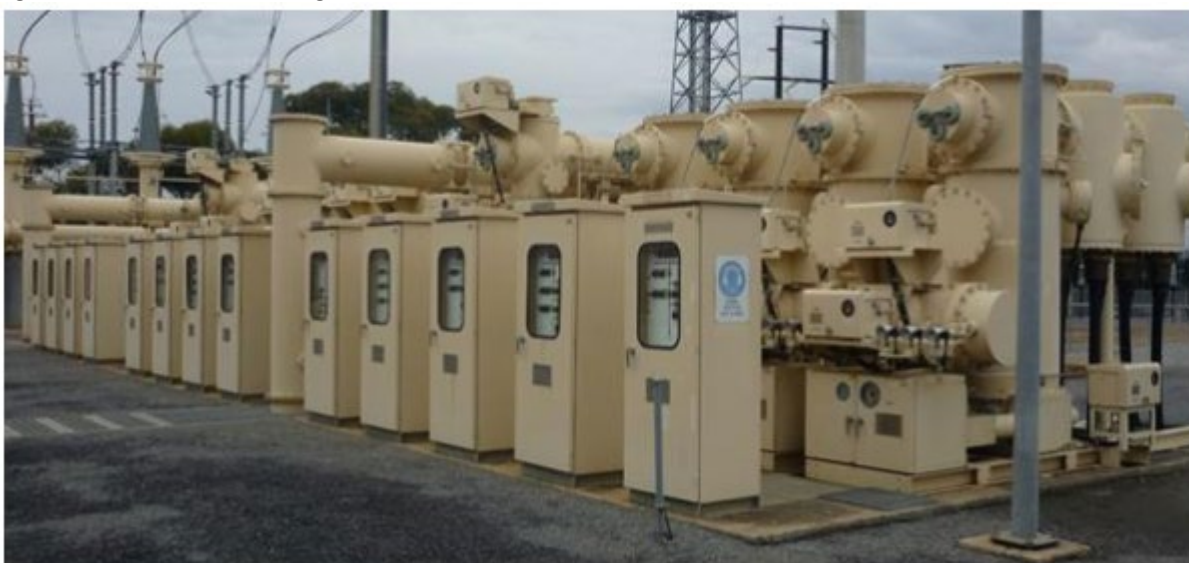
Figure 3 below shows the 66kV GIS at the Northfield substation and a corresponding simplified single line diagram is shown in Figure 4.

Figure 3: Present 66kV GIS configuration

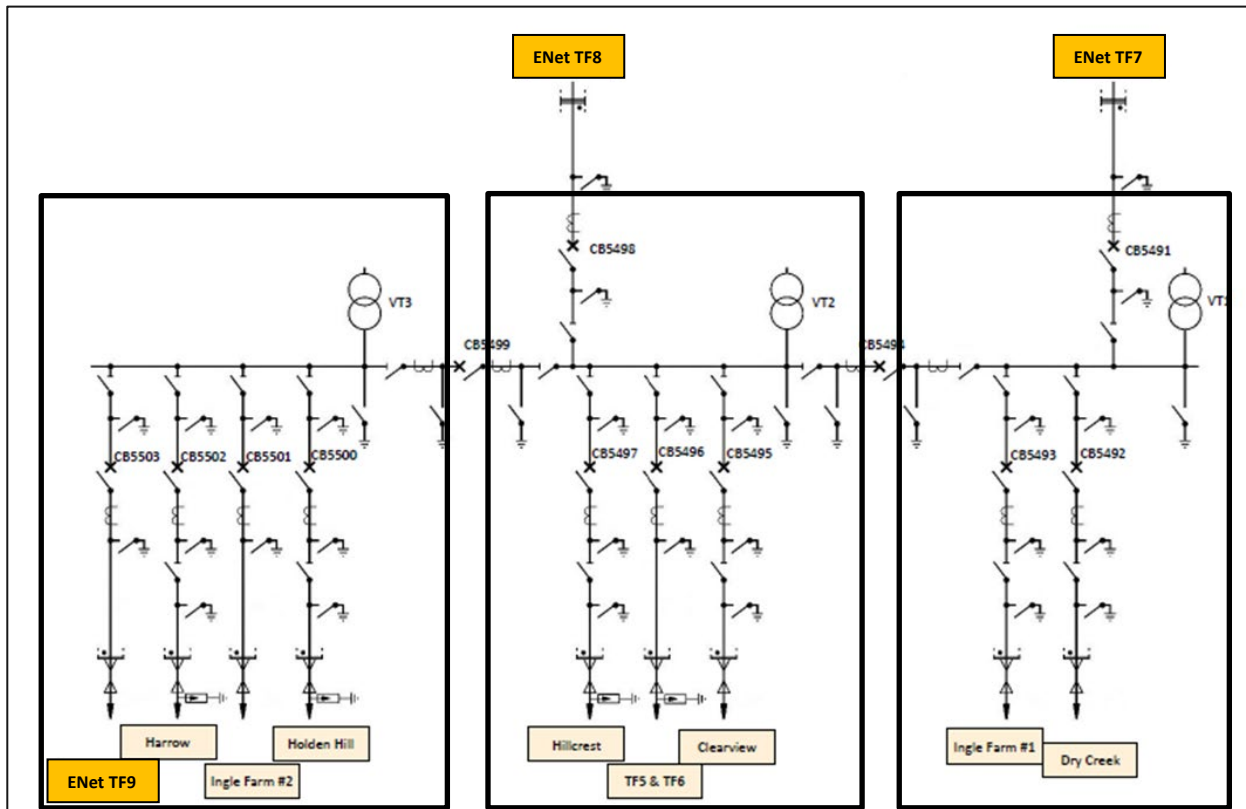
Figure 4: 66kV GIS configuration

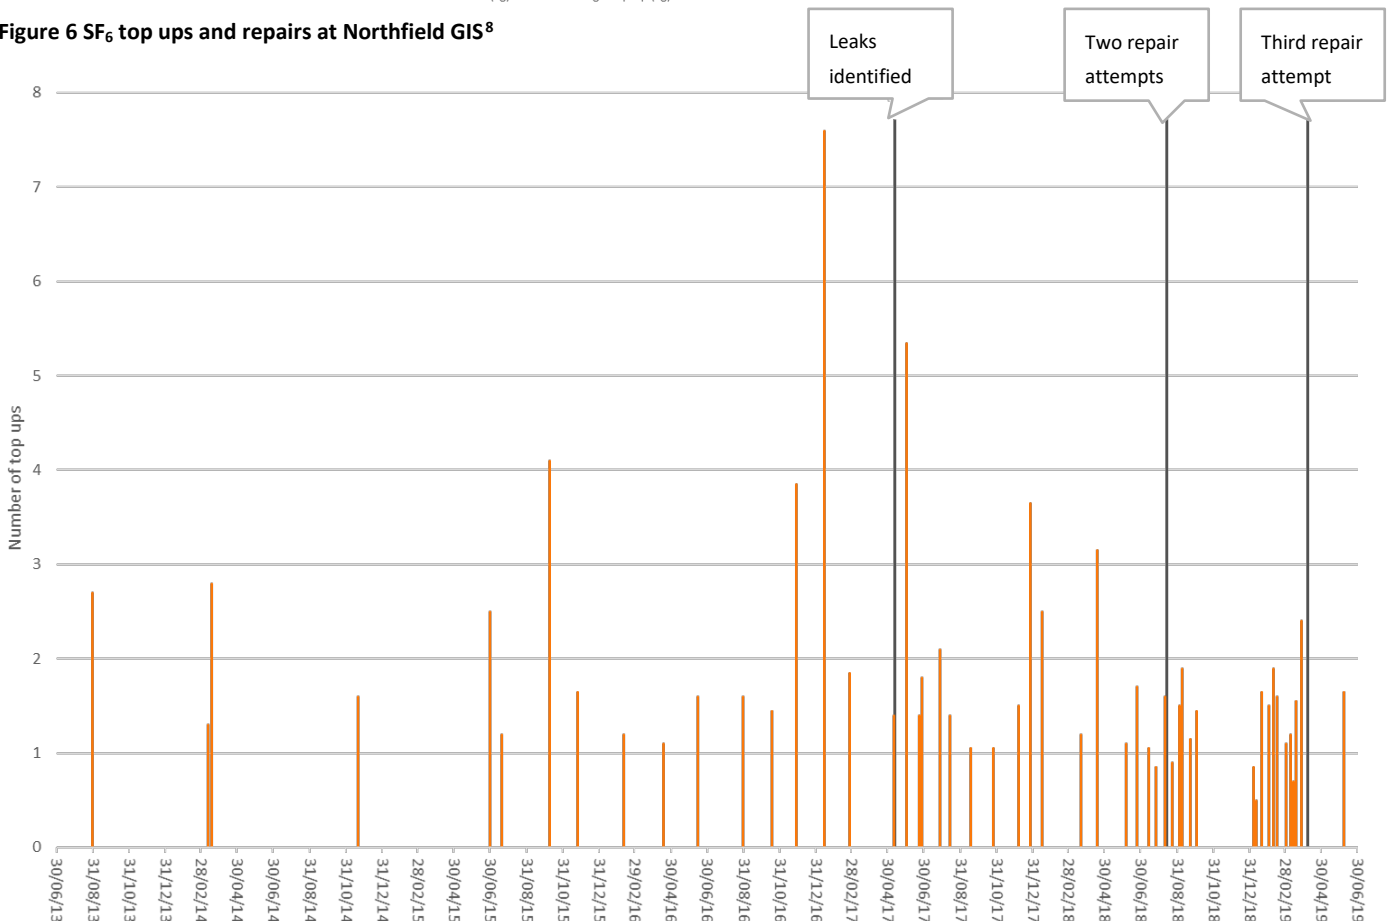
Figure 5 and Figure 6 show the required SF₆ top-ups at Northfield GIS over the 2013 to 2019 period, and the top-ups and repairs at the Northfield GIS site.

Figure 6 SF₆ top ups and repairs at Northfield GIS⁸

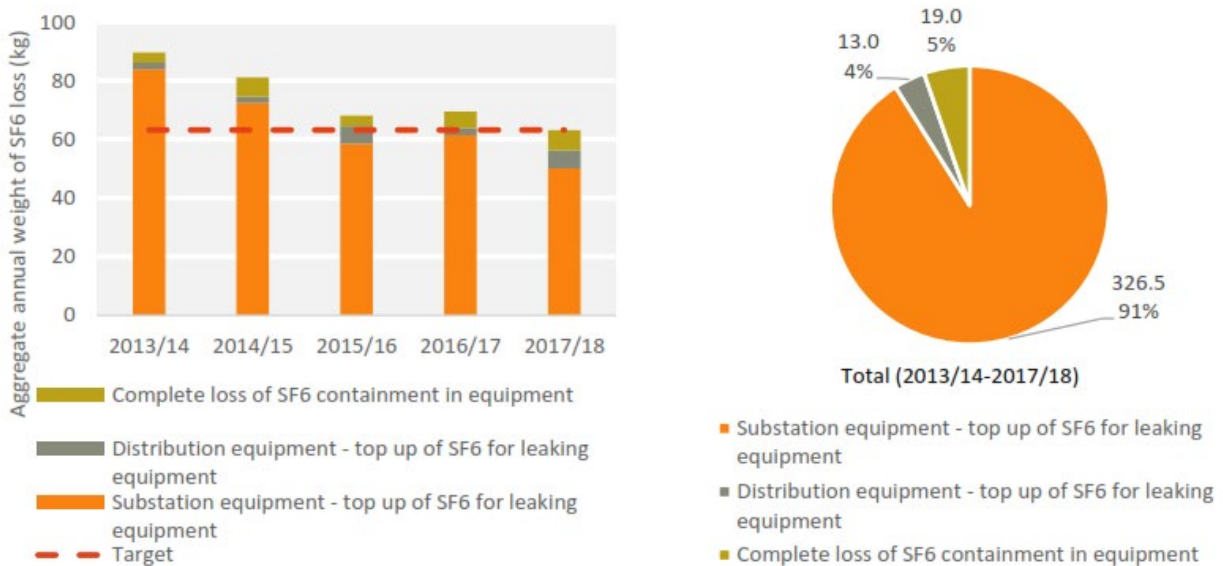
The SF₆ leaks from the Northfield Substation are the largest component of reportable greenhouse emissions for SA Power Networks. Figure 8 depicts the quantity of SF₆ emissions over the period 2013-14 to 2017-18.

Figure 8: Aggregate annual weight of SF₆ loss (kg) 2013-14 to 2017-18

Figure 8 shows that substations contribute the largest emissions of SF₆, which is primarily caused by the common use of SF₆ gas as an insulation and interrupting medium in 33kV and 66kV circuit breakers. The majority of the reportable SF₆ emissions in substations are attributable to the 66kV GIS at the Northfield Substation (approximately 27 kg out of a total of 105 kg in 2018-19).
