Investment Evaluation Summary (IES)

Project Name:	Low Conductor Span Rectification - Low Clearance LV CAPEX
Project ID:	00545
Thread:	Overhead
CAPEX/OPEX:	CAPEX
Service Classification:	Standard Control
Scope Type:	D
Work Category Code:	RELCR
Work Category Description:	Replace/relocate LV OH (Low Clearance)
Preferred Option Description:	Rectification of backlog of 2200 defects over 17/18 - 20/21. Ongoing rectification of 506 defects per year over 17/18 – 26/27.
Preferred Option Estimate (Nominal Dollars):	\$32,057,823

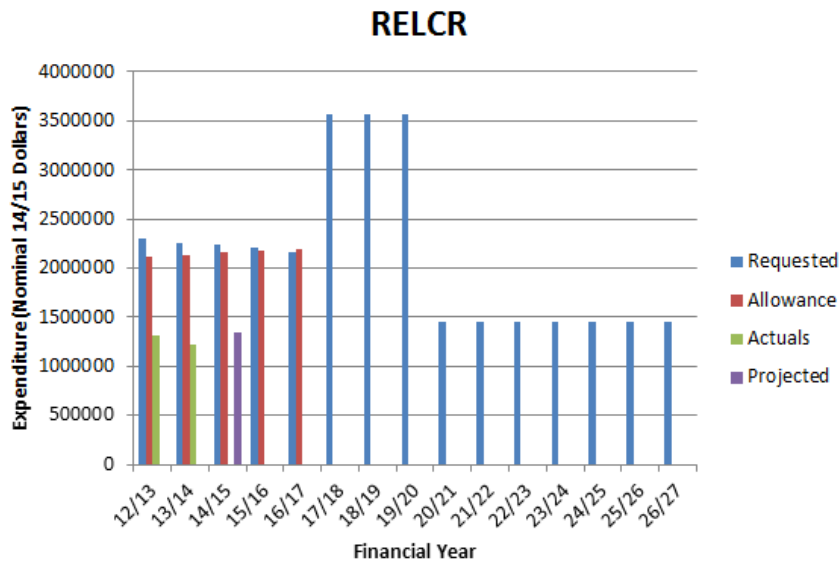
Figure 2: Replace/relocate LV OH (Low Clearance) Expenditure

The expenditure for this project will be ongoing to address the quantity of asset defects; however there is a greater expenditure budgeted for the first financial years to address the quantity of high risk defects present in the distribution network.
