Investment Evaluation Summary (IES)

Project Name:	Low Conductor Span Rectification - Low Clearance HV CAPEX
Project ID:	00581
Thread:	Overhead
CAPEX/OPEX:	CAPEX
Service Classification:	Standard Control
Scope Type:	D
Work Category Code:	REHCR
Work Category Description:	Replace/relocate HV OH (Low Clearance)
Preferred Option Description:	Rectification of backlog of 2200 defects over 17/18 - 20/21. Ongoing rectification of 506 defects per year over 17/18 – 26/27.
Preferred Option Estimate (Nominal Dollars):	\$34,290,120

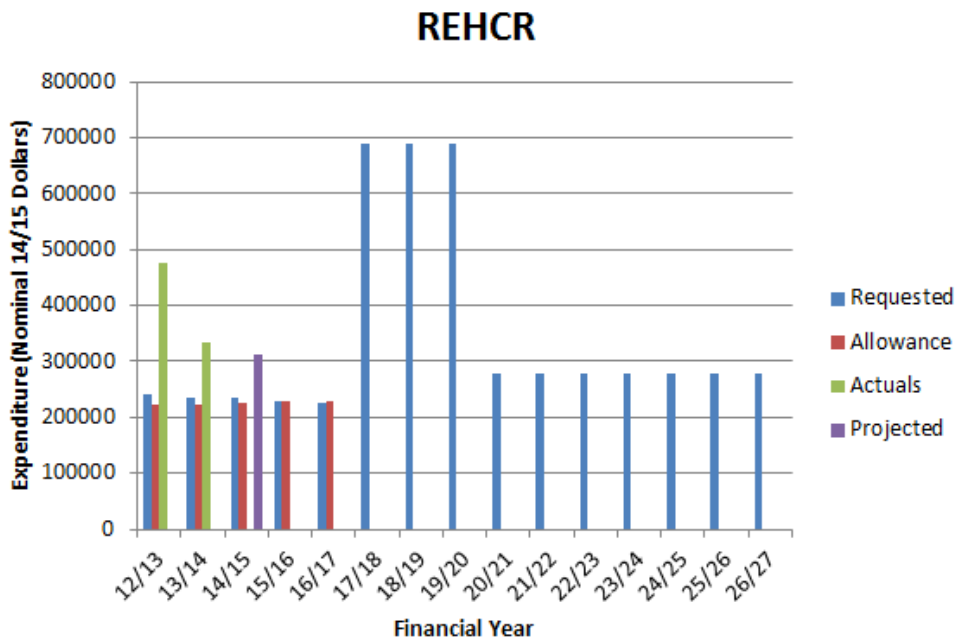
Figure 2: Replace/relocate HV OH (Low Clearance) Expenditure

The expenditure for this project will be ongoing to address the quantity of asset defects; however there is a greater expenditure budgeted for the first financial years to address the quantity of high risk defects present in the distribution network.
