Investment Evaluation Summary (IES)

Project Name:	Pole Replacements
Project ID:	00661
Business Segment:	Distribution
Thread:	Structures
CAPEX/OPEX:	CAPEX
Service Classification:	Standard Control
Scope Type:	B
Work Category Code:	REPOL
Work Category Description:	Pole Replacements
Preferred Option Description:	Replace poles based on condition.
Preferred Option Estimate (Dollars \$2016/2017):	\$70,720,260

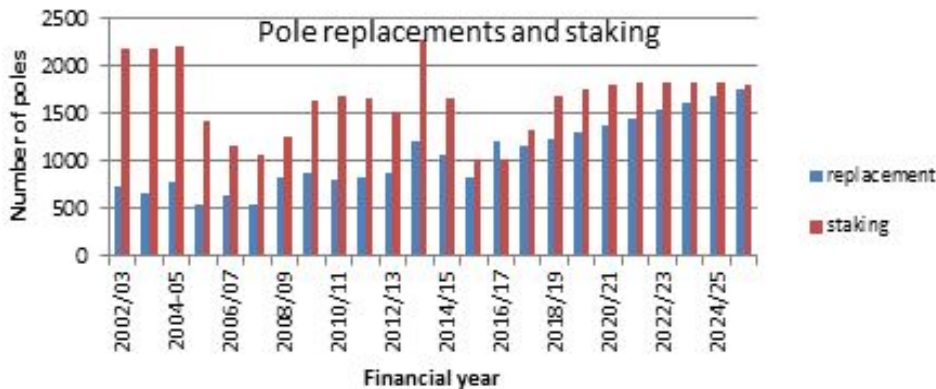
As shown in Figure 3 below, there is an increasing annual rate of pole replacements based on the inspection results. This rise follows the ageing trend of the pole population, however, this annual increase does not fully cover the ageing profile rate. Parallel to this, the condemning and subsequent replacement of already staked wood poles is also anticipated to rise over the coming years as an increase in staking works carried out around 15 years ago reaches the end of their lifespan and thus, the annual replacement volumes will need to be further increased in the coming years as shown in Figure 3.

Figure 3: Historic and forecast replacement and staking volumes

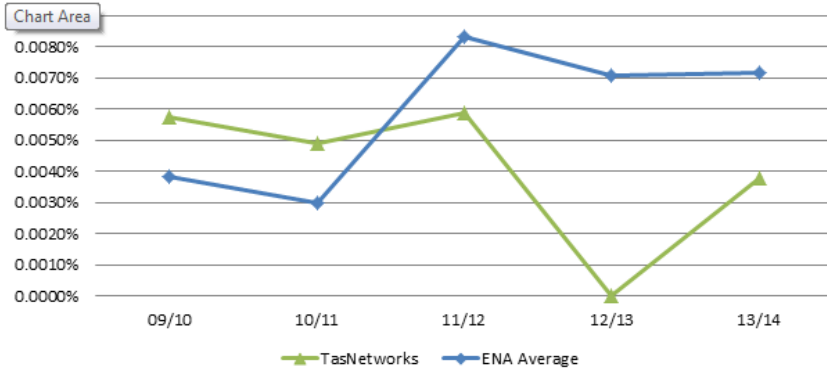
The Electricity Networks Australia Power Pole and Crossarm Forum hold an annual Pole Failure Survey to capture unassisted pole failure rates around the country. In the past TasNetworks unassisted pole failure rate has been consistently below the average pole failure rate for all networks. The reduction in 2012/13 of no TasNetworks owned unassisted pole failures is due to an increased volume of pole replacements that year due to a change in work practices for applying pole safety factors, which lead to poles being condemned prematurely. The work practice has since reverted to previous, as the increased condemning rate was not sustainable. Figure 4 outlines the pole failure rate as provided by the Electricity Networks Australia annual Pole Failure Survey.

Figure 4 - Electricity Networks Australia annual pole failure rate

Pole Failure Rate Percentage
