Investment Evaluation Summary (IES)

Project Name:	Replace Underground Furniture - LV Fibreglass Pillars
Project ID:	00514
Thread:	Underground System
CAPEX/OPEX:	CAPEX
Service Classification:	Standard Control
Scope Type:	A
Work Category Code:	REUGF
Work Category Description:	Replace UG furniture
Preferred Option Description:	Option 1: Replace LV Underground Furniture [Preferred Option]
	Replace poor condition cabinets and pillars with a focus on: frequently operated units and units located in high risk areas
	Advantages: • Minimises likelihood of exposure to the public
	Disadvantages: • CAPEX needed
	This option reduces the business risks to manageable.
Preferred Option Estimate (Nominal Dollars):	\$4,436,083

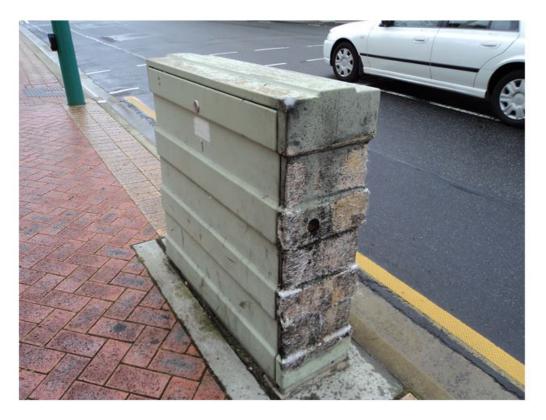
Figure 1 - Fibreglass Pillar with external damage

The low voltage fiberglass pillars are of an older design which contains exposed energized bus bars. These are mounted on metal frames which are prone to rust. The fiberglass enclosures are also prone to weathering as these degrade and become brittle in the sun. There is furniture considered to have a higher safety risk located in areas around schools and parks, as well as the ones in cities that are visited regularly for switching are proposed for replacement. These sites will be monitored more frequently and replacements having a higher priority.

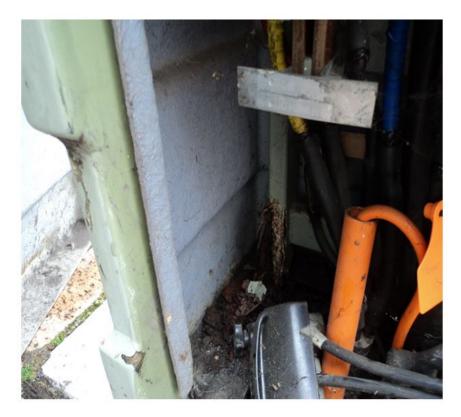
Figure 2 - Low voltage pillar with significant structural corrosion

Poor condition enclosures expose the public to live bus work. The deterioration of the enclosures will increase the safety risk. External condition is not the only concern as the buses are fastened to the ground, as the connections and structure weaken due to rust, the force applied to introduce fuses/links by operators flexes the structure. The movement of the structure can close the air insulation gap and it has potential for flashover with metal clad enclosures.
